## Banks Pumping Plant: Pumping - TOC, DOC – EC

## Jones Pumping Plant: Pumping – TOC, DOC - EC

## Gianelli – Pumping, Organic Carbon, EC

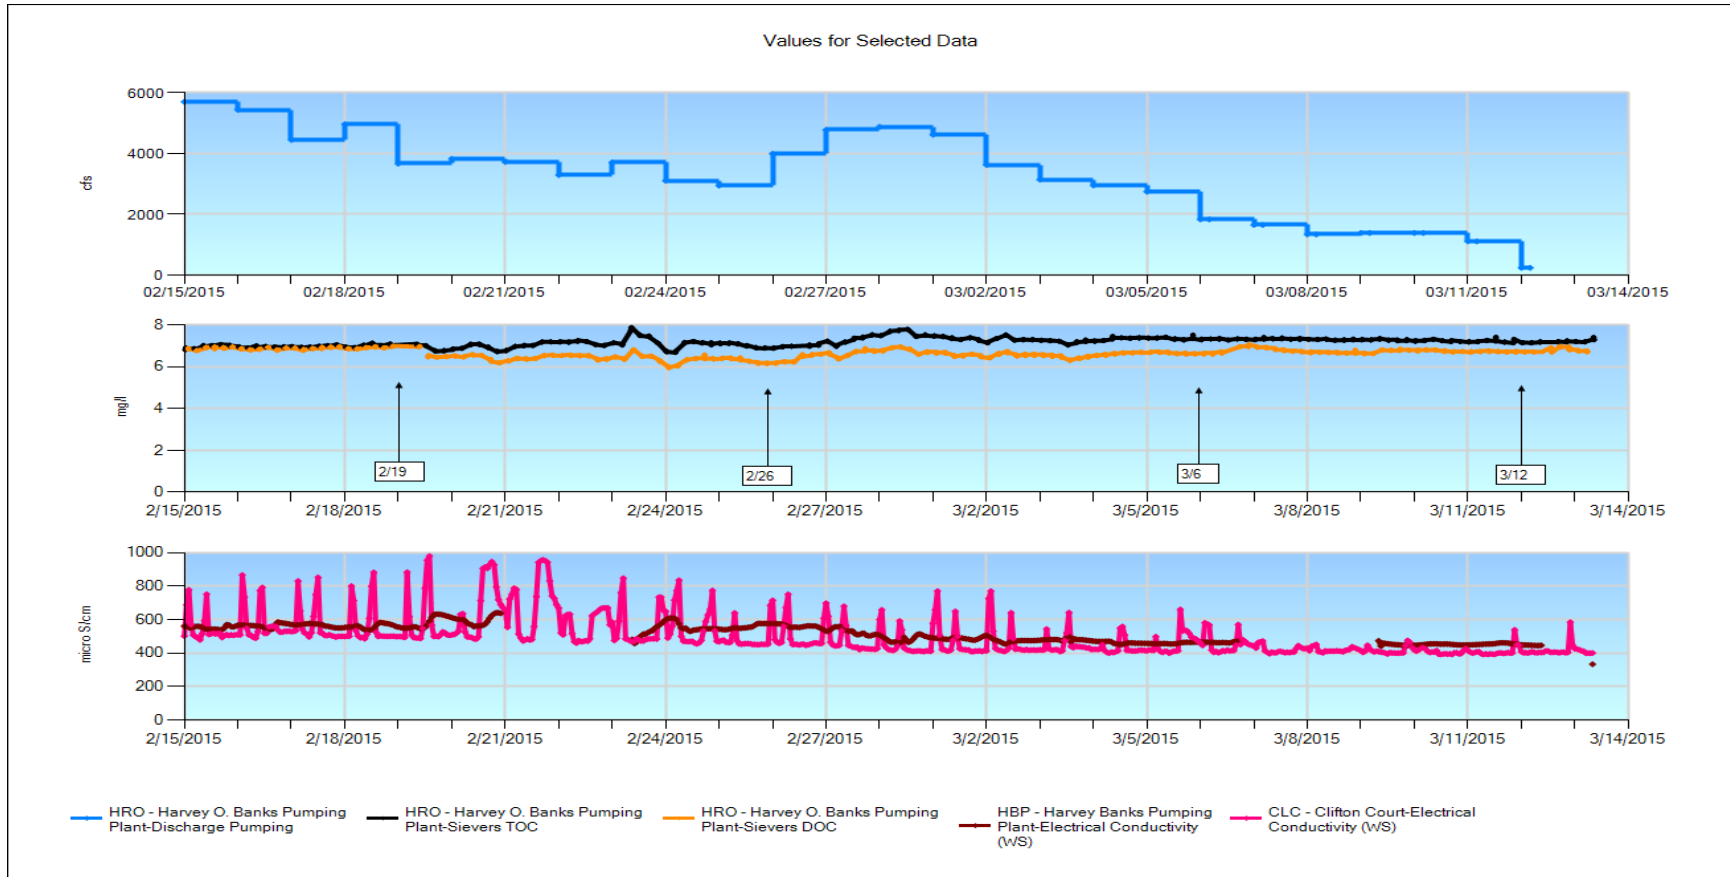
2/19 – Changed all sample delivery system filters - Prior to this station visit, DOC data were artificially elevated due to fouling of a TOC valve which prevented it from closing all the way allowing TOC water to mix with DOC water during DOC analysis.

2/26 – Changed all sample delivery system filters – Cleaned all delivery system lines – Analyzed all QC samples

3/6 – Changed all sample delivery system filters

3/12 – Replaced the 10 inch 100 um filter housing with a 20 inch housing and a 20 inch 100 um filter – Replaced the 0.45 um sample delivery system filter – Analyzed all QC samples – Steve repaired an FDOM valve issue.

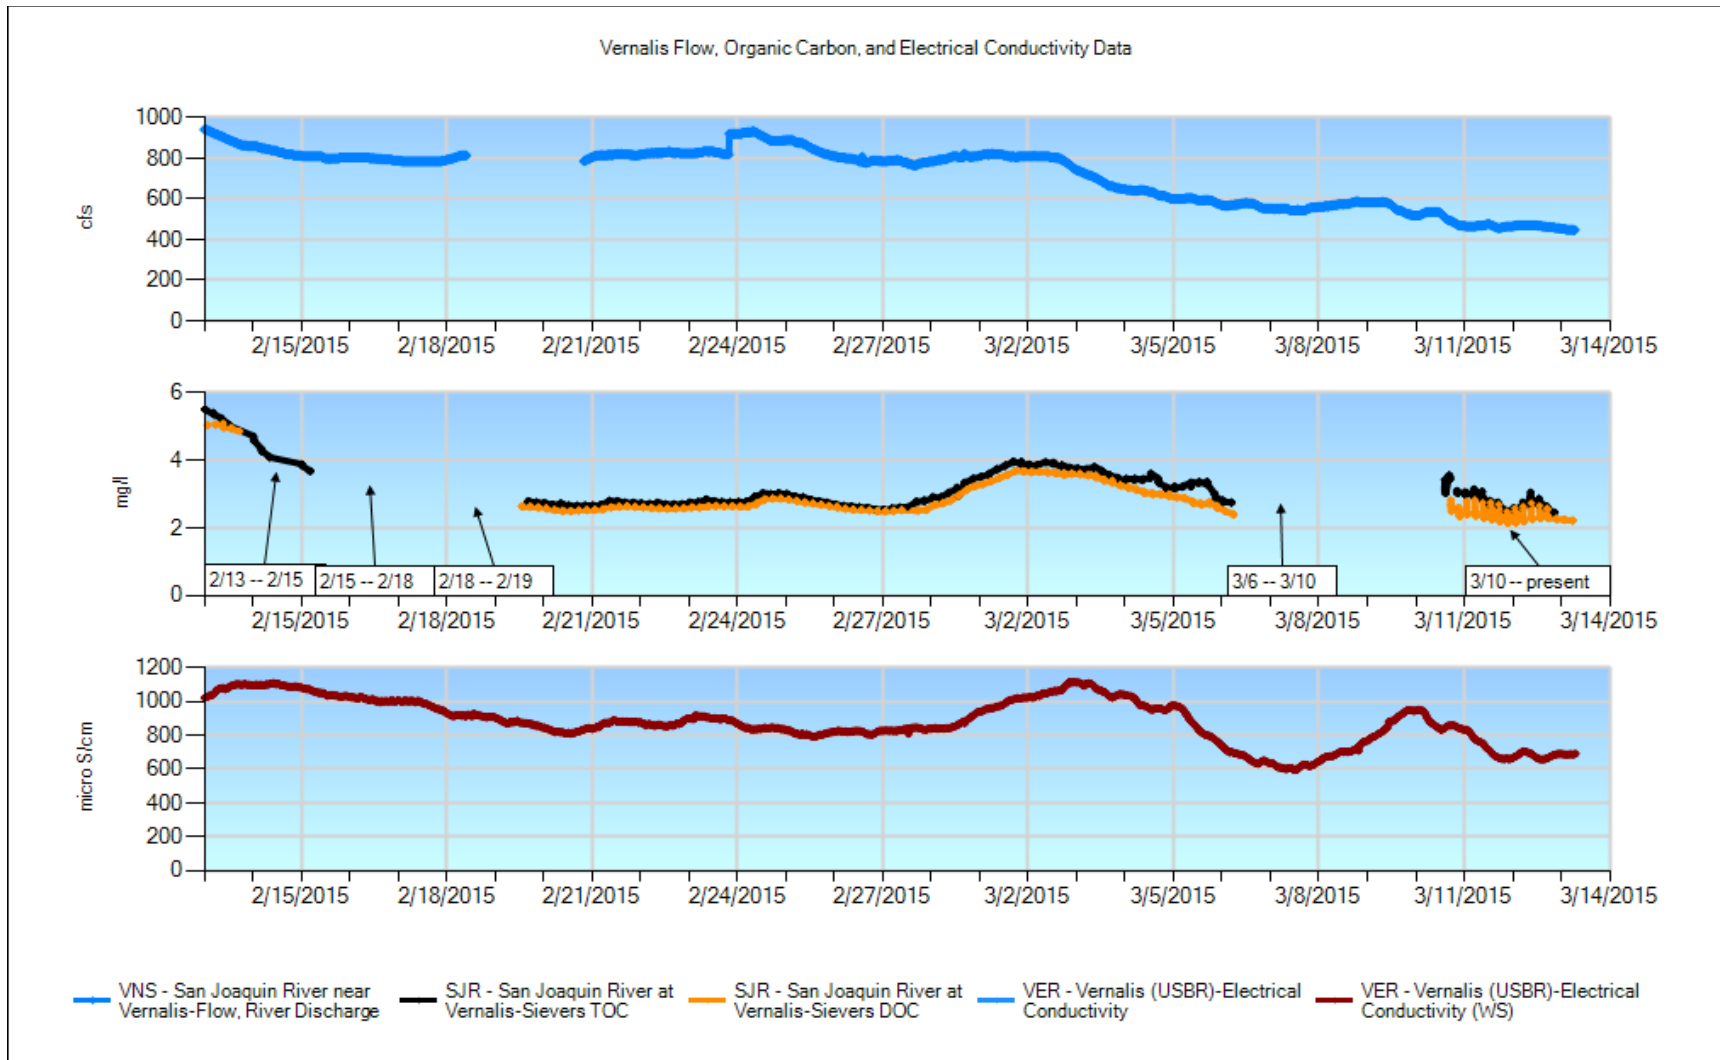
**Filter Changes:** 2/10 = all filters, 2/18 = prefilters only, 2/27 = all filters, 3/10 = all filters. **Events:** 2/13 – 2/15: Failing pump not providing adequate flow, resulting in questionable data. 2/15 – 2/18: Clogged intake not allowing enough flow to initiate the Sievers into sampling. Pump cleaned on 2/18. 2/18-2/19: Data logging software, Indigo, was not functioning. Program restarted and data was exported from the Sievers and into the DMU manually. 3/6-3/10: Power outage over the weekend. 3/10 – present: TOC valve failing, causing high DOC, then burned out.

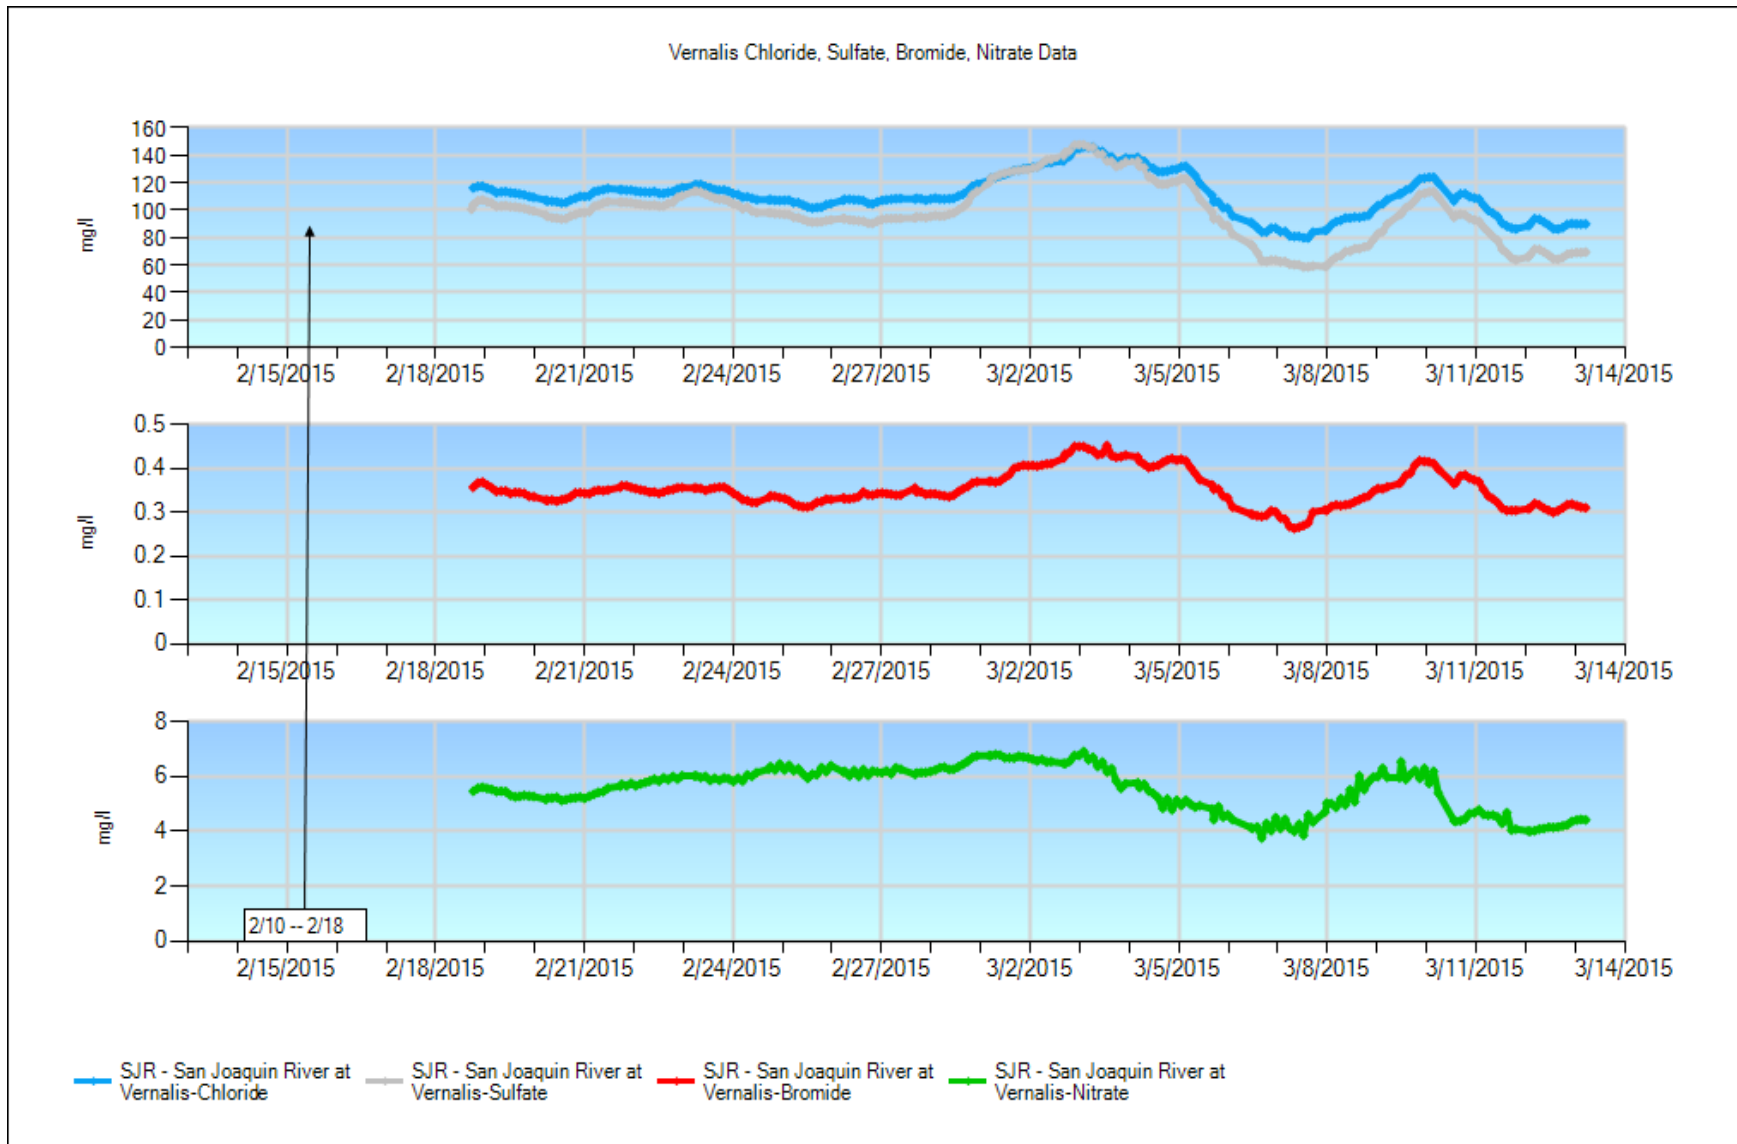
**Events: 2/10 – 2/18:** Previously thought of as a failing pump, the Dionex tech said it was “vapor lock” not allowing liquid to enter the sample pump. Another attempt at priming the system was successful and the analyzer was restarted, though the sample pump still has a minor leak.

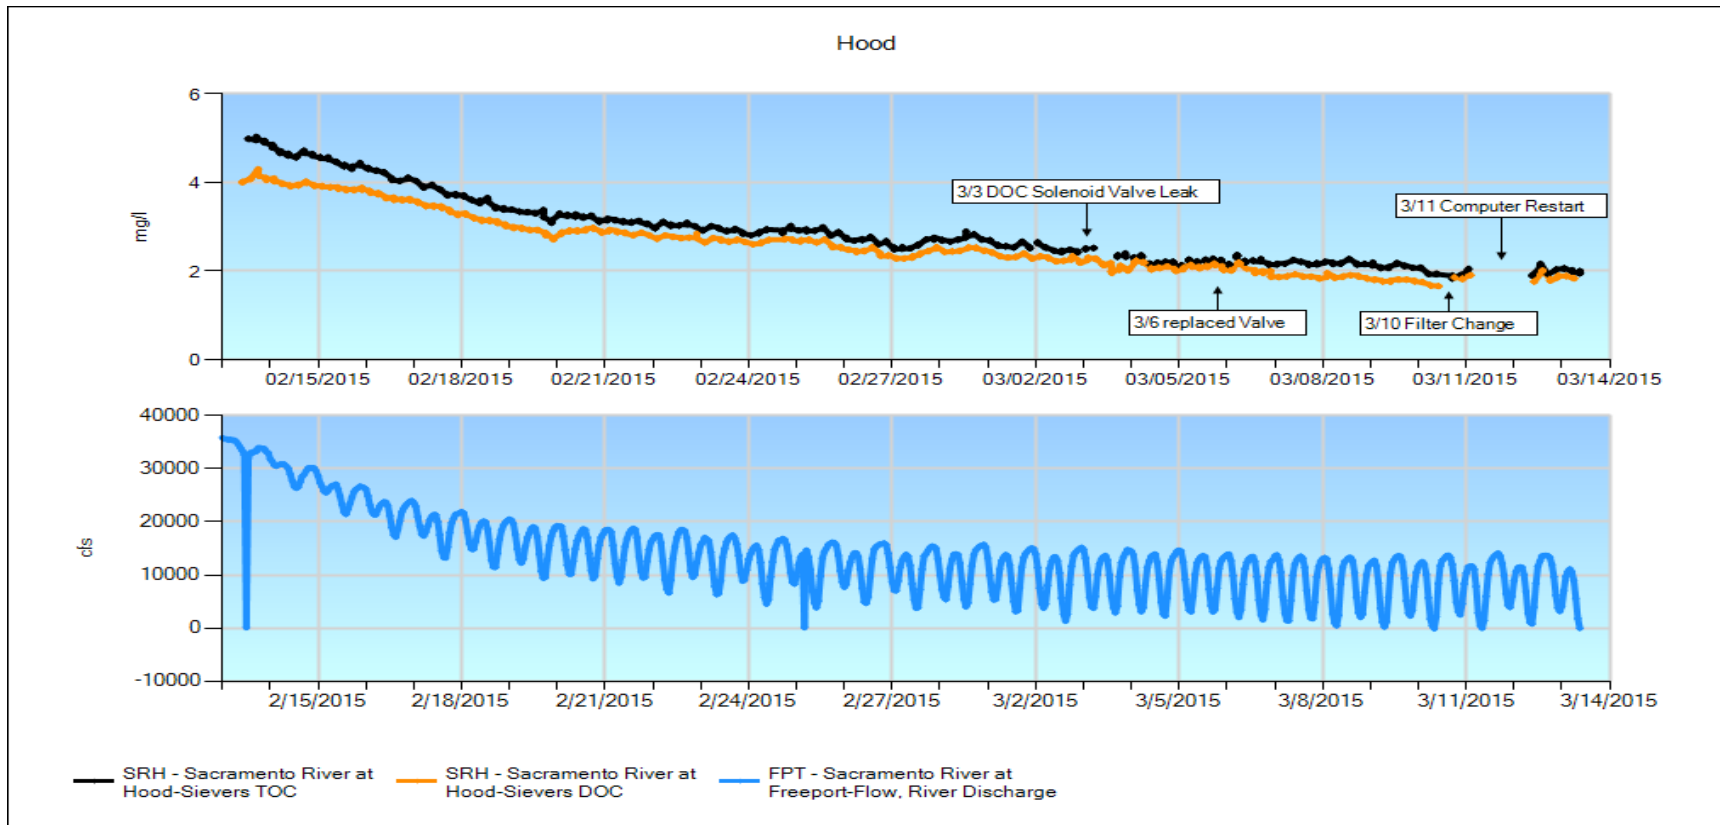
**Significant Events:** February 13<sup>th</sup> 2015 to March 13<sup>th</sup> 2015

- **3/3 DOC Solenoid Valve leak:** The DOC solenoid valve started to leak Doc sample water while running TOC water. This resulted in a mixture of water giving false TOC readings.
- **3/6 Replaced Solenoid Valve:** Replaced the DOC valve with a new valve. These valves can be cleaned from the inside and possibly be reused.
- **3/10 Filter Change:** The DOC water line .45micron filter was not flushed with DI water prior to installing it. This caused a spike on the sample water that was omitted by the data utility automatically.
- **3/11 Computer Restart:** The computer was restarted automatically causing Indigo to close and not to report to CDEC.

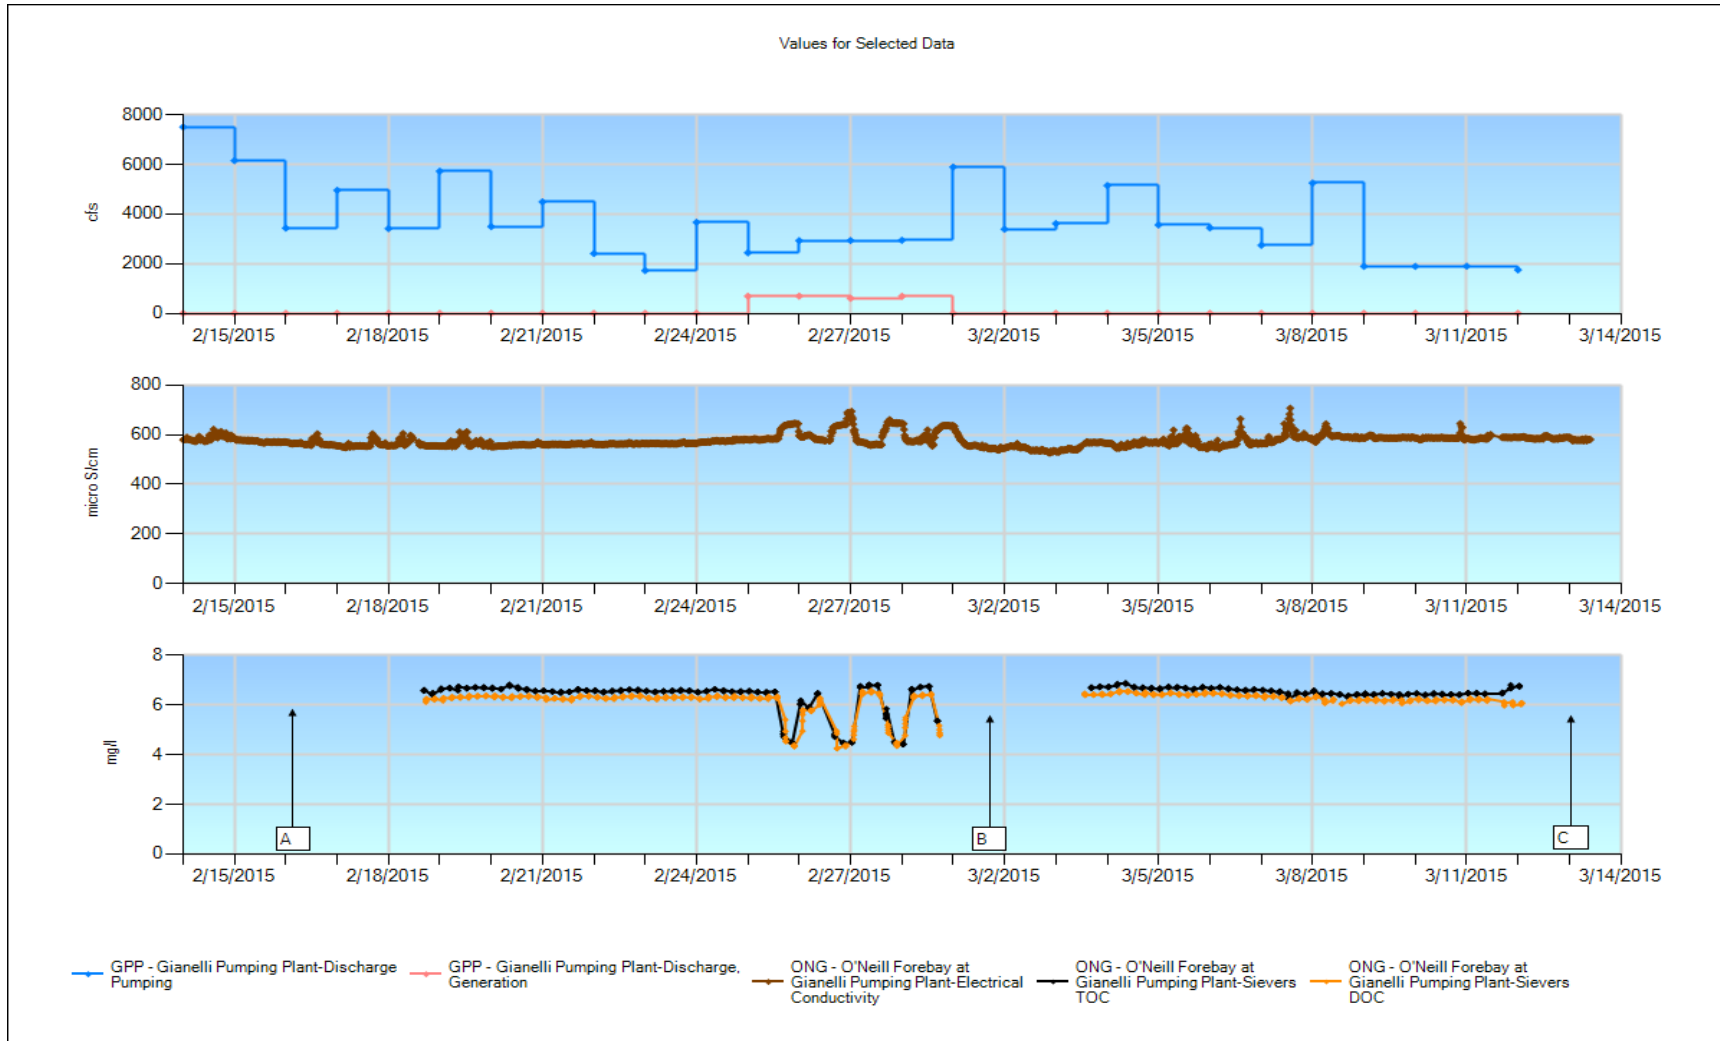
- A – Backup battery failed and Sievers was left in grab mode after station visit.
- B – Oxidizer syringe motor was stuck in place; had to reset it manually.
- C – Water supply solenoid system is having a problem.

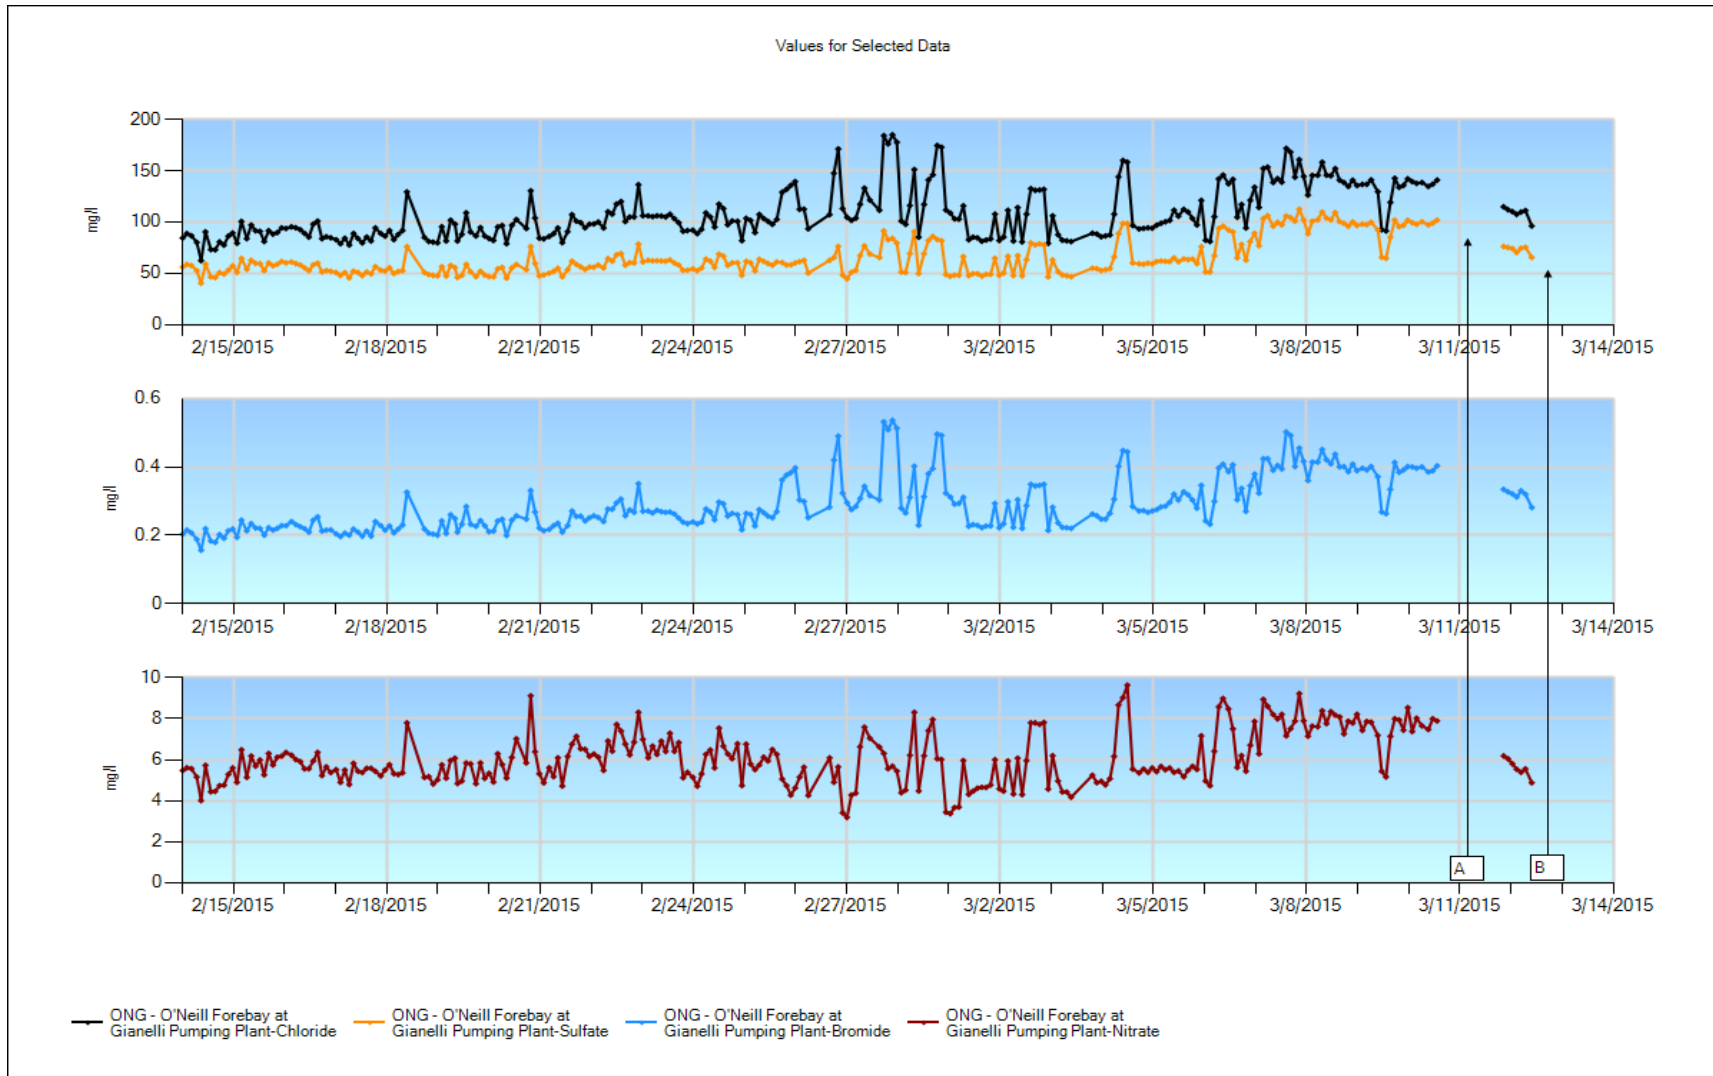
Gianelli – Chloride, Sulfate, Bromide, Nitrate

- A – The communication error returned.
- B – Low flow, possibly due to OC solenoid problem, caused errant readings.
