Significant Events: Sep 23th 2017 to Oct 24th 2017

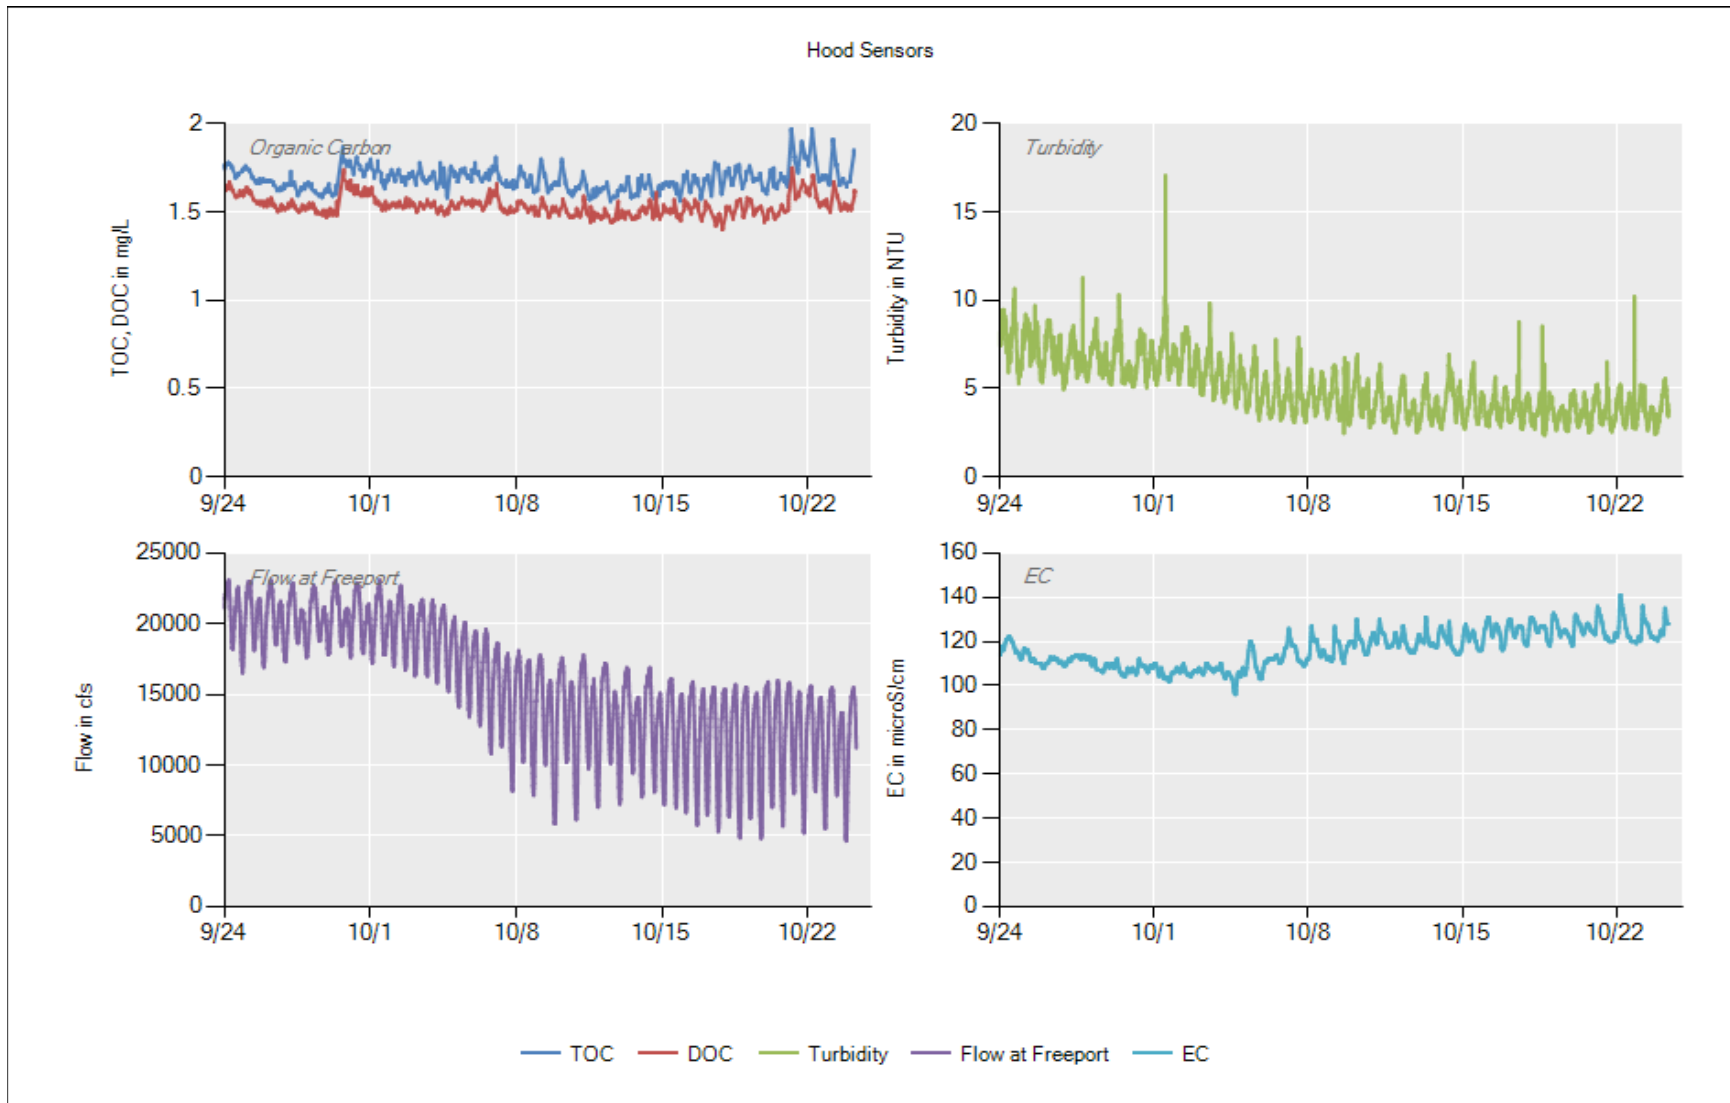
9/29: Cleaned settling chamber. Replaced 50, 1 and 0.45 um filters.

10/17: Cleaned filter housings. Cleaned 50 um filter. Replaced 1 um filter. Did not replace 0.45 um filter.

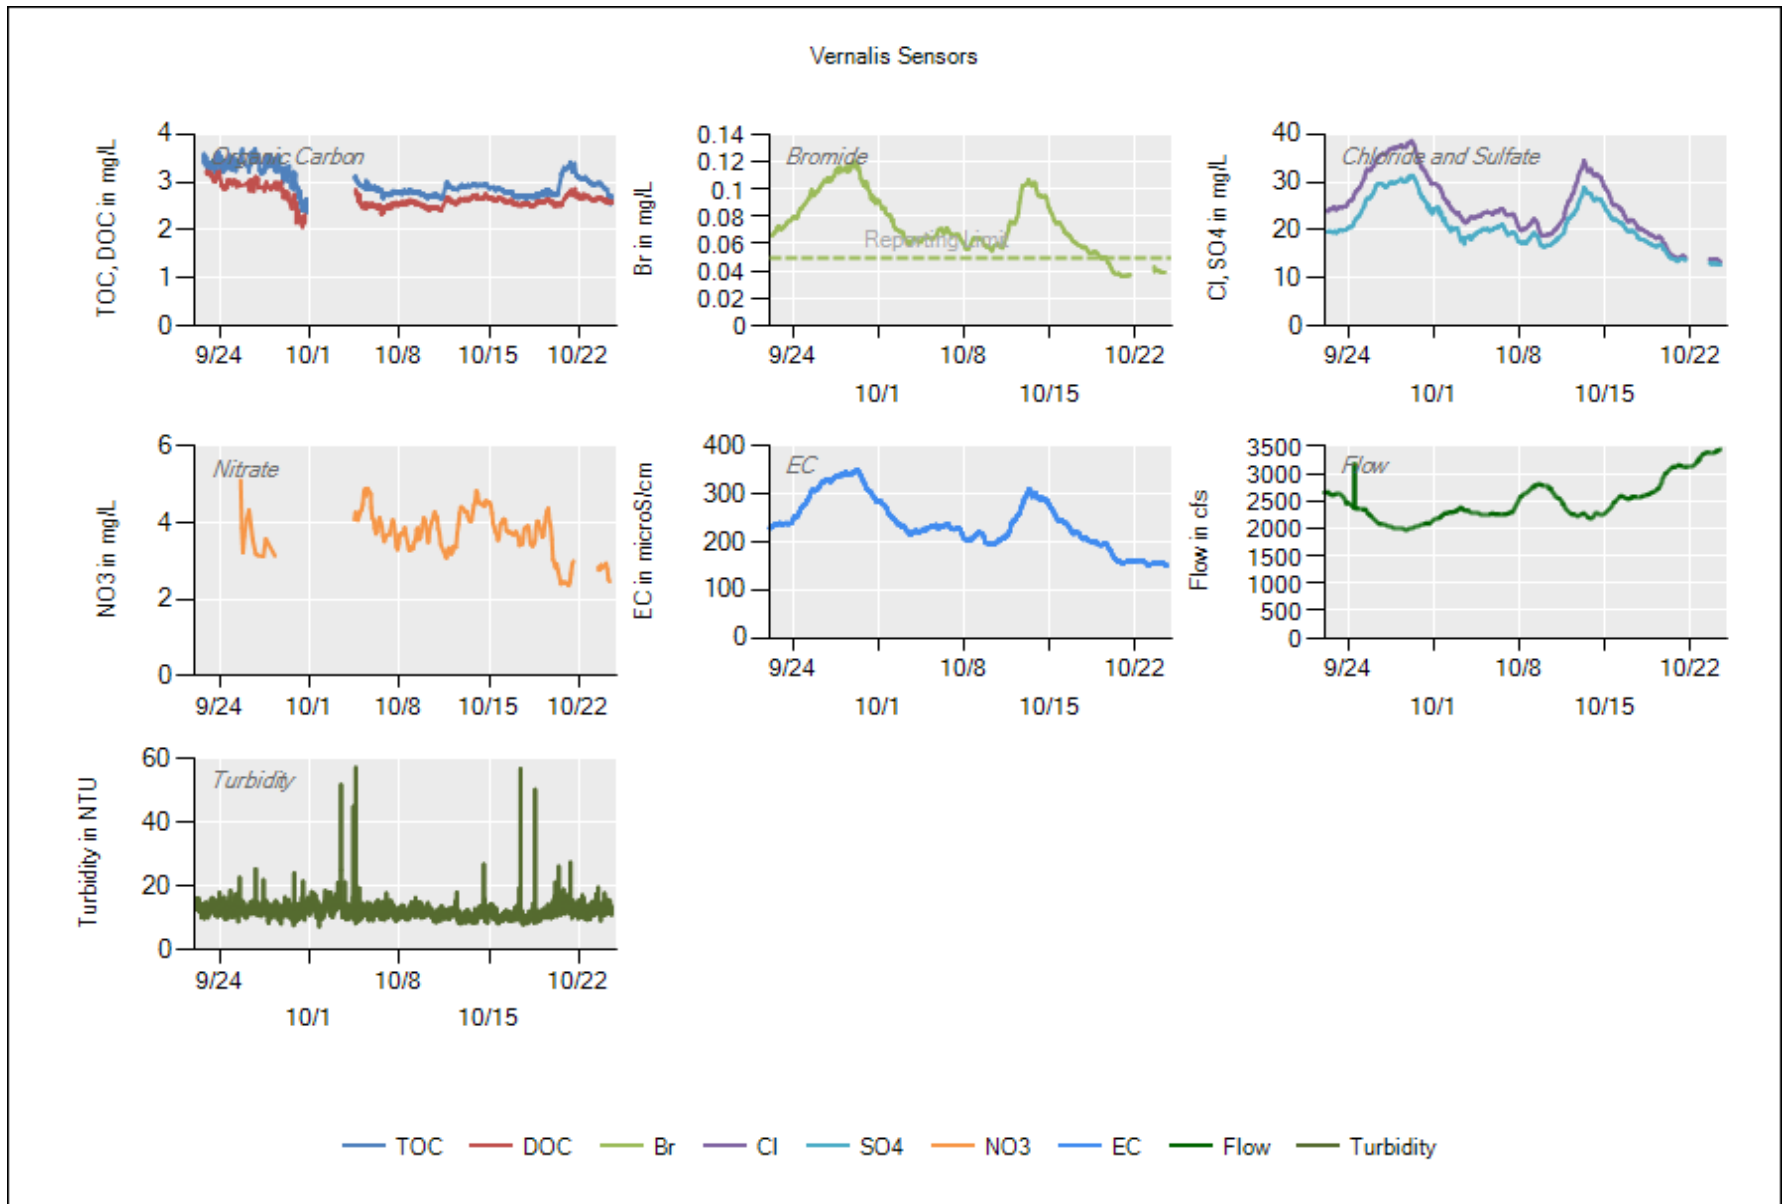
9/23 = TOC/DOC results overlap from a leaking valve (data edited). 10/1-10/4 = Clog in the Sievers sample inlet. 10/22 = Dionex software glitch.

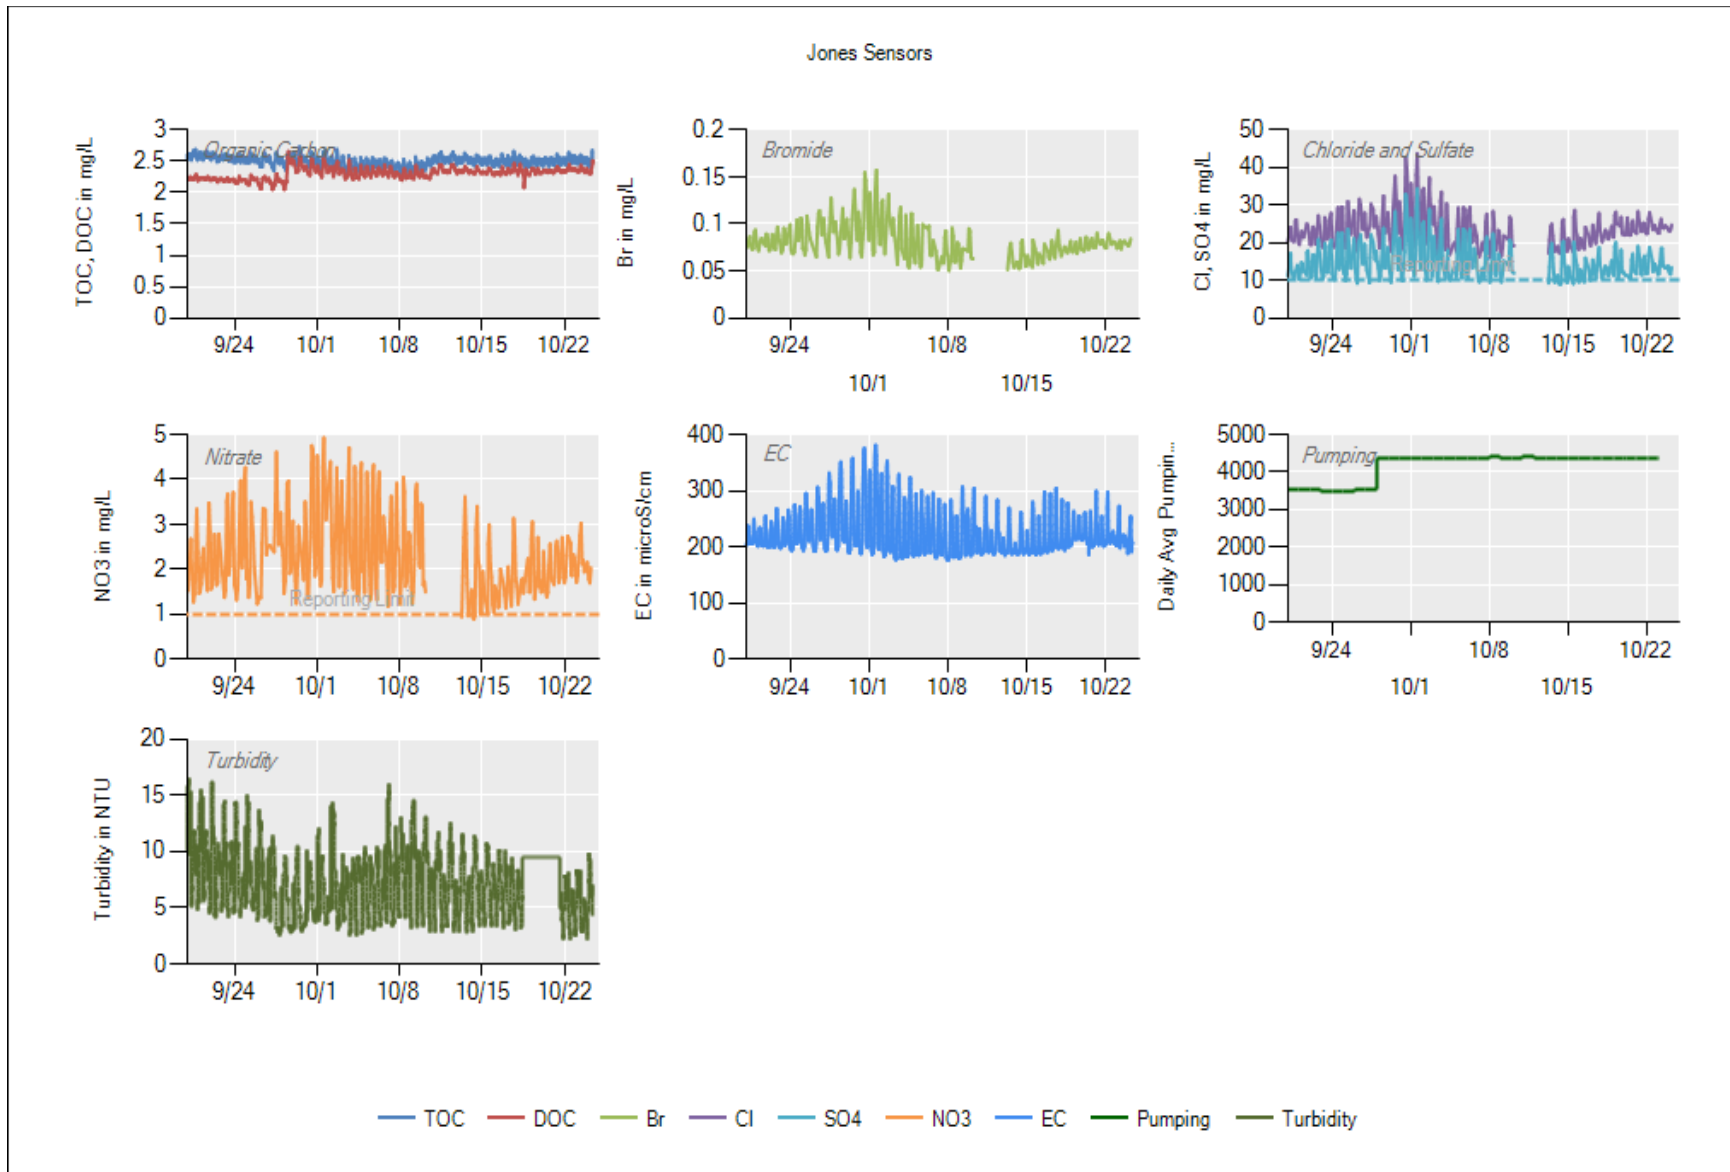
9/28/17 – filter change. **10/10/17** – The Dionex eluent generator was replaced and the Dionex was recalibrated. Filter change.

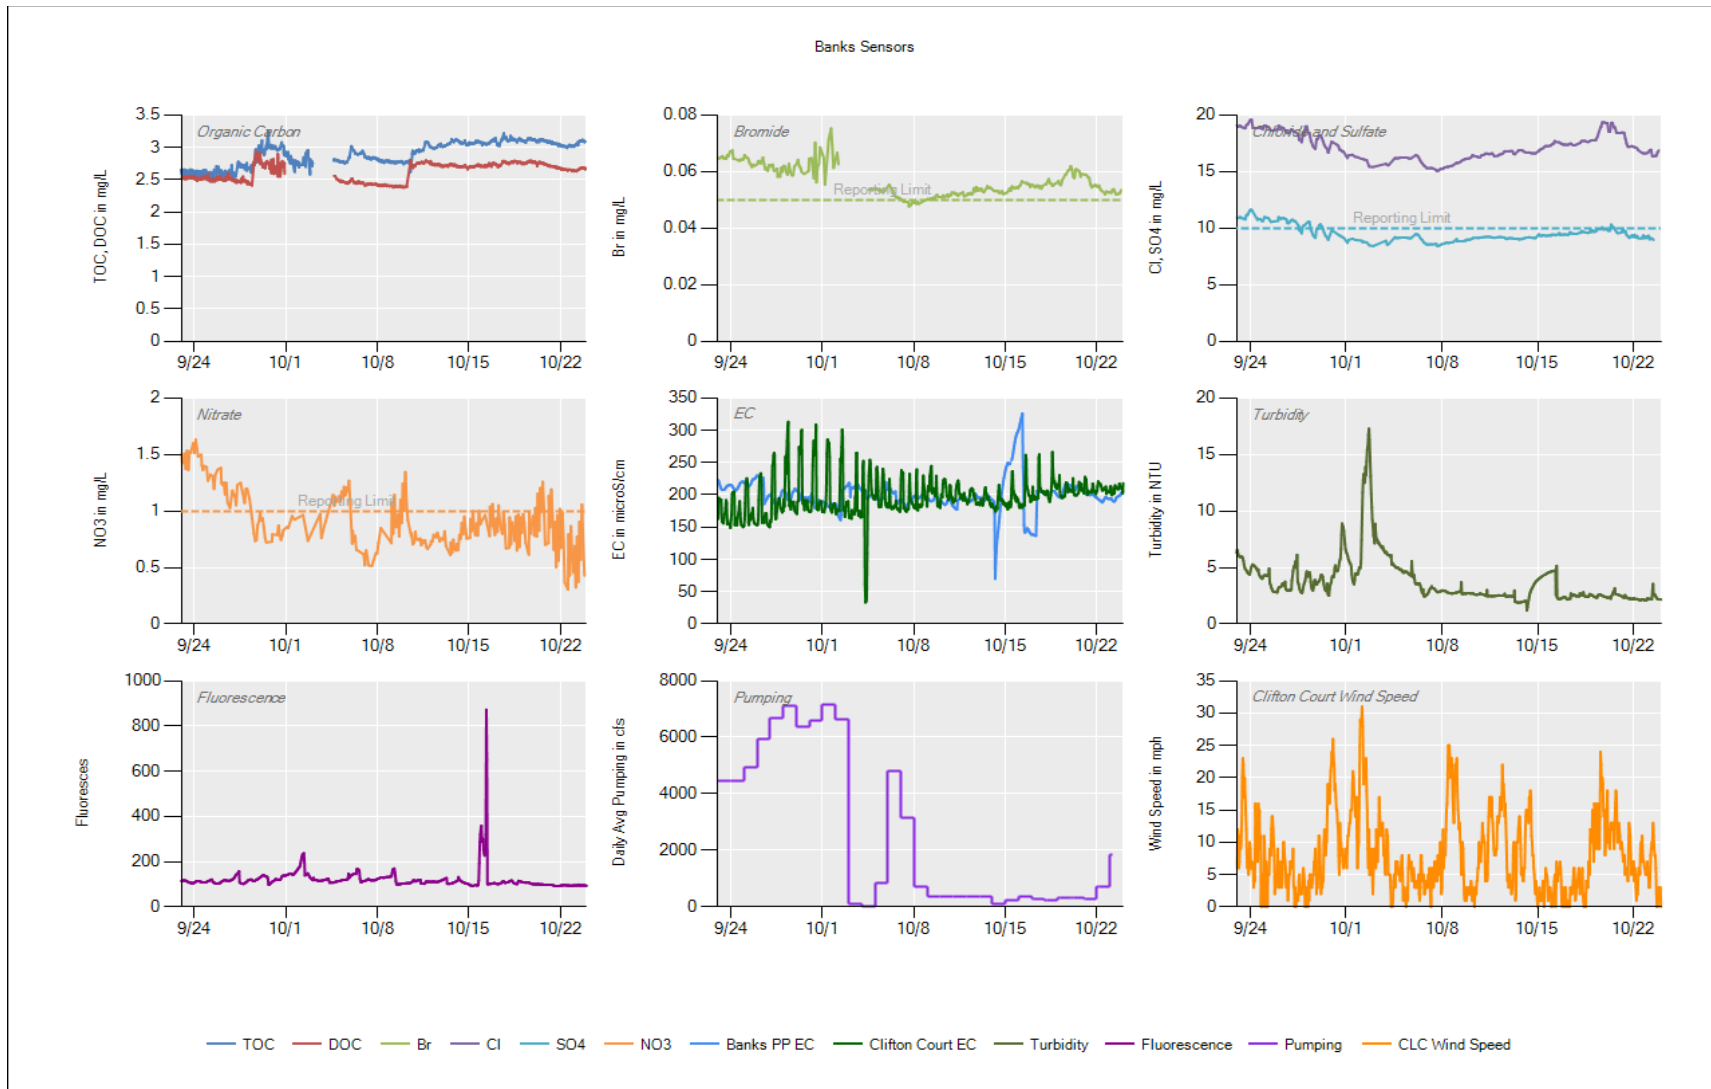
- **10/2 Foot valve clog:** The main water intake foot valve was clogged. Had to replace the foot valve and restart the water pump.

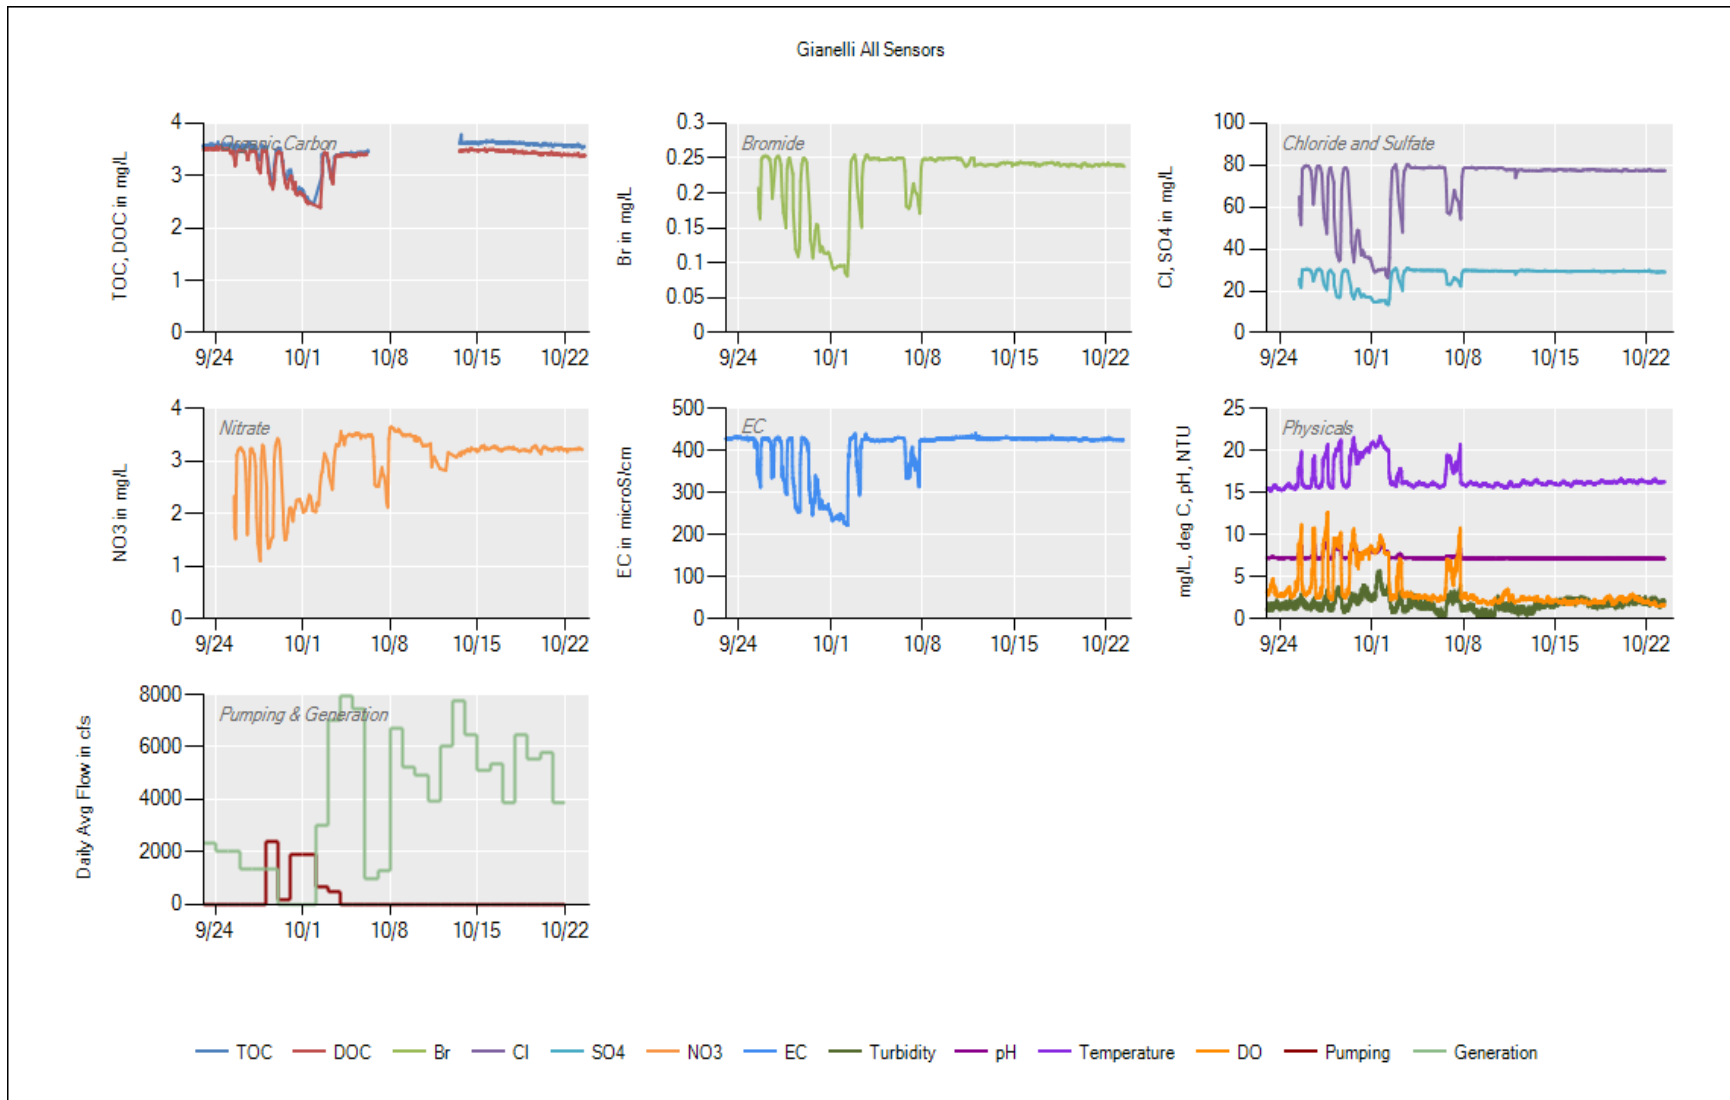
- 10/6 to 10/13 – The Sievers stopped recording for an unknown reason. There were no indications of a power outage or other cause. This error has not resurfaced.
