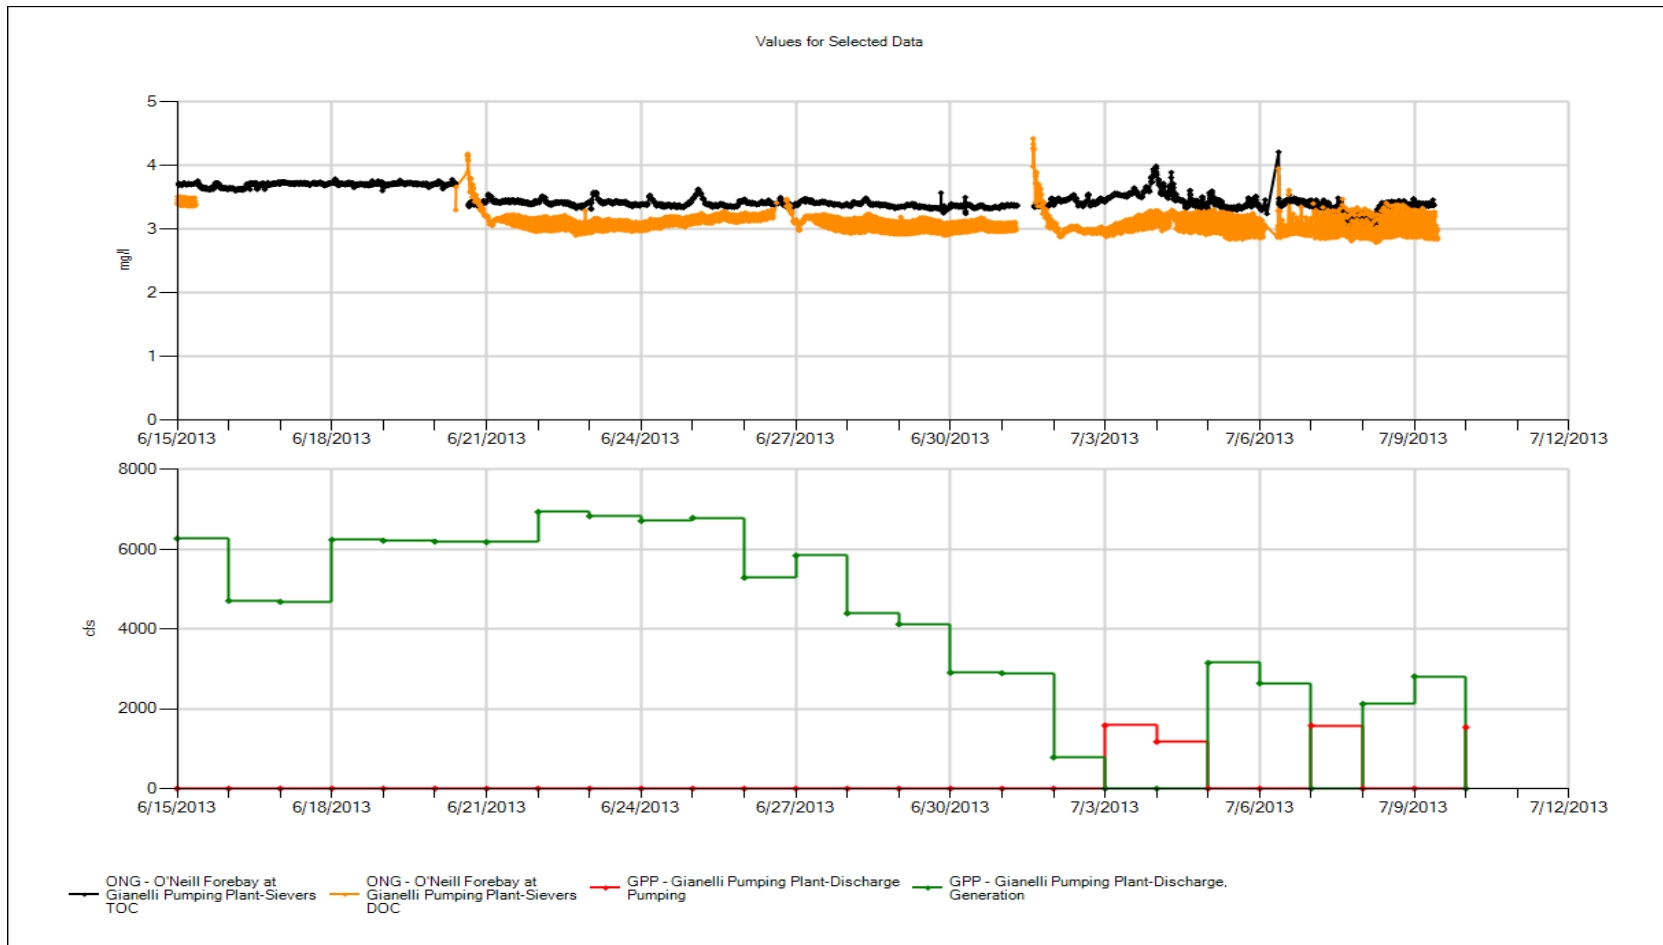
Gianelli Organic Carbon and Pumping/Generating

Gianelli Significant Sievers Events: June 15, 2013 – July 12, 2013

- Power outage on **6/15** caused the StreamWalker to only process TOC samples.
- System calibration on **6/20** and standard QC on **7/1**.
- Wide ranging DOC readings after **7/3** most likely caused by plug of algae.
- Data after 7/9 was not reported due to modem problems. The data exists and will be backfilled as soon as possible.

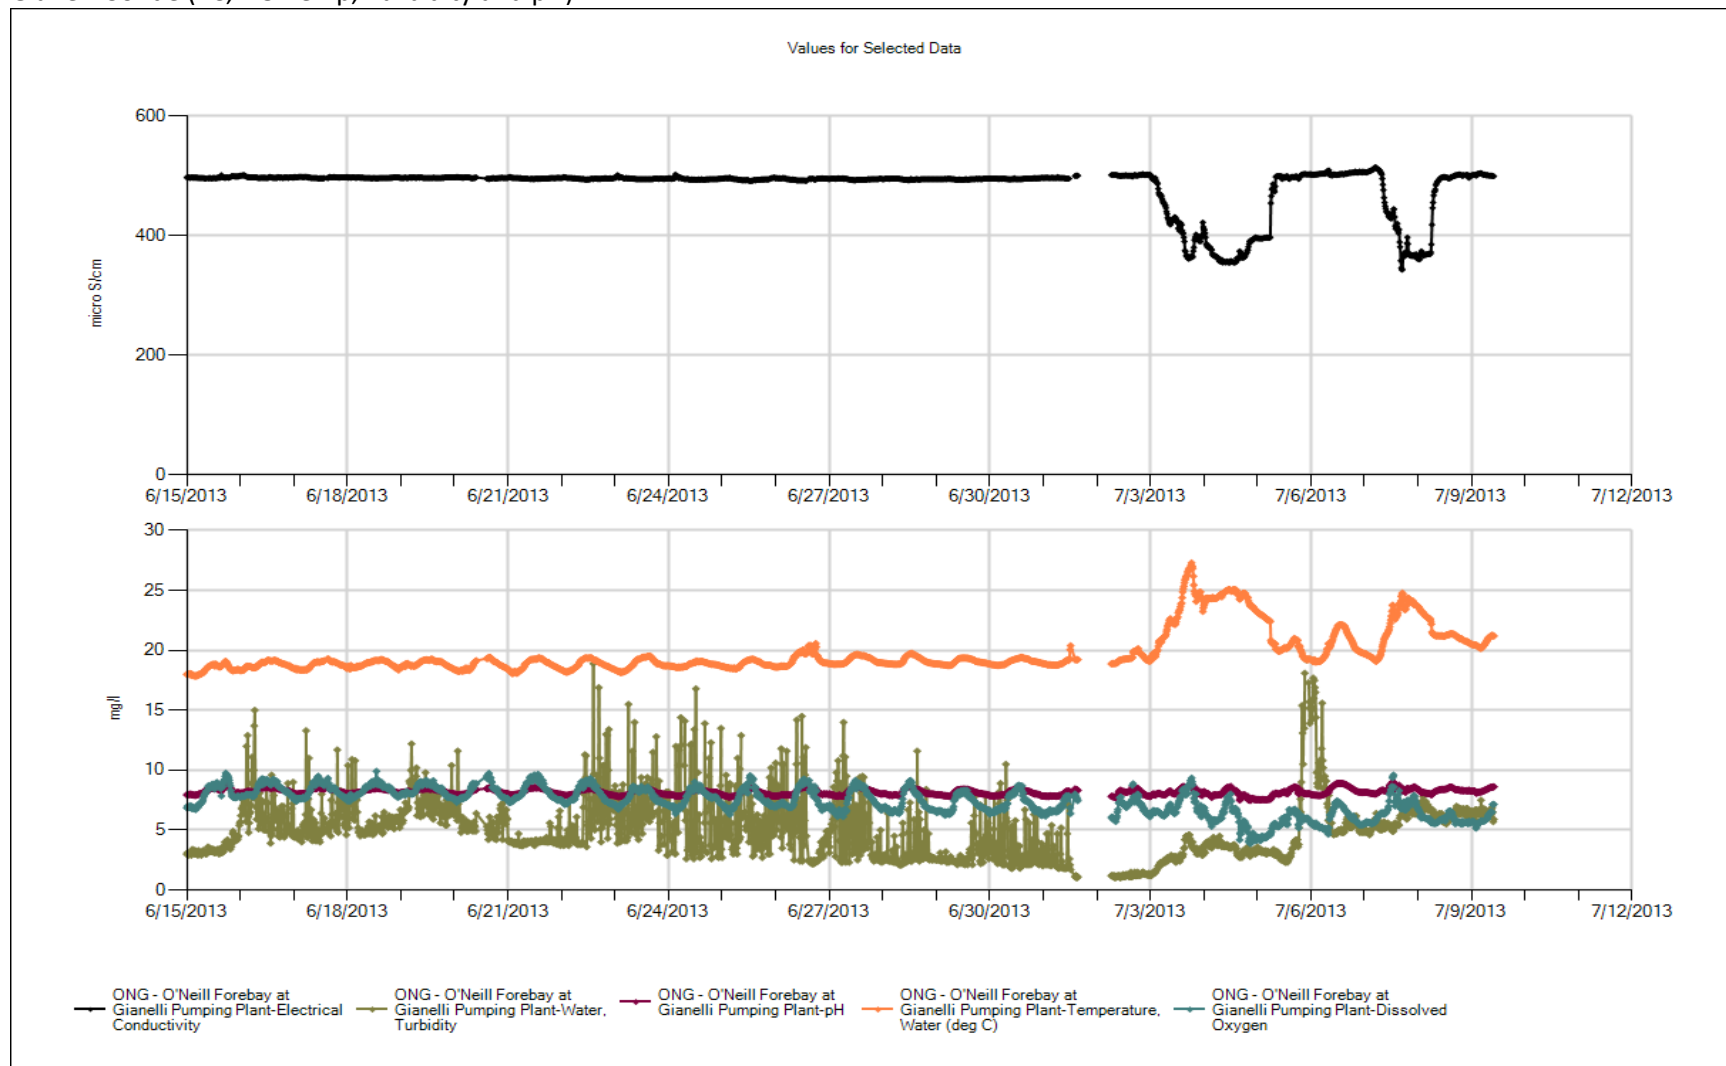
Gianelli Sonde (EC, DO Temp, Turbidity and pH):

Gianelli Significant Sonde Events: June 15, 2013 – July 12, 2013

- Erratic turbidity spikes due to build up in the sonde housing.
- Sonde data reporting wasn't turned back on after station visit. Data will be backfilled once it has been downloaded.

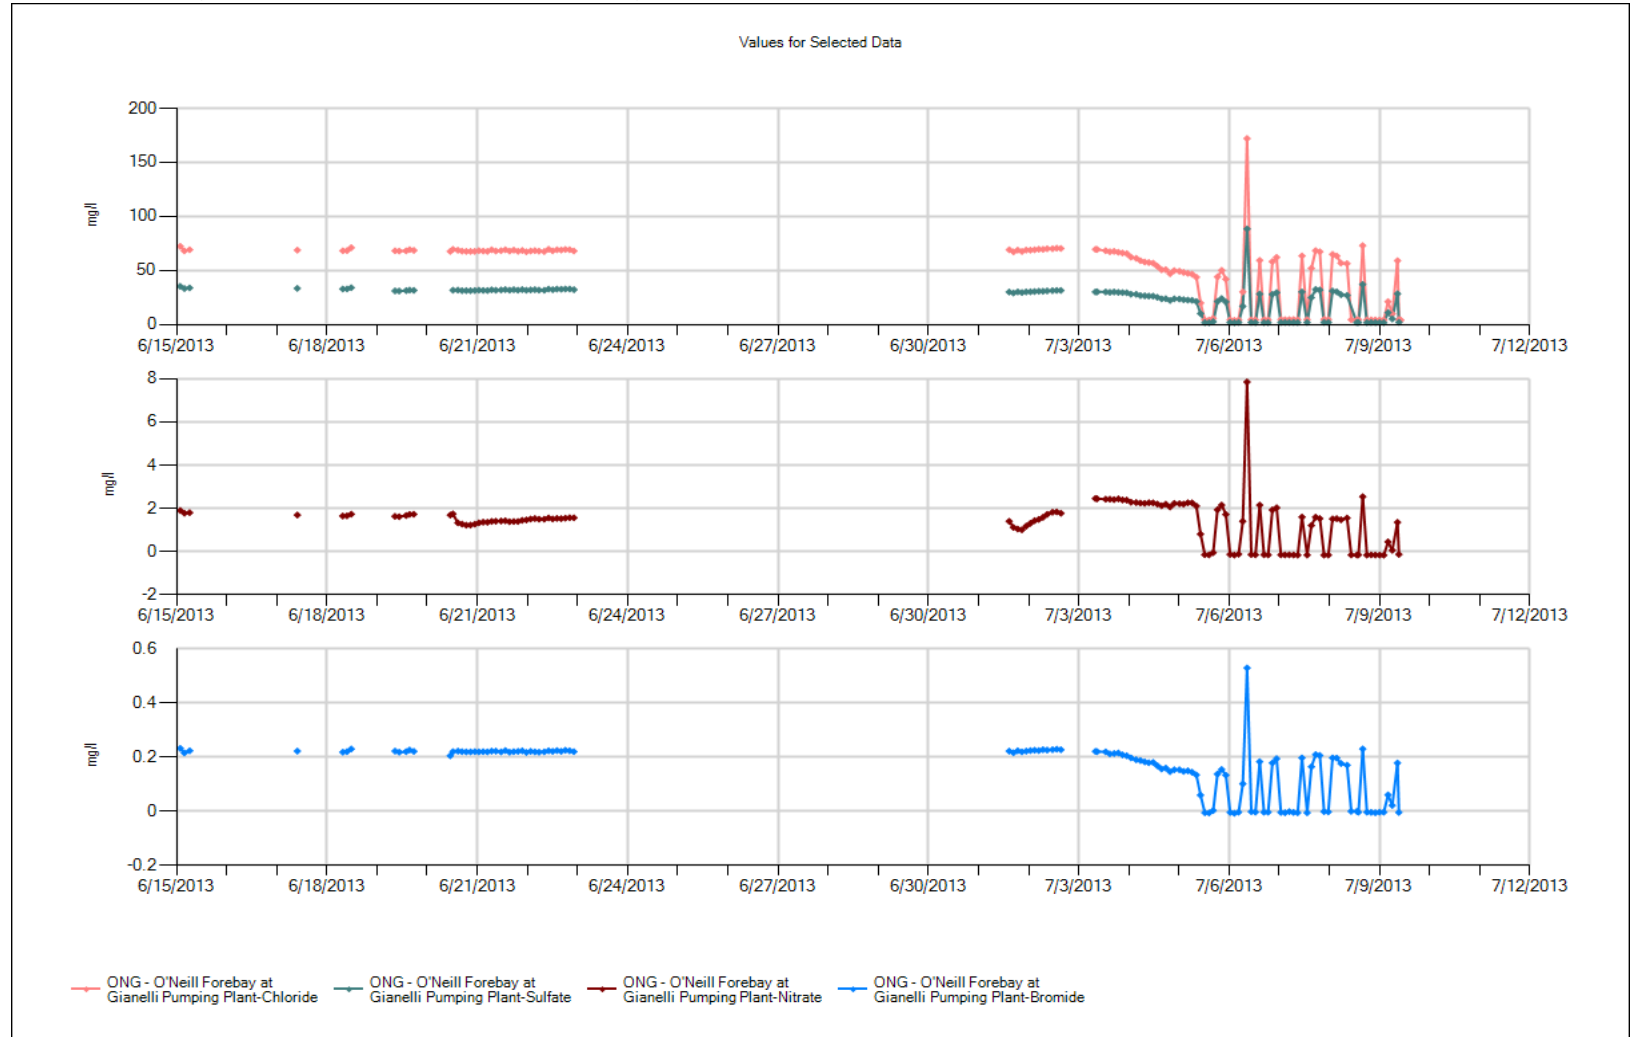
Gianelli Anions (Chloride, Sulfate, Nitrate & Bromide)

Gianelli Significant Metrohm Events: June 15, 2013 – July 12, 2013

- Power outage on **6/15** caused instrument to shut down.
- Instrument lost communication with a periphery device and shut down on **6/18, 6/20, and 6/22**.
- Obstruction in sample flow path caused erratically low readings from **7/5 to 7/9**.

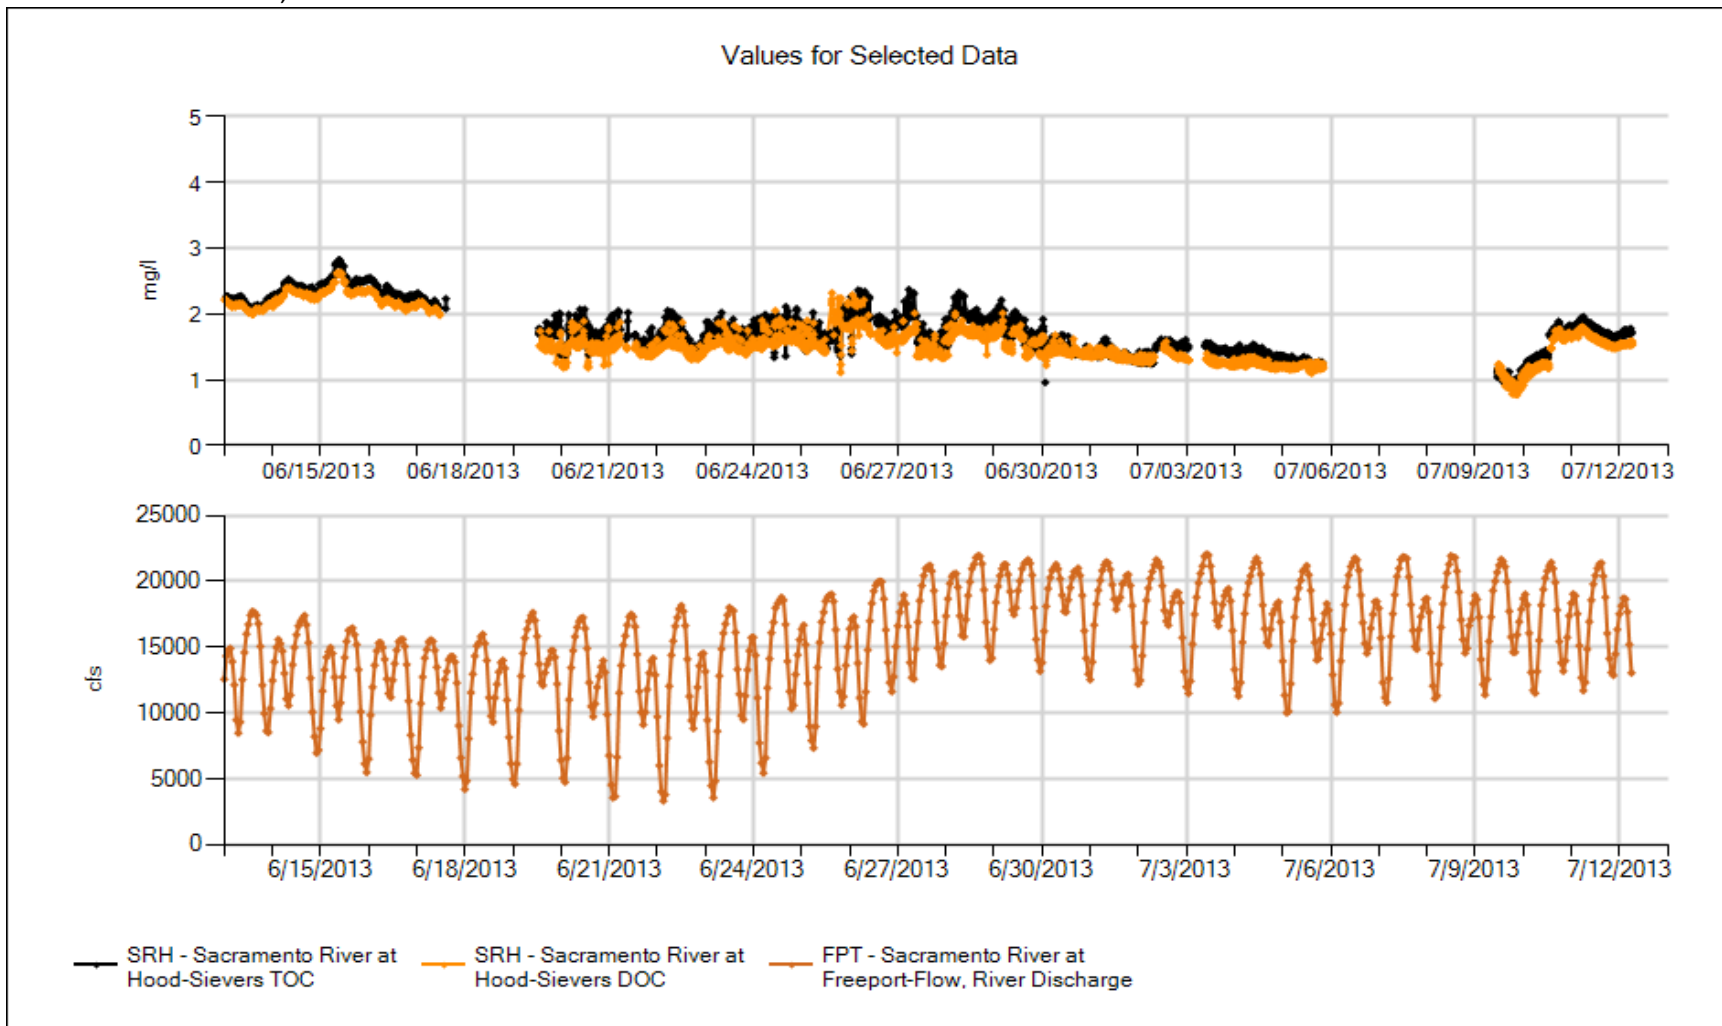
Sacramento River: TOC, DOC and Flow rate

Significant events: **6/17** – Filters changed, oxidizer cartridge changed, pre-calibration procedures conducted. **6/18** – Calibration postponed due to resin bed flushing. **6/19** – Calibration passed. **6/21** – Acid cartridge was changed. For about two weeks the analyzer experienced erratic readings and software glitches. It was finally determined that the micro-tubing running from the DI reservoir to one of the solenoid valves was completely clogged. After the system was flushed and the micro-tubing cleaned, the analyzer began running smoothly. **6/28** – back-flushed membranes to remove any clogs. **7/2** – Filters changed. **7/10** – Cleaned and re-installed solenoid tubing.

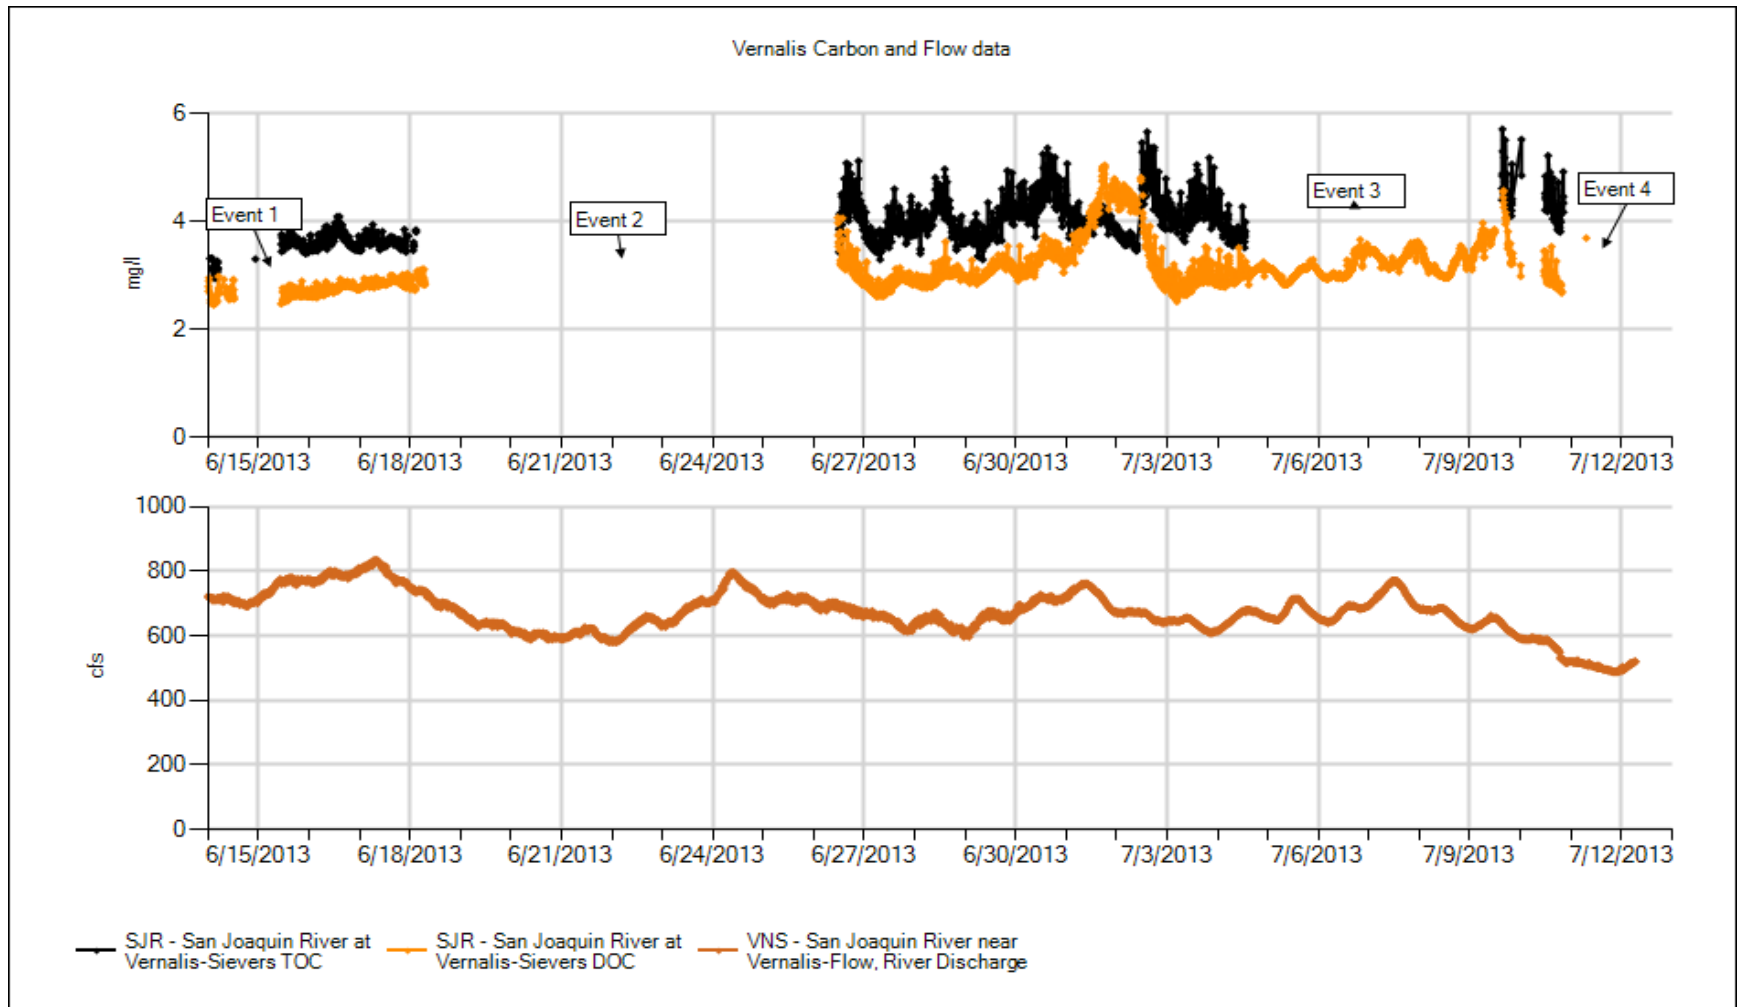
Event 1: Possibly low water left pump dry. **Event 2:** Low water caused pump to run dry. Pump was shut off and the standpipe and river substrate altered to allow the pump to sit deeper. The pump was already damaged and needed replacement. Purchasing restrictions (no Cal-Cards) made it difficult to procure a new pump/motor. New pump installed on 6/26. **Event 3:** Power outage caused the stream-splitter to run only one stream, DOC, until it could physically reset. **Event 4:** Low water and sediment loading around the pump will not allow the motor to dissipate heat, thereby tripping the thermo-protection switch and not providing water to the station. Should be fixed today, 7/12.

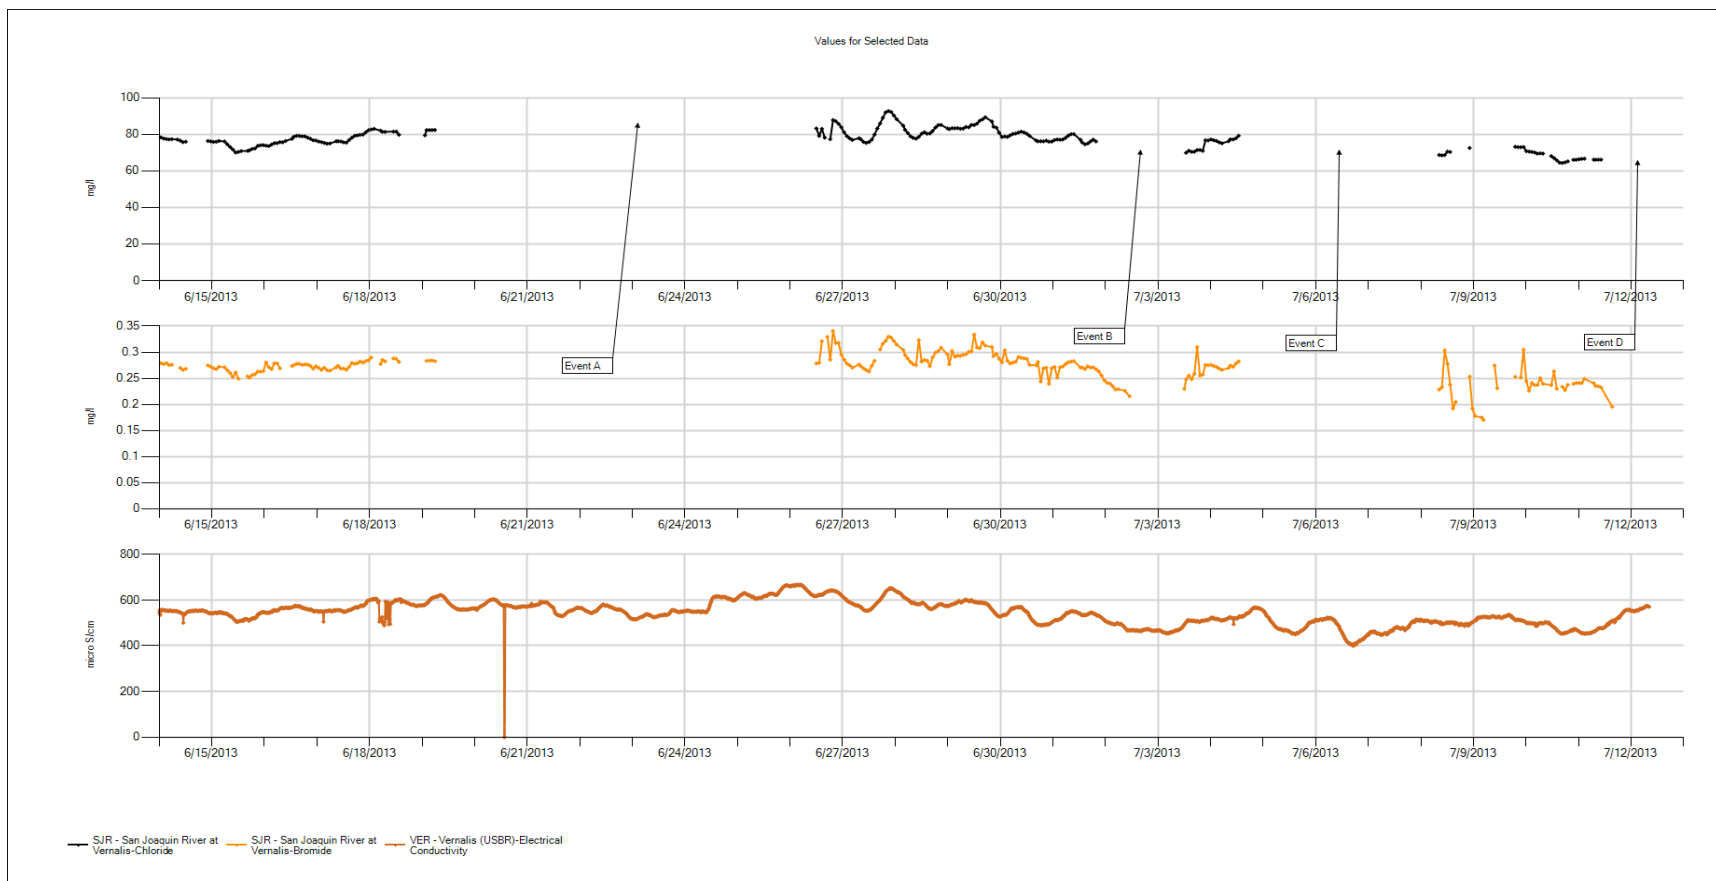
Vernalis Chloride, Bromide and EC

Event A: Low water caused pump to run dry. Pump was shut off and the standpipe and river substrate altered to allow the pump to sit deeper. The pump was already damaged and needed replacement. Purchasing restrictions (no Cal-Cards) made it difficult to procure a new pump/motor. New pump installed on 6/26. **Event B:** Clogged delivery/waste line on the Dionex. Also some difficulty with a dirty solenoid valve. **Event C:** Power outage during the holiday. Dionex was restarted on Friday, but did not report the good data. Could not reset the Dionex until Tuesday (new site recon on Monday), but did provide some data (albeit suspect) on Monday from a remote restart. **Event D:** Low water and sediment loading around the pump will not allow the motor to dissipate heat, thereby tripping the thermo-protection switch and not providing water to the station. Should be fixed today, 7/12.
