Banks Pumping Plant – Pumping, TOC, DOC and EC – Clifton Court EC

Significant Events: January 16th 2015 to February 13th 2015

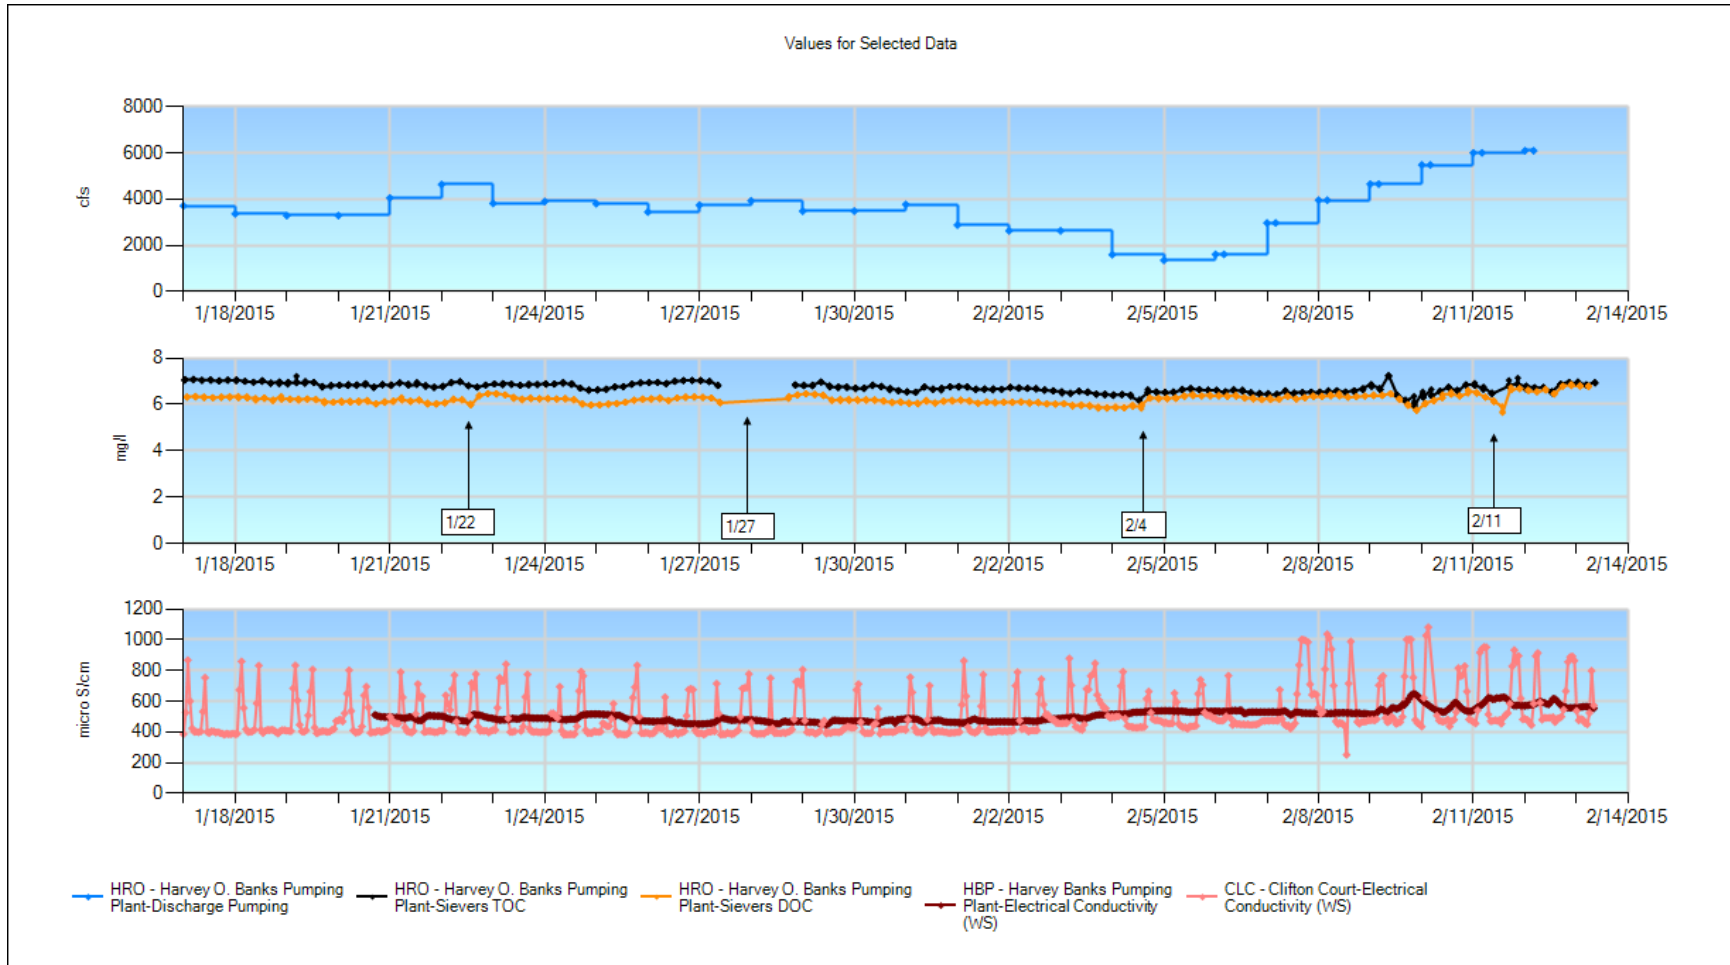
1/22 – Delivery system filter change

1/27 – Sievers preventative maintenance and calibration

2/4 – Delivery system filter change

2/11 – Delivery system filter change, QC sample analyses

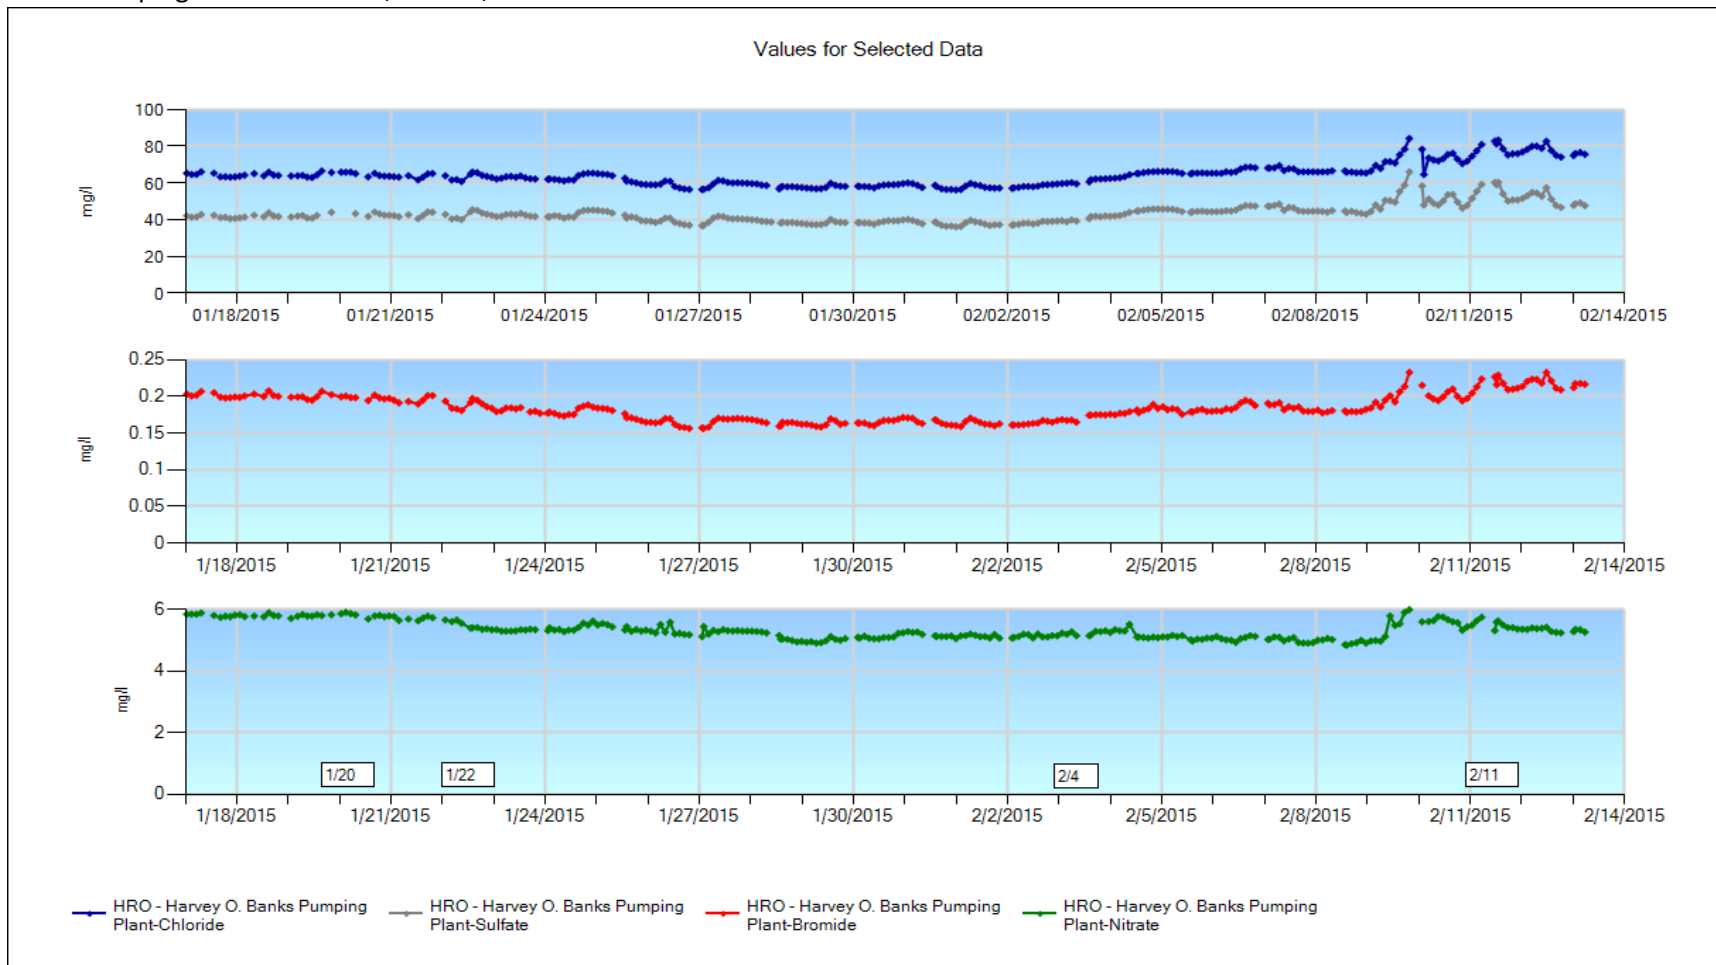
1/20 – Dionex sample flow obstruction

1/22 – Delivery system filter change

2/4 – Delivery system filter change

2/11 - Delivery system filter change, QC sample analyses

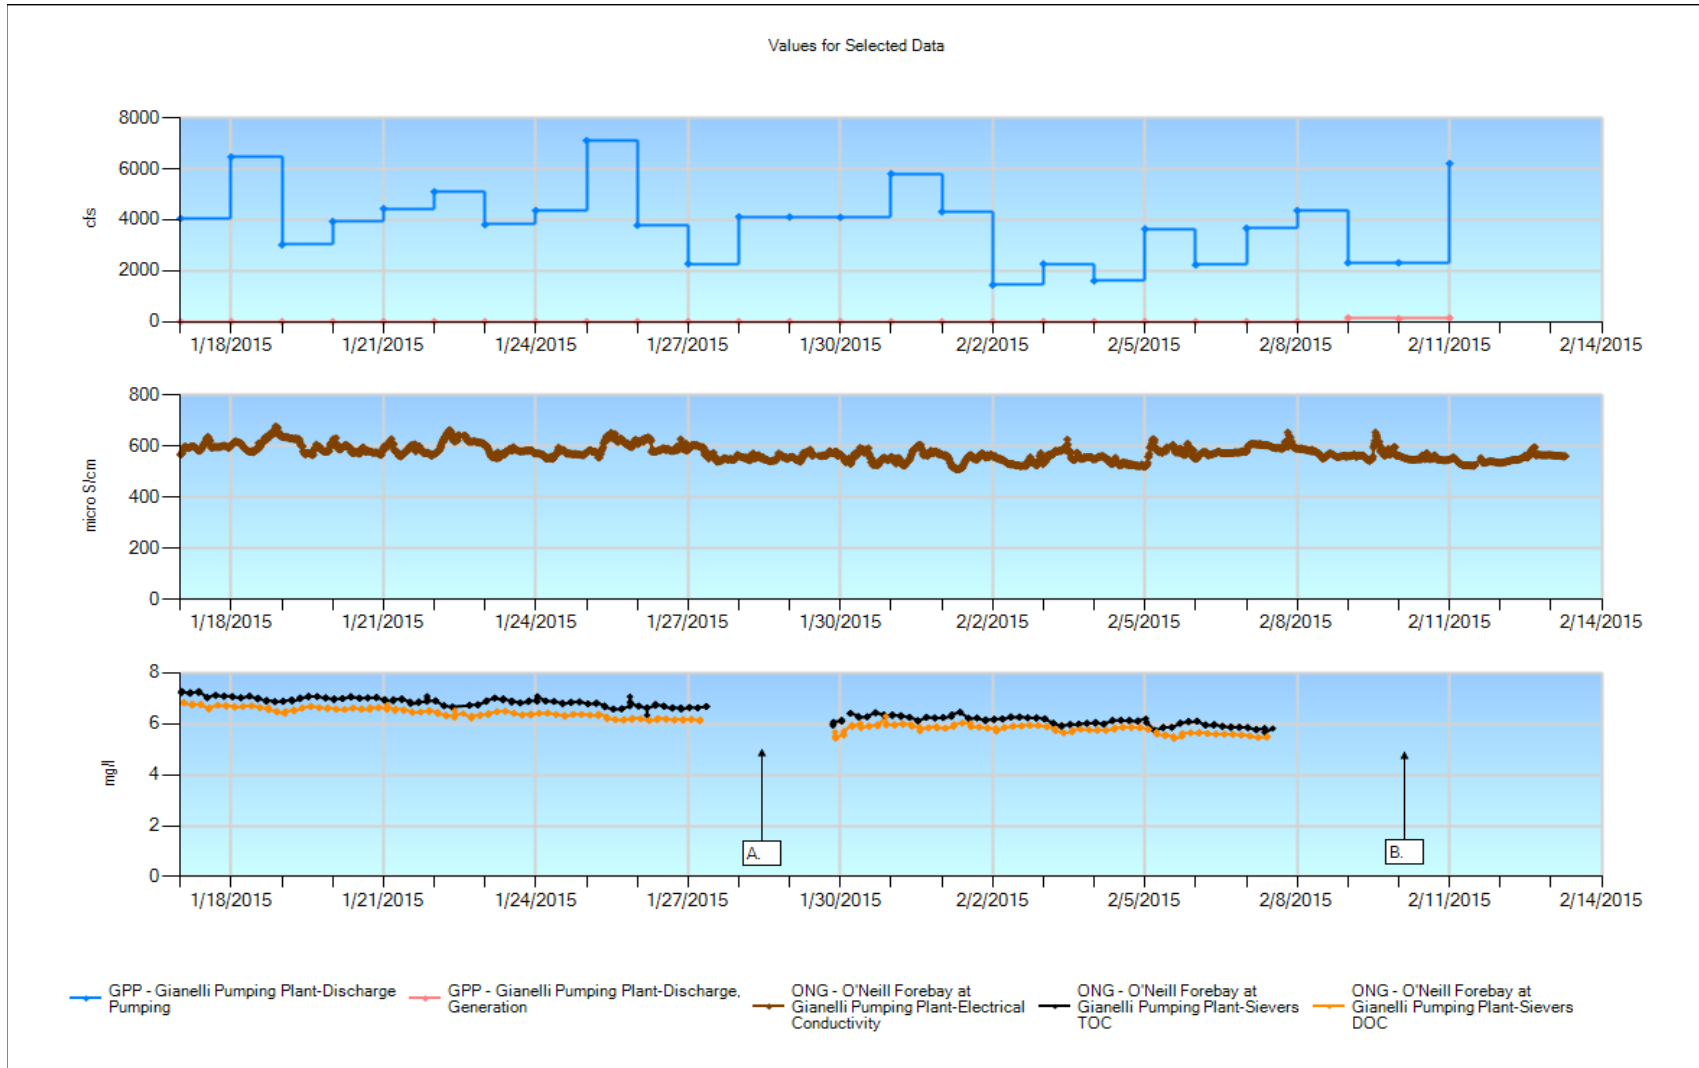
- A – Instrument out due to annual maintenance
- B – Battery backup failed, cutting the power to the instrument.

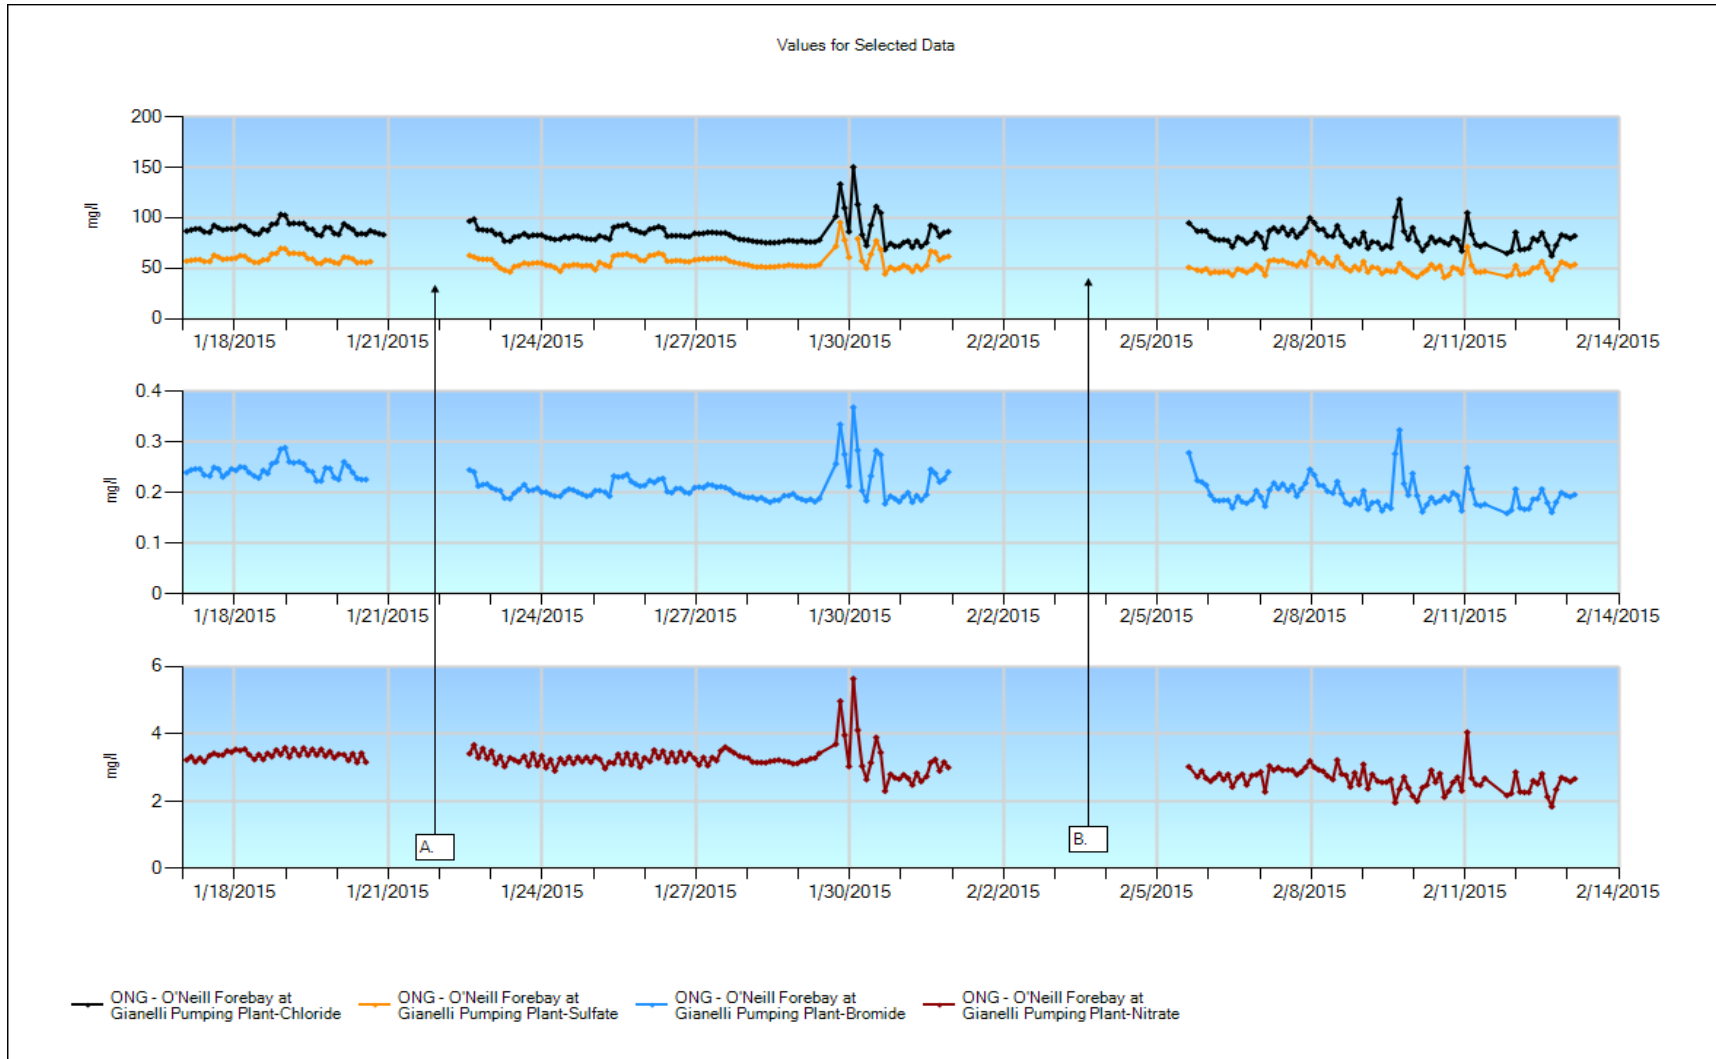
- A – Eluent dilution program pulled in air from the DI and/or sulfuric acid containers.
- B – Sulfuric acid container ran low.

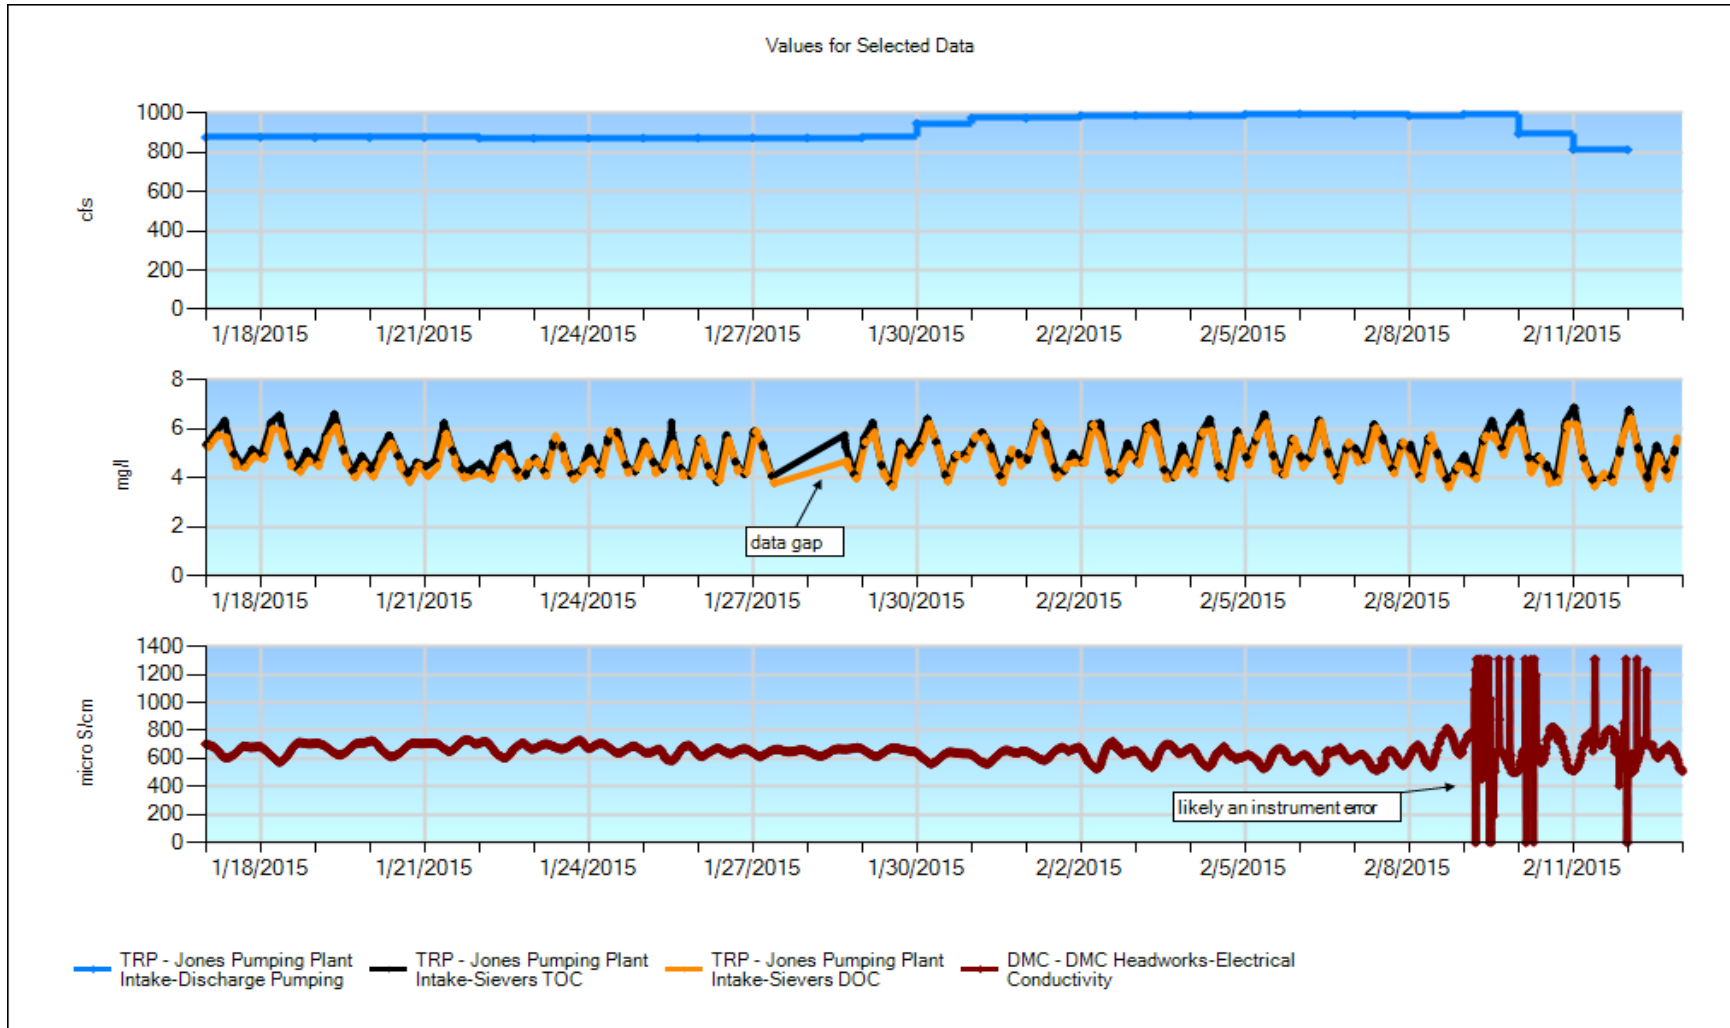
1/22 – filter change **1/27 – 1/28** – Sievers calibration and reinstall. **2/9 – 2/10** – Most likely an instrument malfunction, however this instrument is not maintained by the MWQI field unit, so I cannot say for certain what the issue is here. **2/11** – filter change.

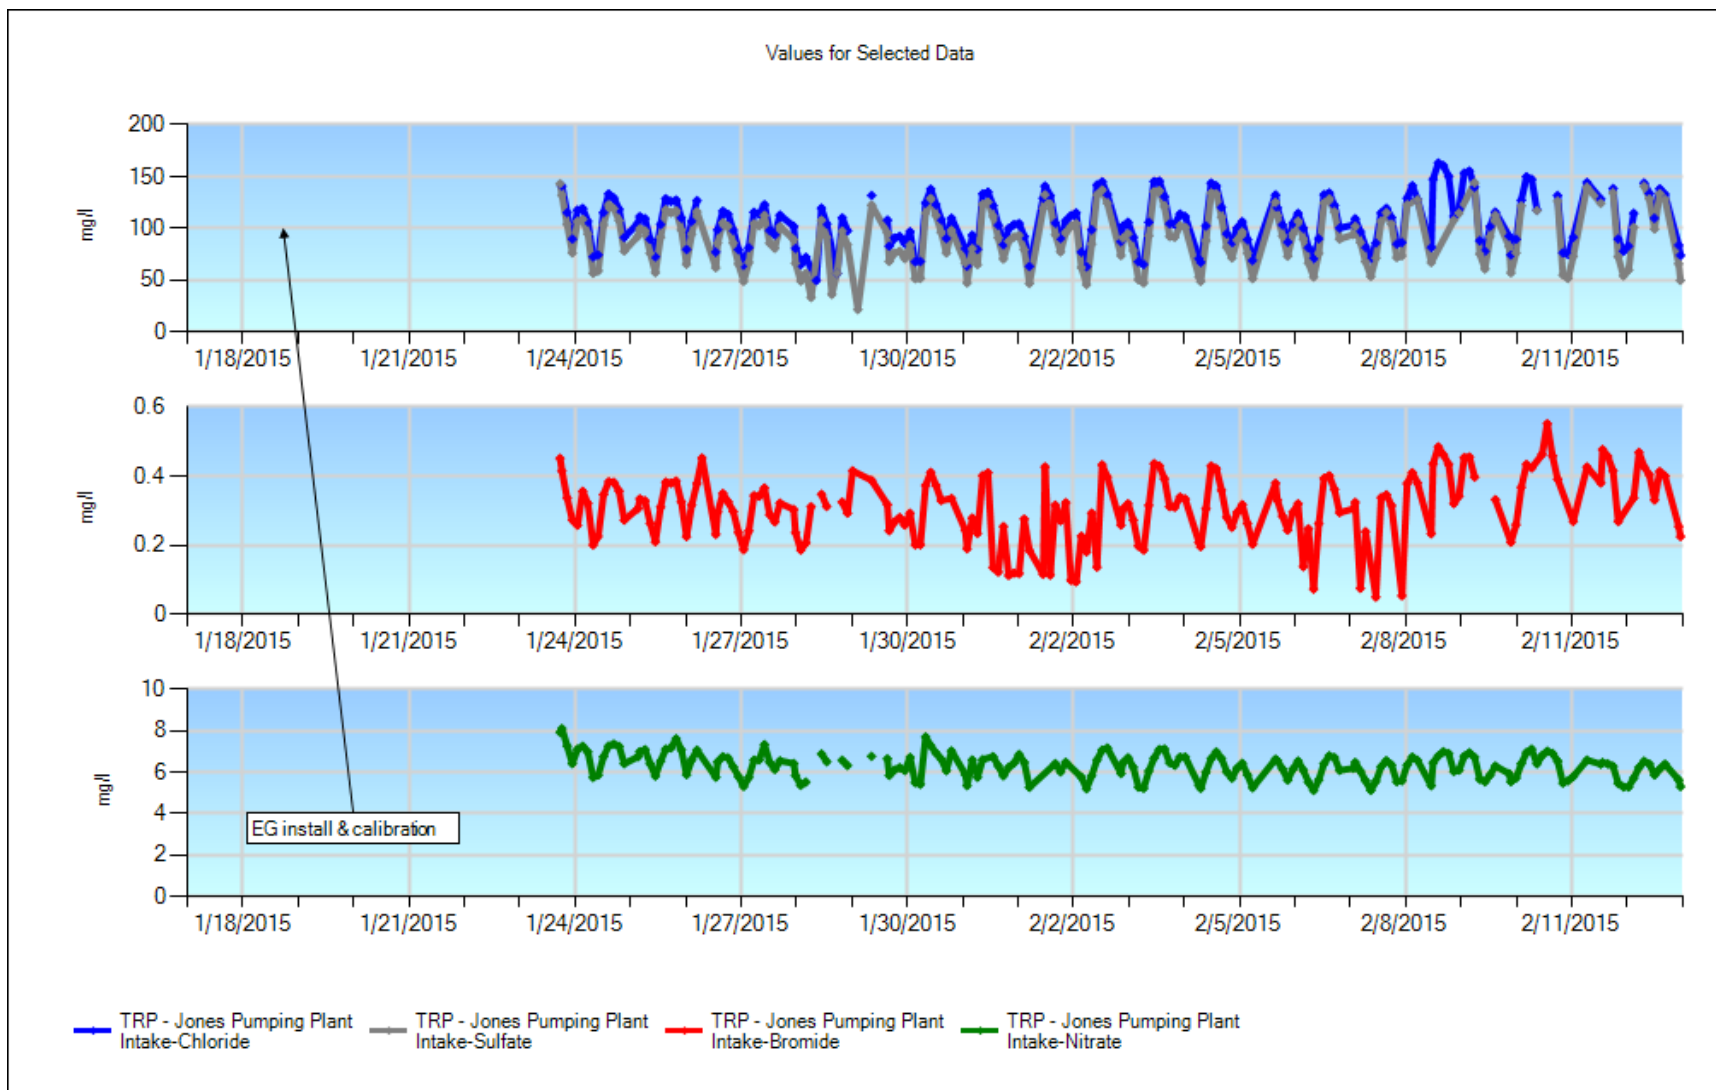
1/16 – 1/23 - replaced the eluent generator and calibrated Dionex. Initial calibrations did not look good, so additional maintenance was performed which included replacing peristaltic tubing and double deionized water. Calibration passed and is currently operational.

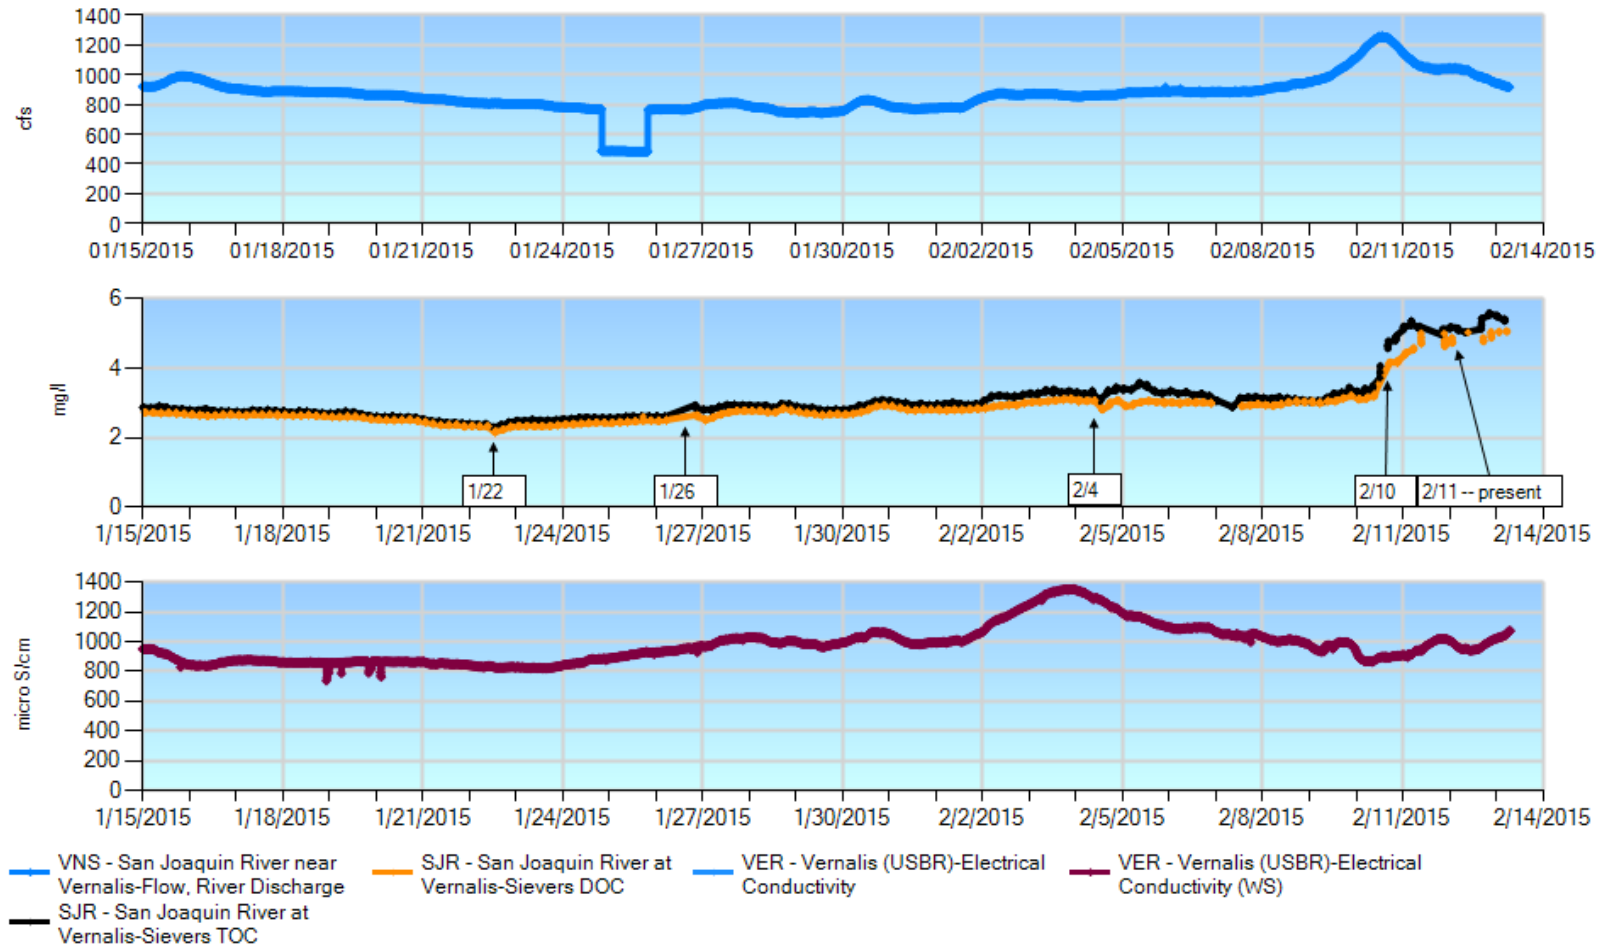
Filter Changes: 1/12 = all filters, 1/22 = prefilters only, 1/26 = all filters, 2/4 = prefilters only, 2/10 = all filters. **Events:** 1/26 = Annual Service by Sievers technicians. 2/10 = Main intake pump starting to fail, providing less flow/pressure. 2/11 – present = Flow restriction within the Sievers tubing or membrane modules is not allowing water to enter the analyzer fast enough, giving higher than normal DOC results for the first two samples out of five in the series, which are essentially TOC water. The first two TOC results are analysis of DOC water. Will be fixed on 2/18.

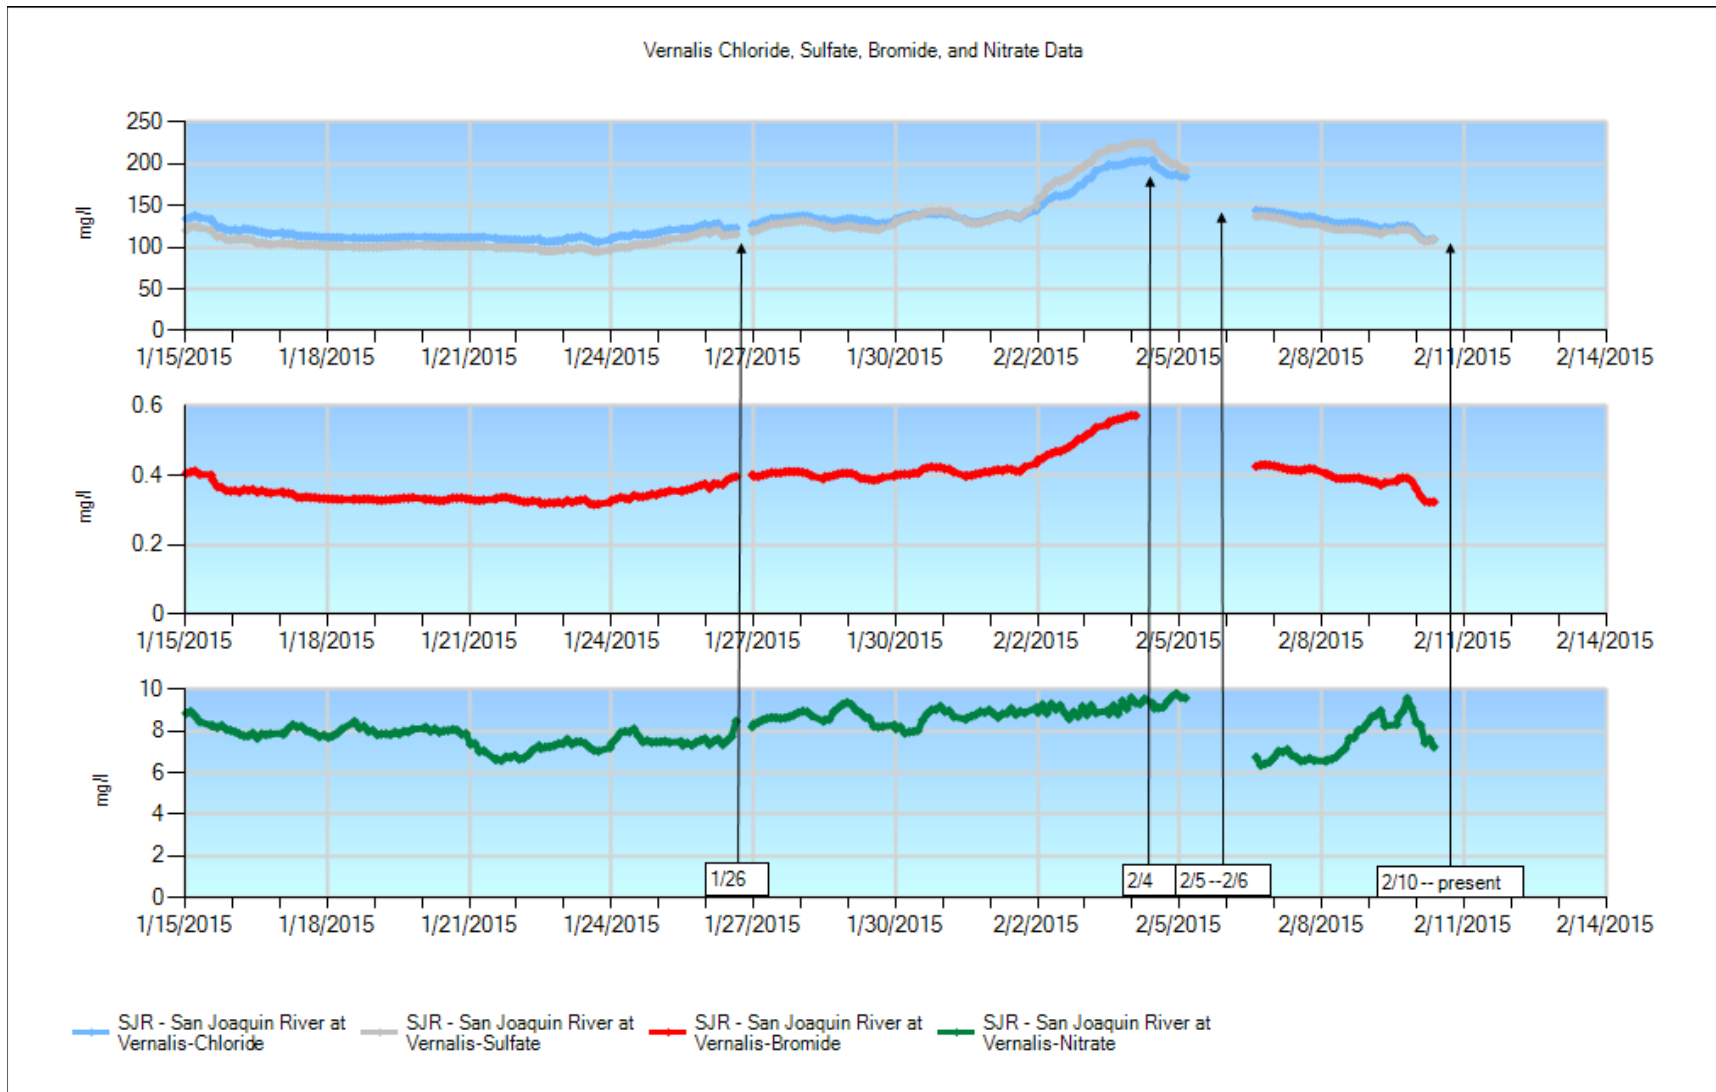
Events: **1/26** = Filter change during service event. **2/4** = Prefilter change and bromide needed a retention time shift. One day of missing data available but not updated at the time of this report. **2/5 – 2/6** = Clog in the system caused the sample pump to overpressure and shut down. Tubing was cleaned and column filters replaced. Sample pump showed evidence of a leak. Analyzer restarted. **2/10** = Analyzer lost pressure during QA/QC event. Sample pump non-responsive and needs repair or replacement. Analyzer will be down until service agreement is reached.

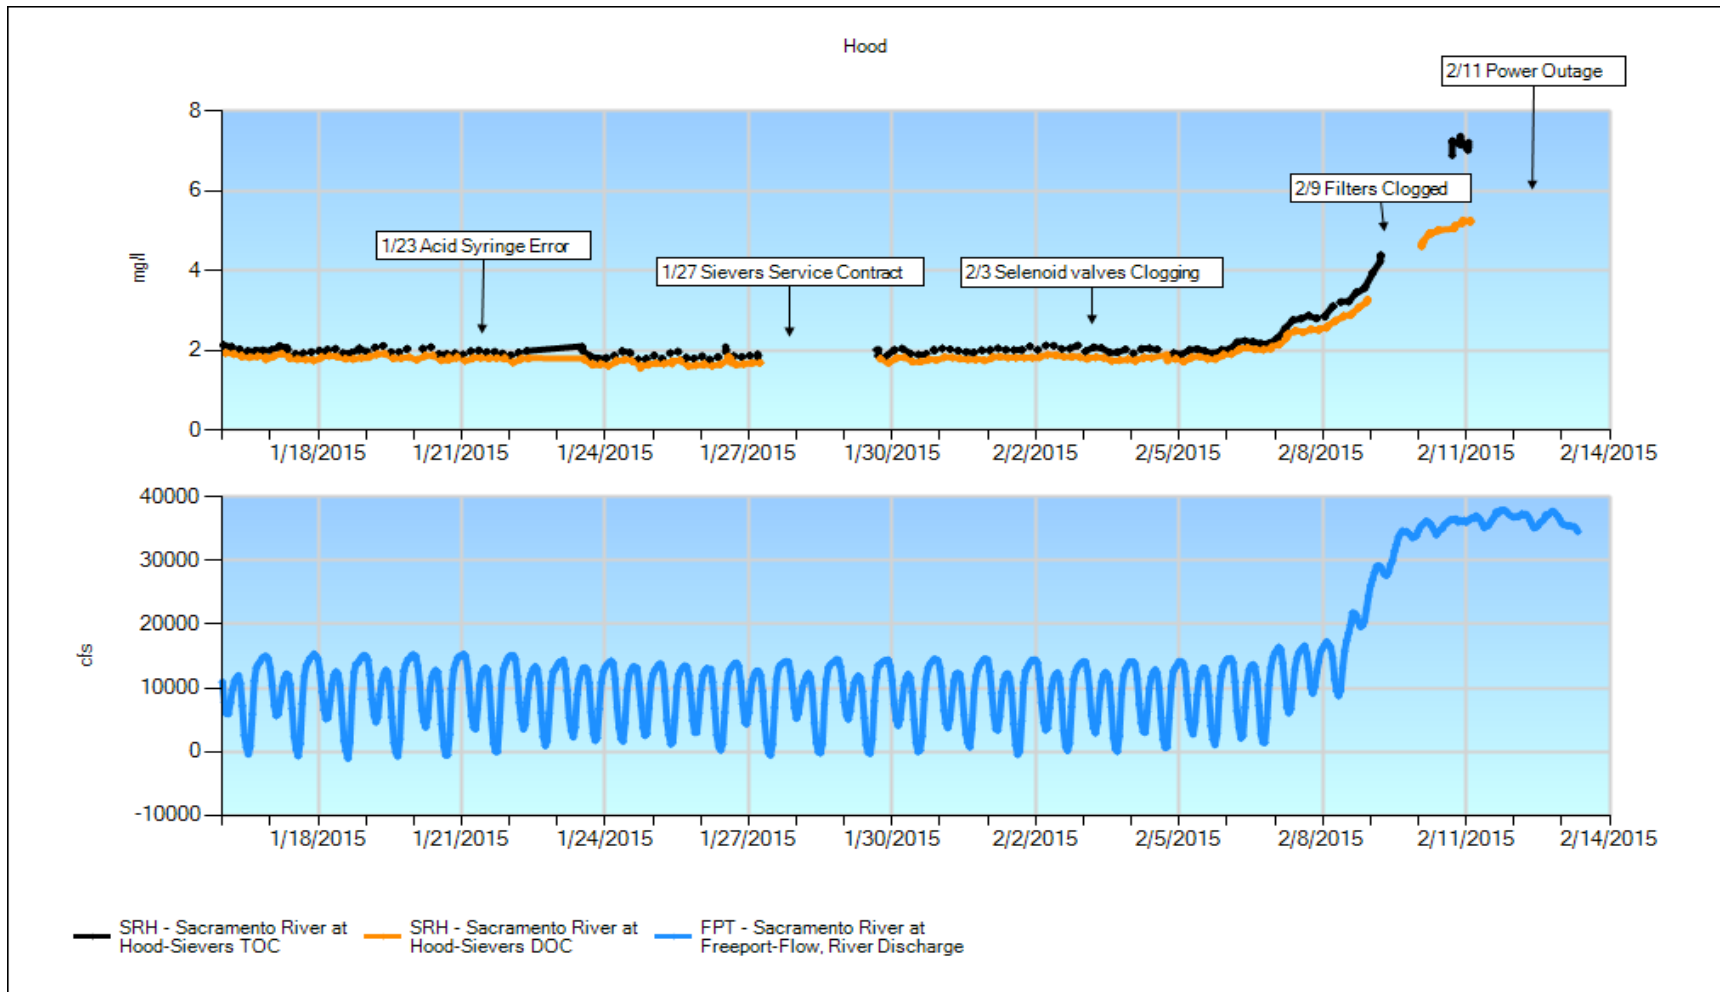
- **1/23 Acid Syringe Error:** Sievers stopped working, just cleaned the Acid Syringe and sievers was operational again.
- **1/27 Sievers Service Contract:** IC and TC levels are not up to standards. Possibly to a conductivity issue due to a slow flowing DI water rate caused by the malfunction of the DI pump.
- **2/3 Solenoid Valves Cloggin:** The solenoid valves that control the stream sample water into the sievers were leaking, This Caused the sievers to continually run instead of stopping at 2 hours intervals.
- **2/9 Filters clogged:** Recent rain caused the turbidity of the Sacramento River to increase. This caused the pre-filters to clog.
- **2/11 Power Outage:** The computer and the sievers were shut down and data was not recorded.
