## Banks Pumping Plant: Discharge Pumping – TOC, DOC – EC

## Significant Events: May 14<sup>th</sup> 2015 to June 11<sup>th</sup> 2015

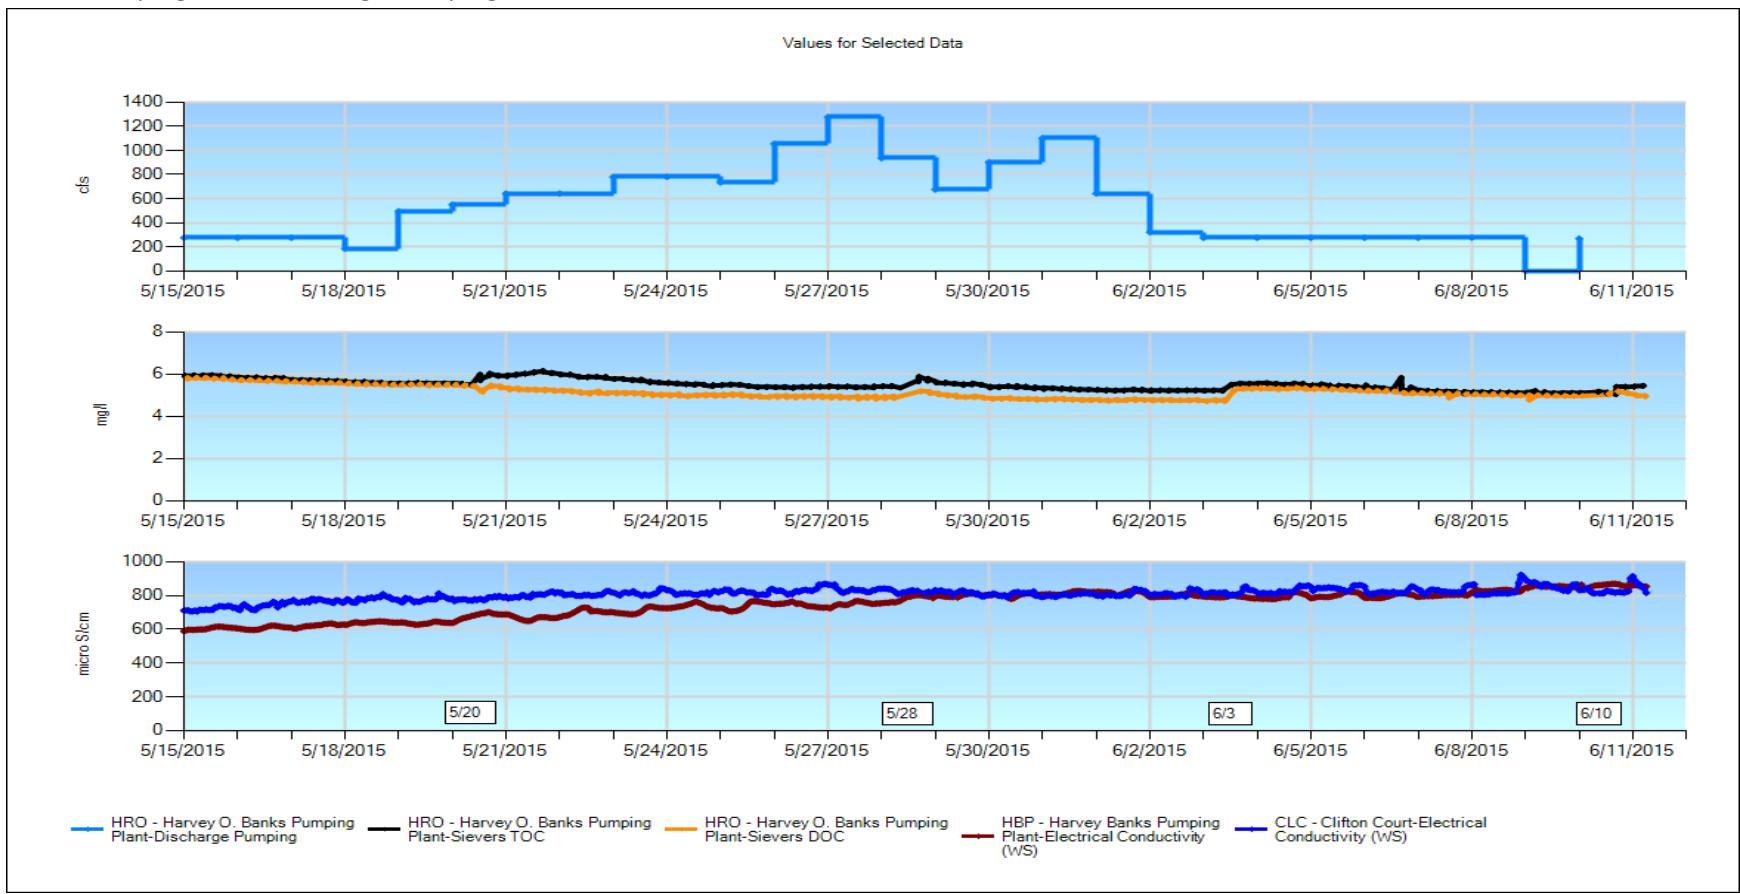
5/20 – Sample delivery system filter change

5/28 – Sample delivery system 100 um and 0.45 um filter change, analysis of organic carbon QC samples

6/3 – Sample delivery system filter change

6/10 - Found that a non-50 um filter was installed in the 50 um housing, replaced with a 50 um filter, replaced the 100 um and 0.45 um, analyzed all QC samples, cleaned various lines

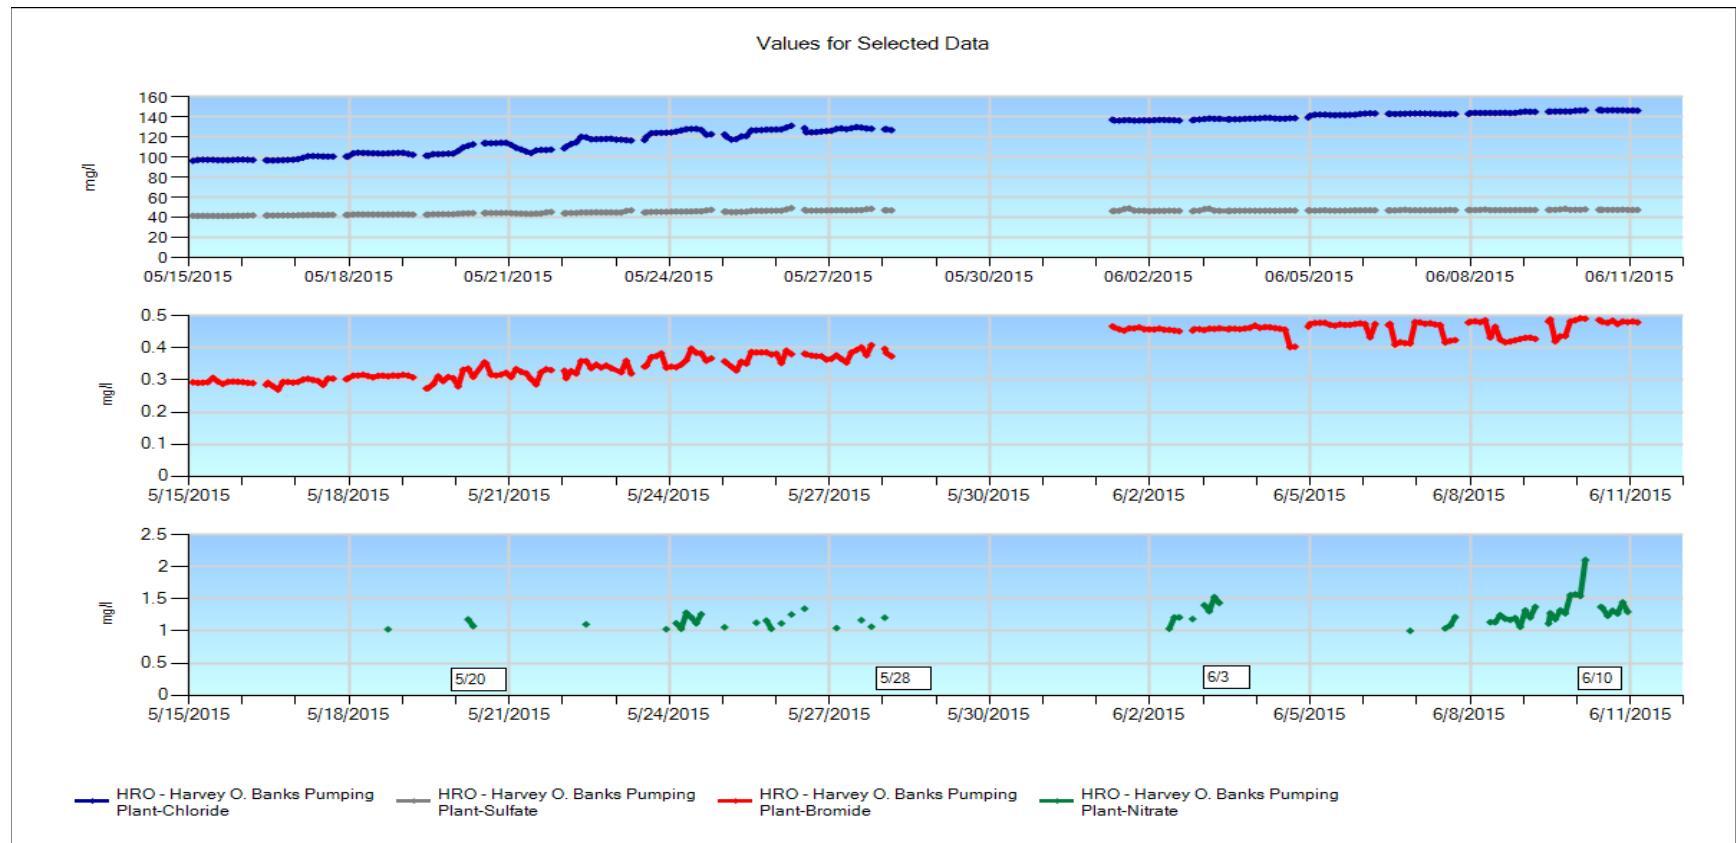
5/20 – Sample delivery system filter change

5/28 – Sample delivery system 100 um and 0.45 um filter change, anion analyzer annual preventative maintenance, calibration issue resolved on June 1

6/3 – Sample delivery system filter change

6/10 - Found that a non-50 um filter was installed in the 50 um housing, replaced with a 50 um filter, replaced the 100 um and 0.45 um, analyzed all QC samples, cleaned various lines

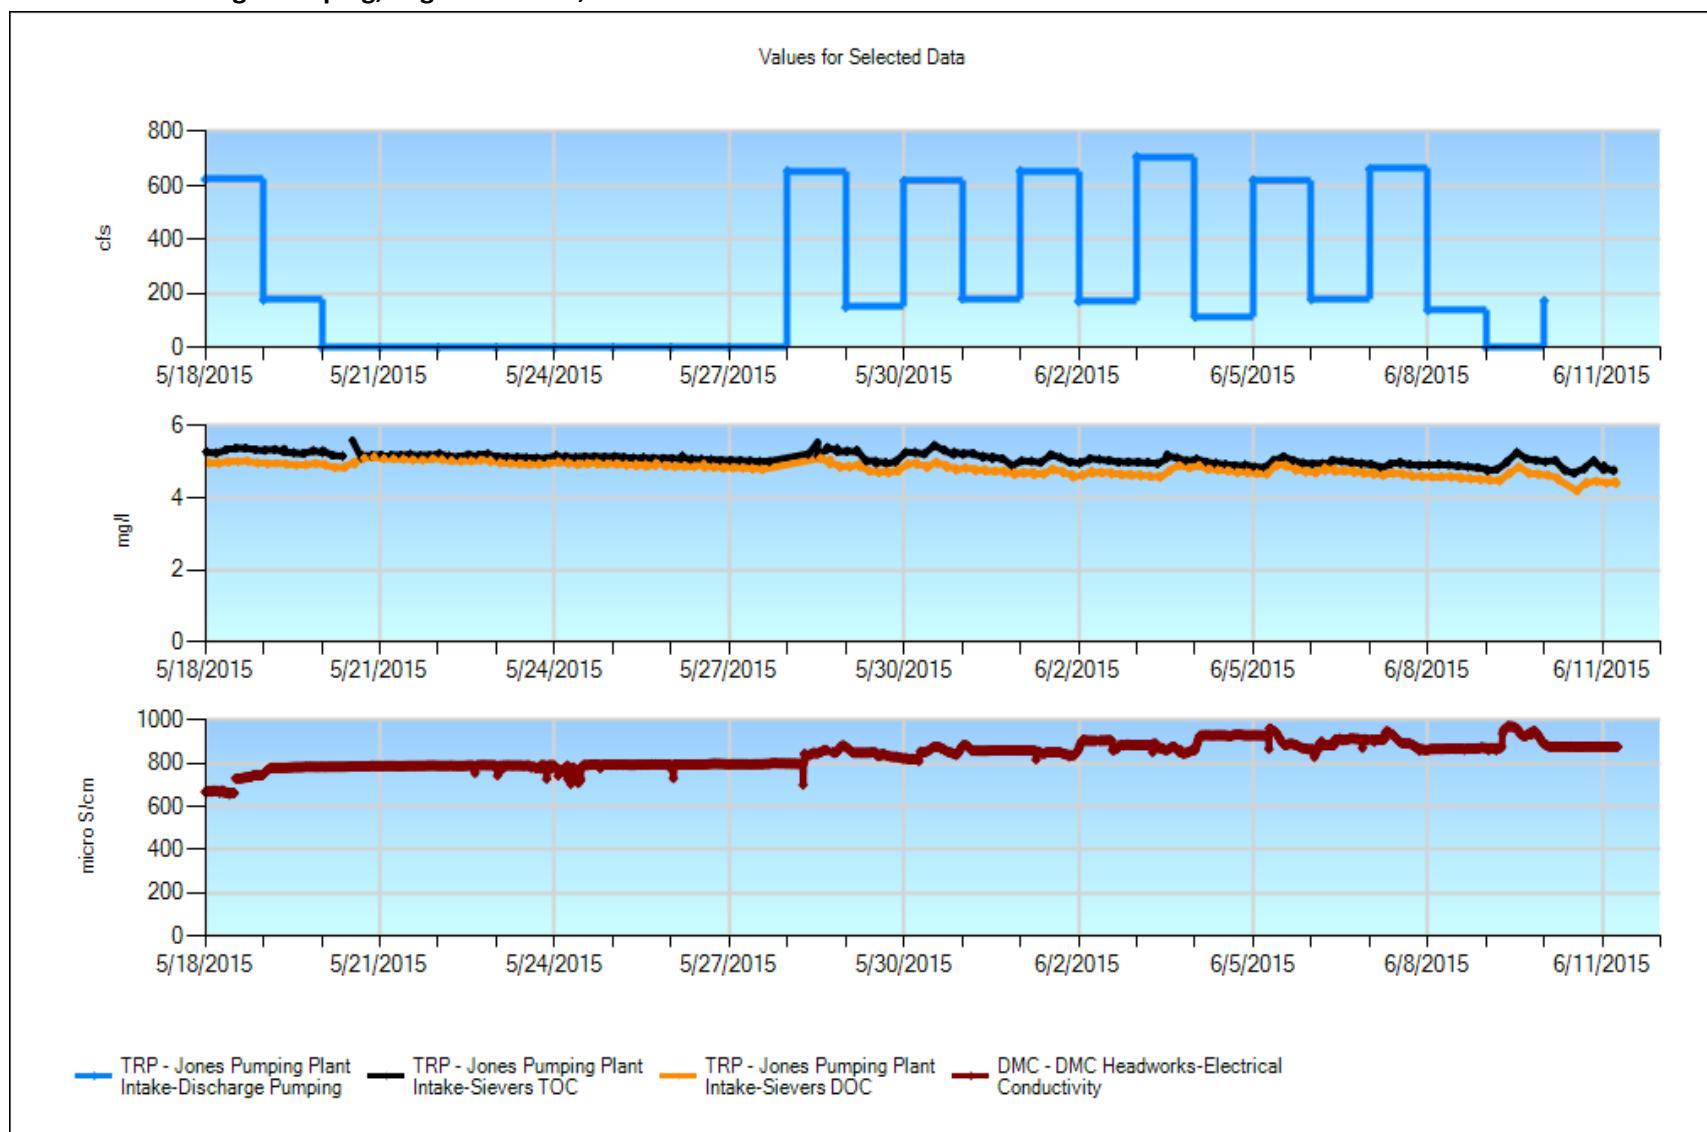
Jones PP – Discharge Pumping, Organic Carbon, and EC

5/20: All filters replaced 5/28: Pre-filters replaced. QC event 6/3: All filters replaced 6/10: Pre-filters replaced. QC event

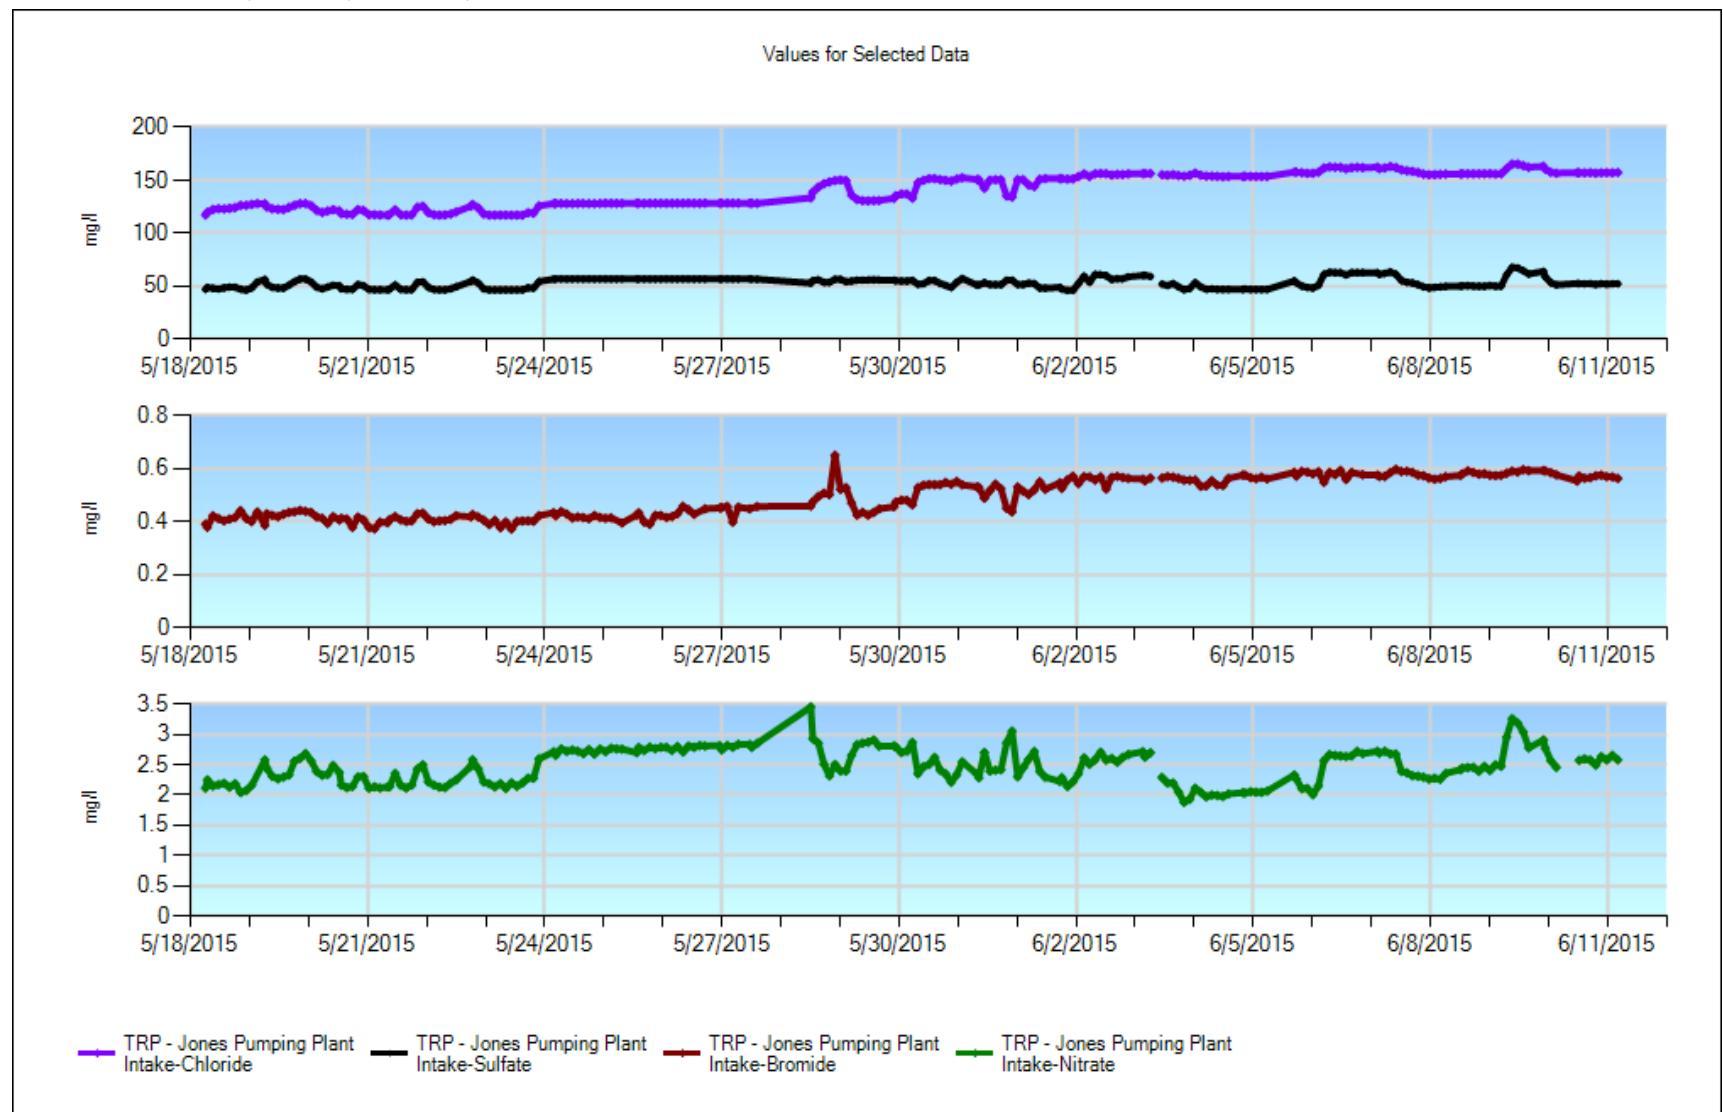
5/28: QC event 6/10: QC event

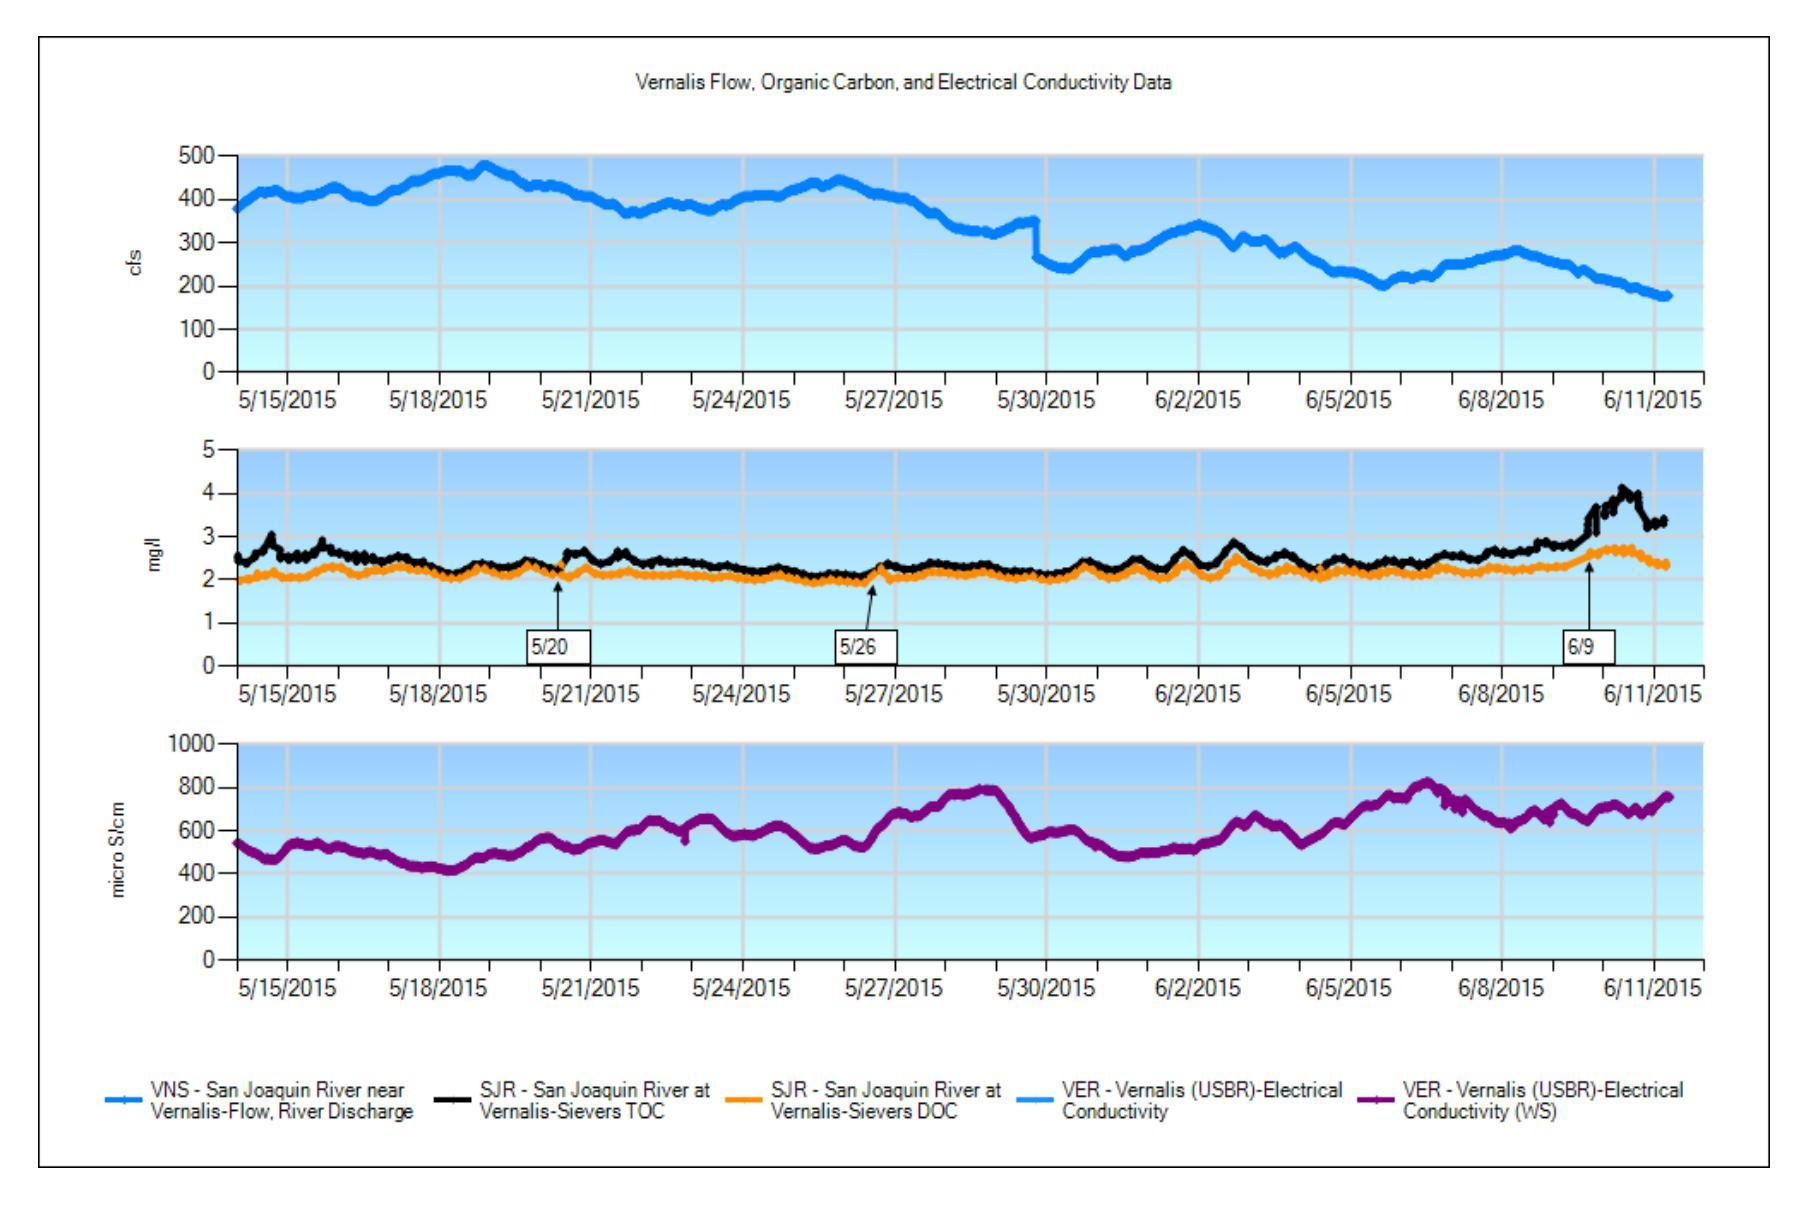
Filter Changes: 5/20 = prefilters only, 5/26 = all filters, 6/9 = all filters. Events: 5/26 & 6/9 = Cleaned pump intake. Increase in TOC in early June.

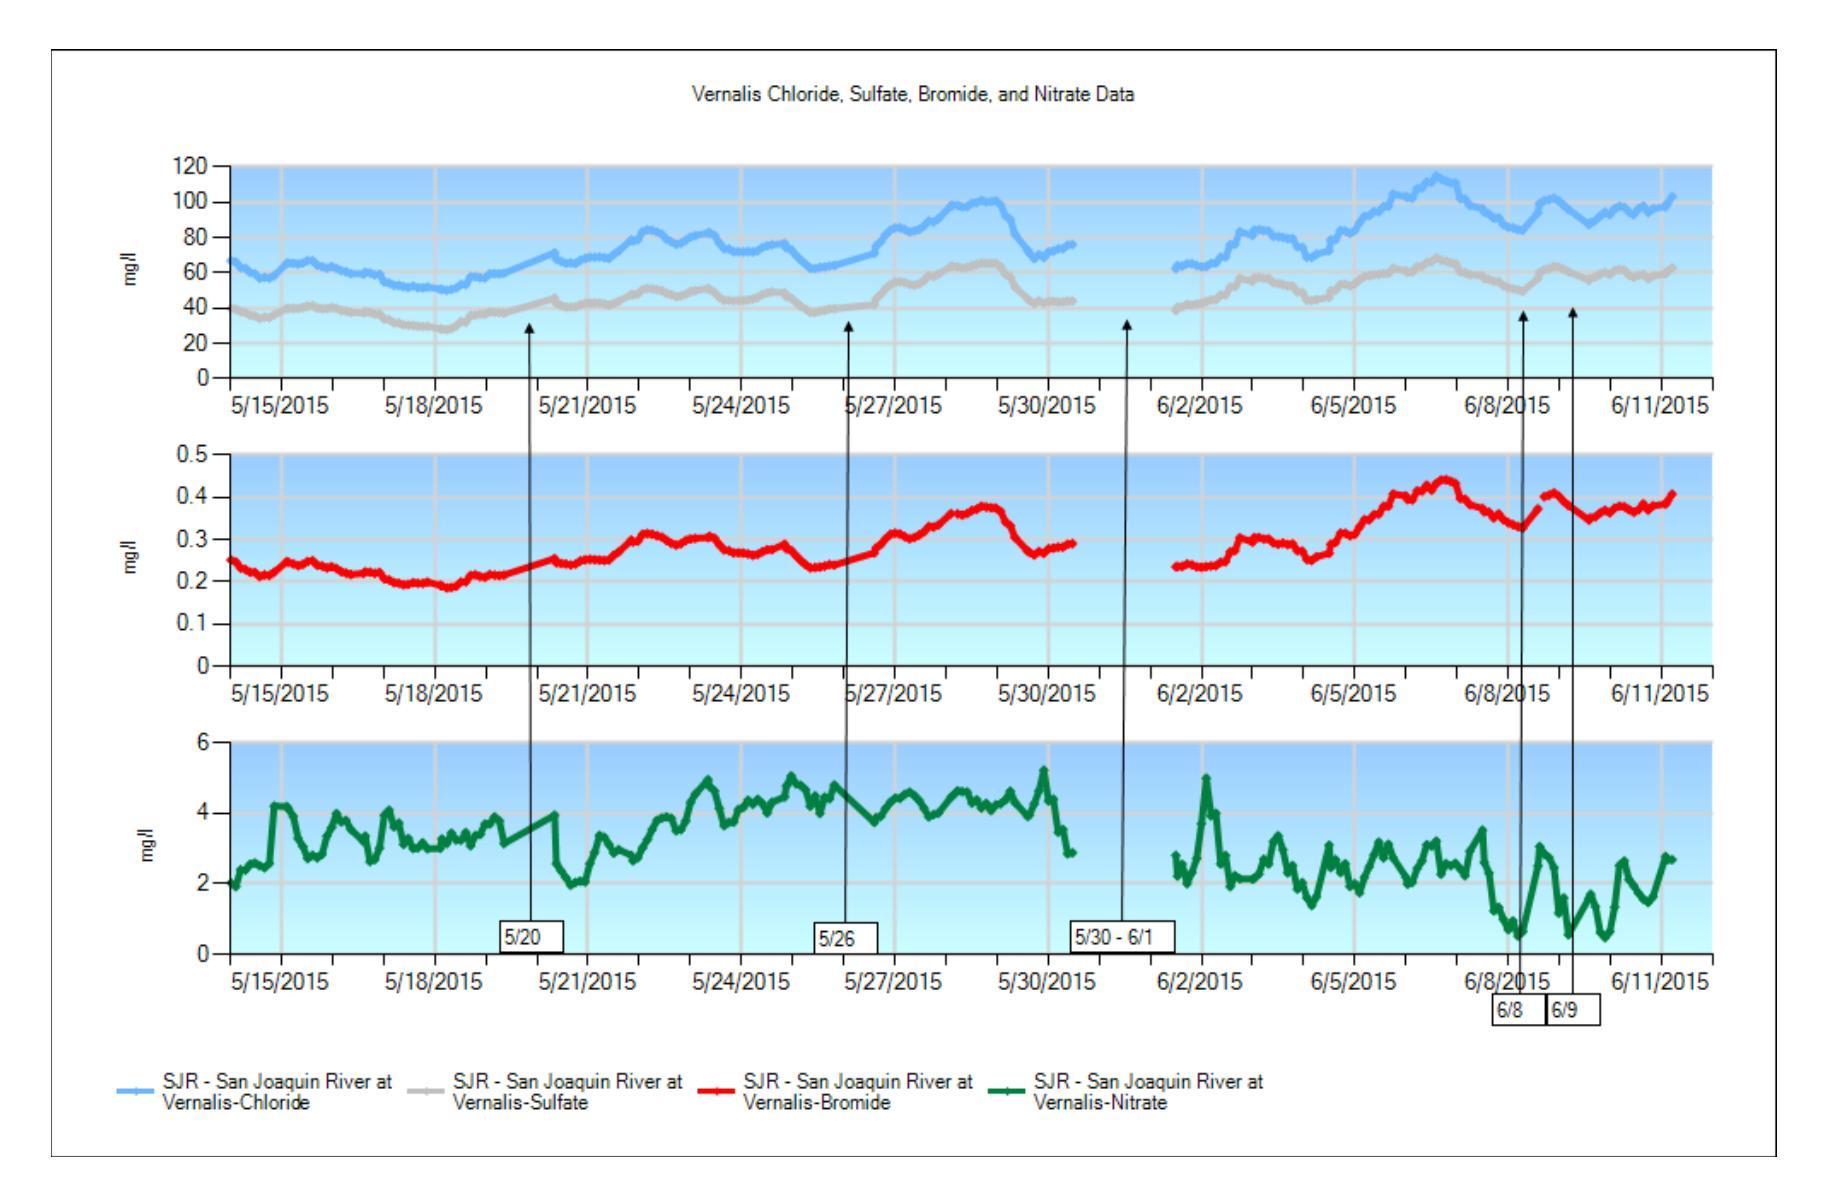
Events: 5/20, 5/26, & 5/30 – 6/1 = Sampling interrupted by unknown entities attempting to gain remote access of the Vernalis computer. 5/26 & 6/9 = QC and maintenance. 6/8 = Annual preventative maintenance performed by Dionex technician. Pumps rebuilt with new seals.

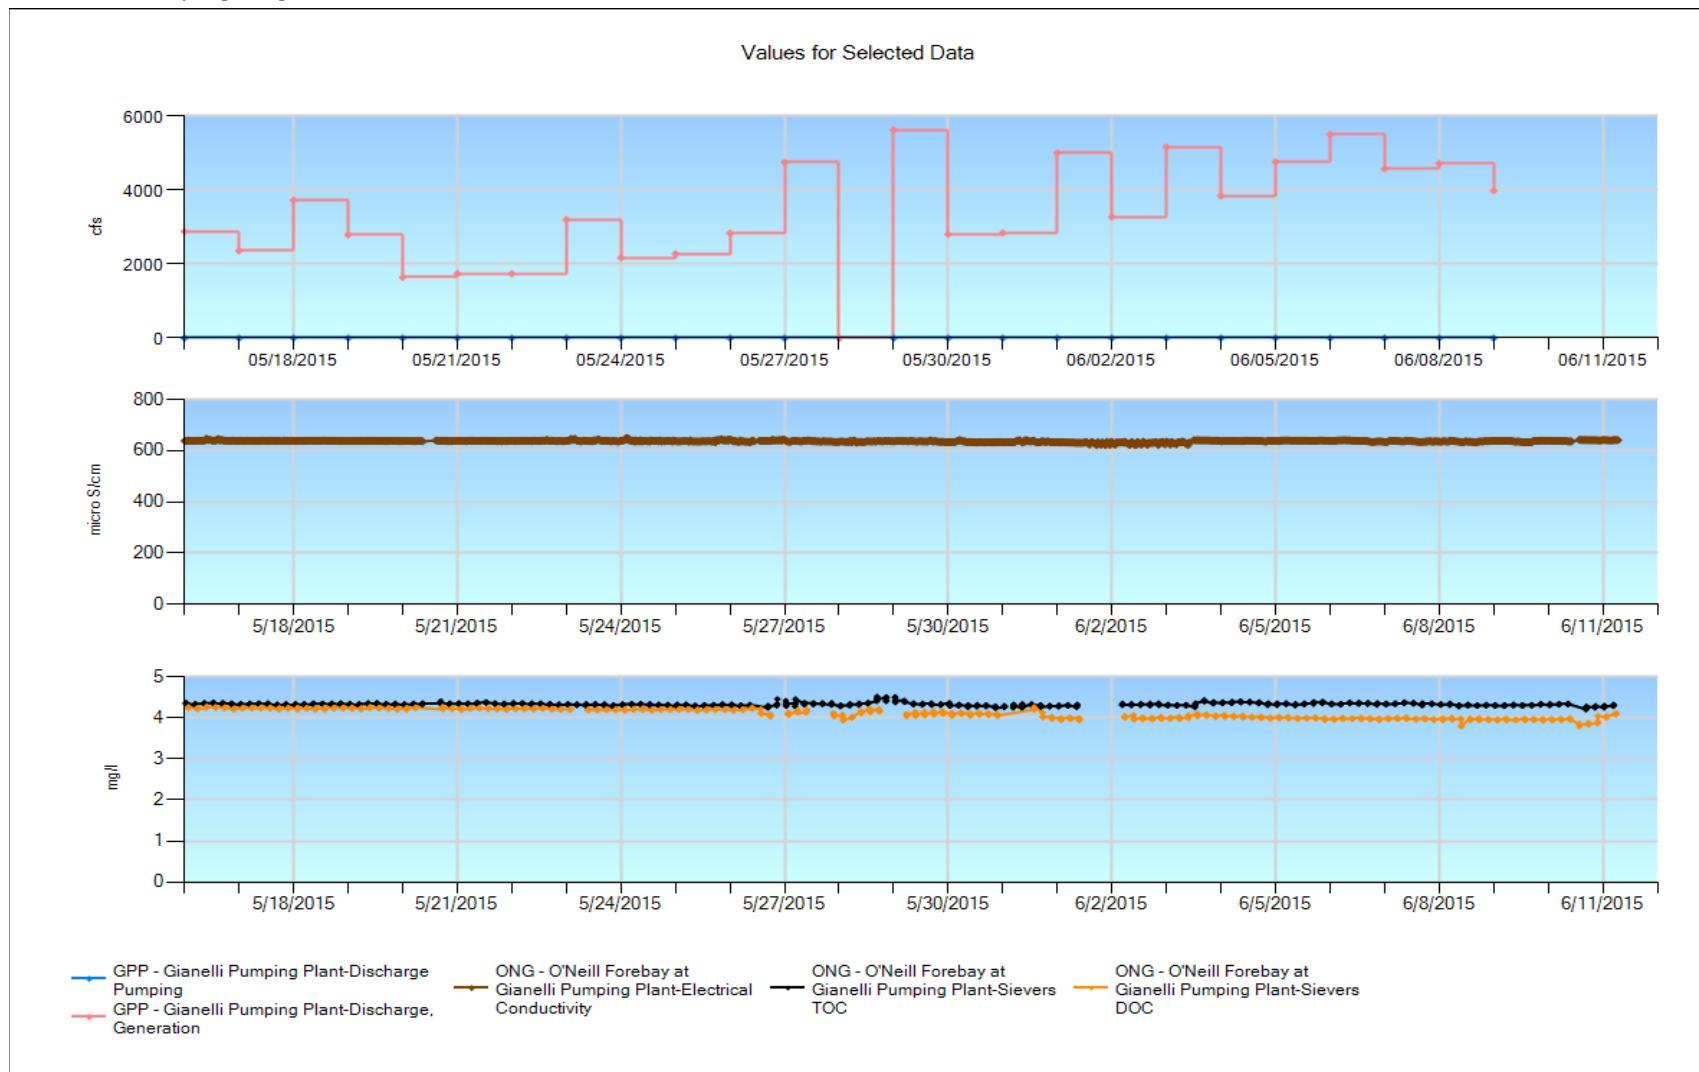
DOC (5/26 – 6/2, intermittent) & TOC (6/1 – 6/2) --- Low flow due to bypass valve setting and/or solenoid valve malfunction caused intermittent readings to measure non-representative water.

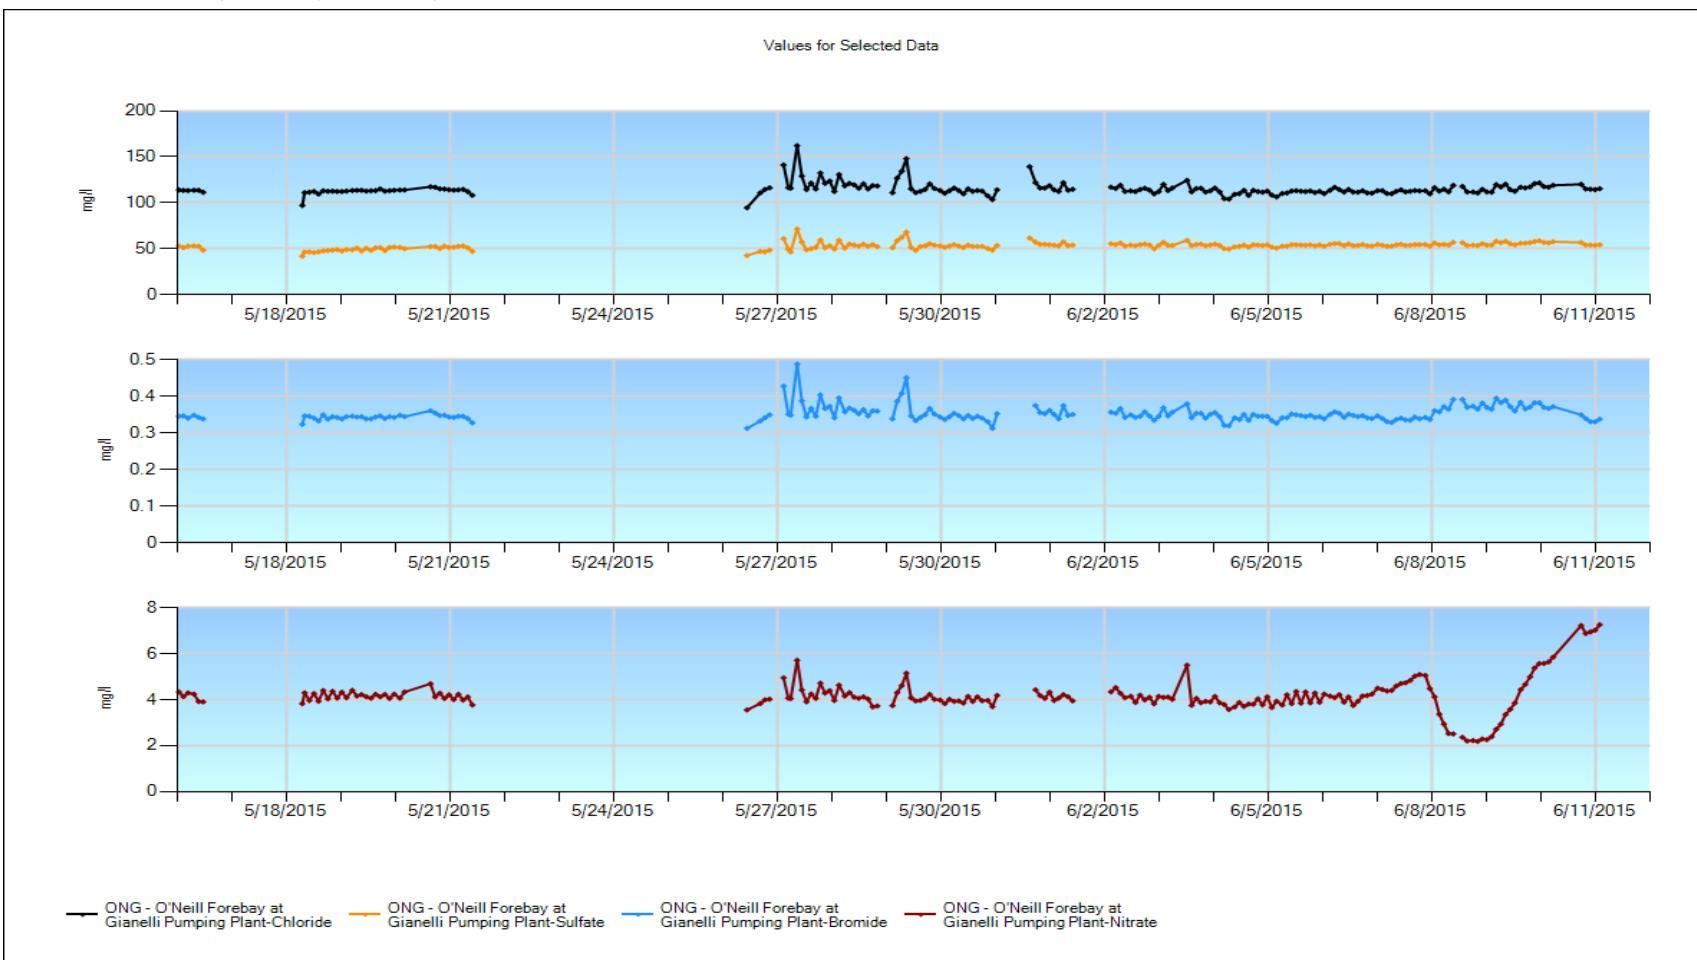
- > All parameters (5/16 5/18) --- Shutdown due to communication error.
- ▶ 5/20 --- Installed new computer to run the Metrohm software exclusively.
- > All parameters (5/21 5/26) --- The new computer shutdown due to incorrect power/hibernation settings.
- All parameters (5/26 6/2, intermittent) --- Low flow due to bypass valve setting and/or solenoid valve malfunction caused intermittent readings to measure non-representative water.

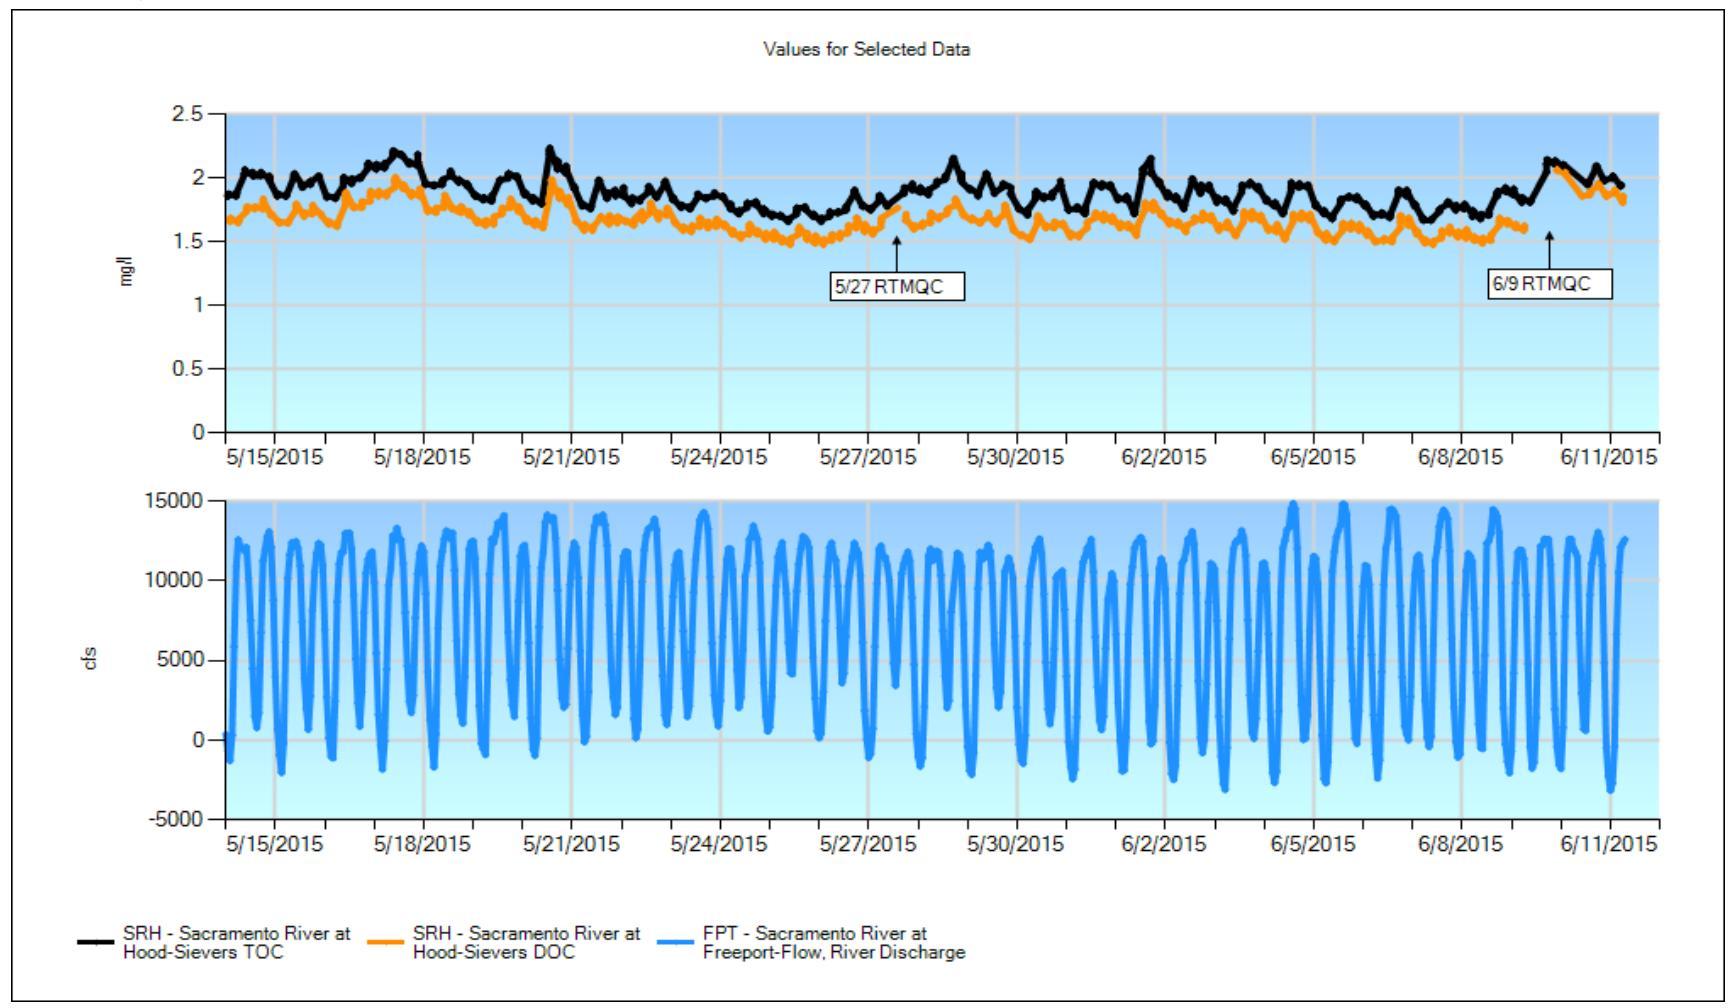
- **5/27 RTMQC**: Changed all pre-filters (75, 50, and 5 micron filters) except for the .45micron.
- 6/9 RTMQC: Changed the 75, 50 and .45 micron filters. The .45 micron filter was not flushed prior to install. This caused a spike in DOC values on the first 6 readings and I had to QC the data as unacceptable. Also, the computer restarted around 4:00 AM and Indigo never reopened.
