Hood Sensors

Significant Events: May 25th 2017 to August 26th 2017

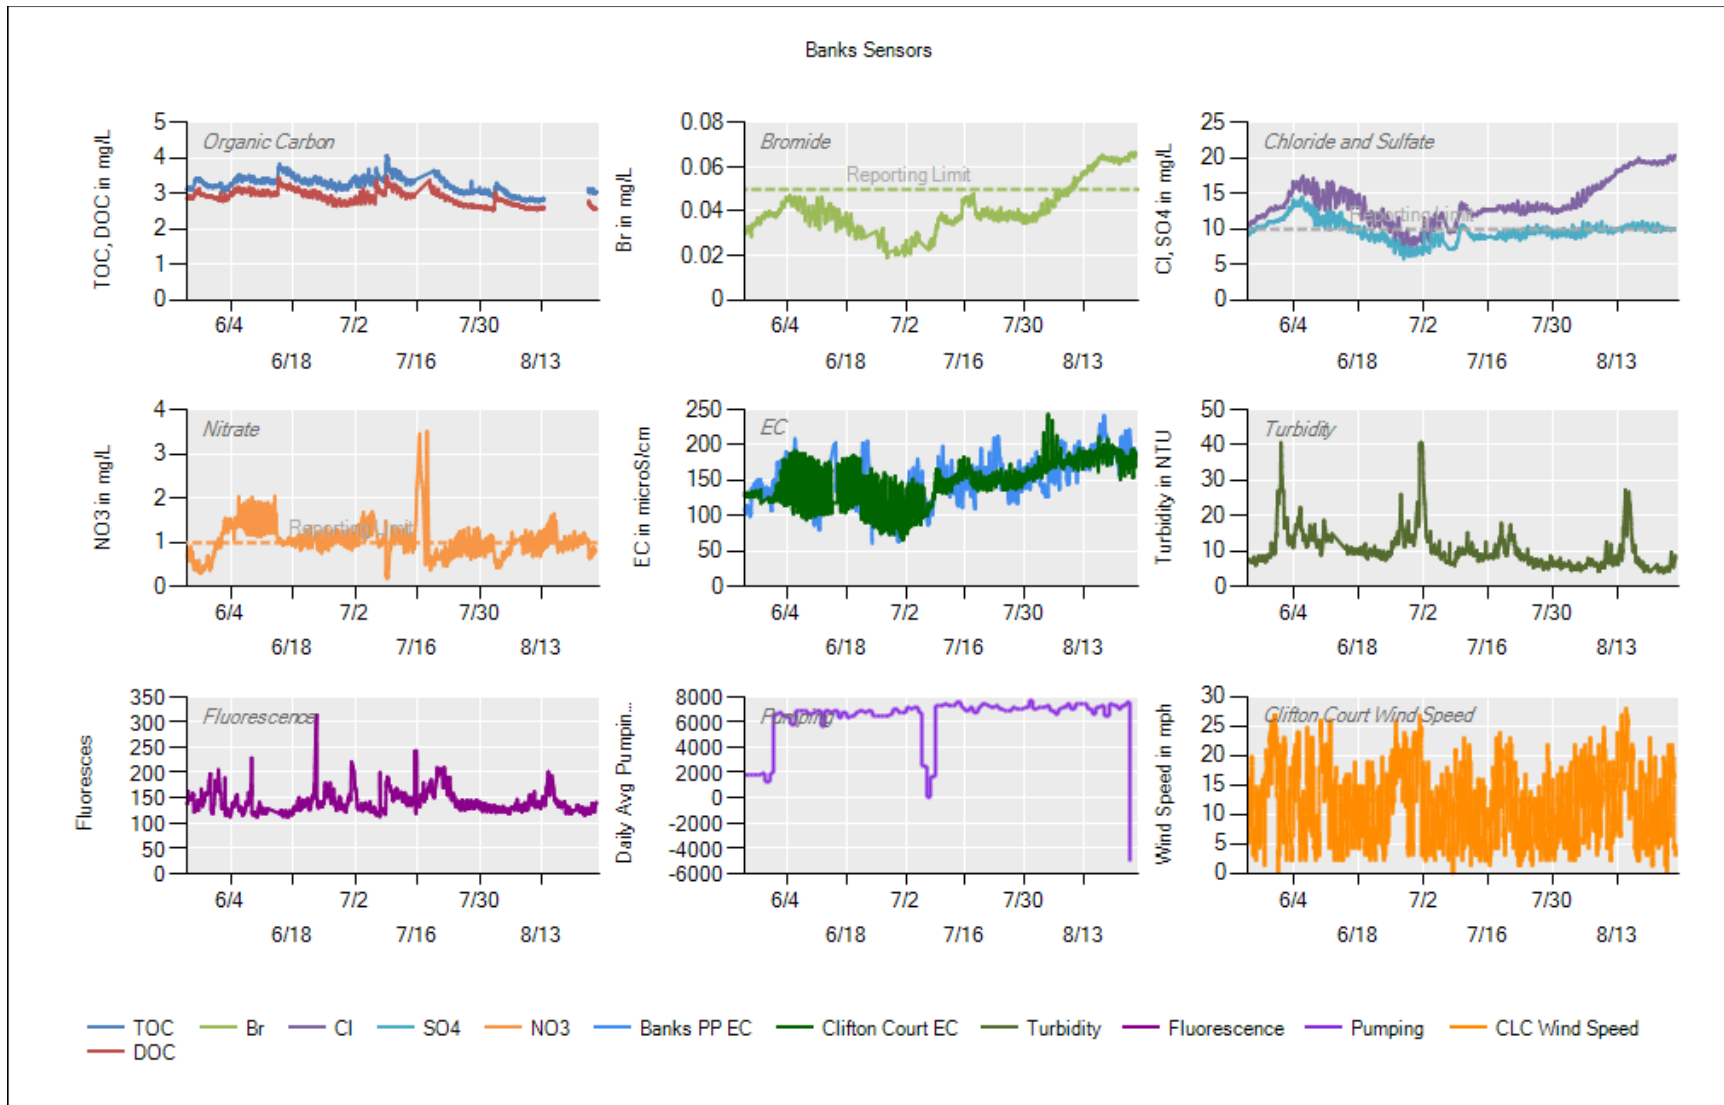
- **8/13 SIEVERS down:** sievers analytical component went bad, had to order a new part and replace it.

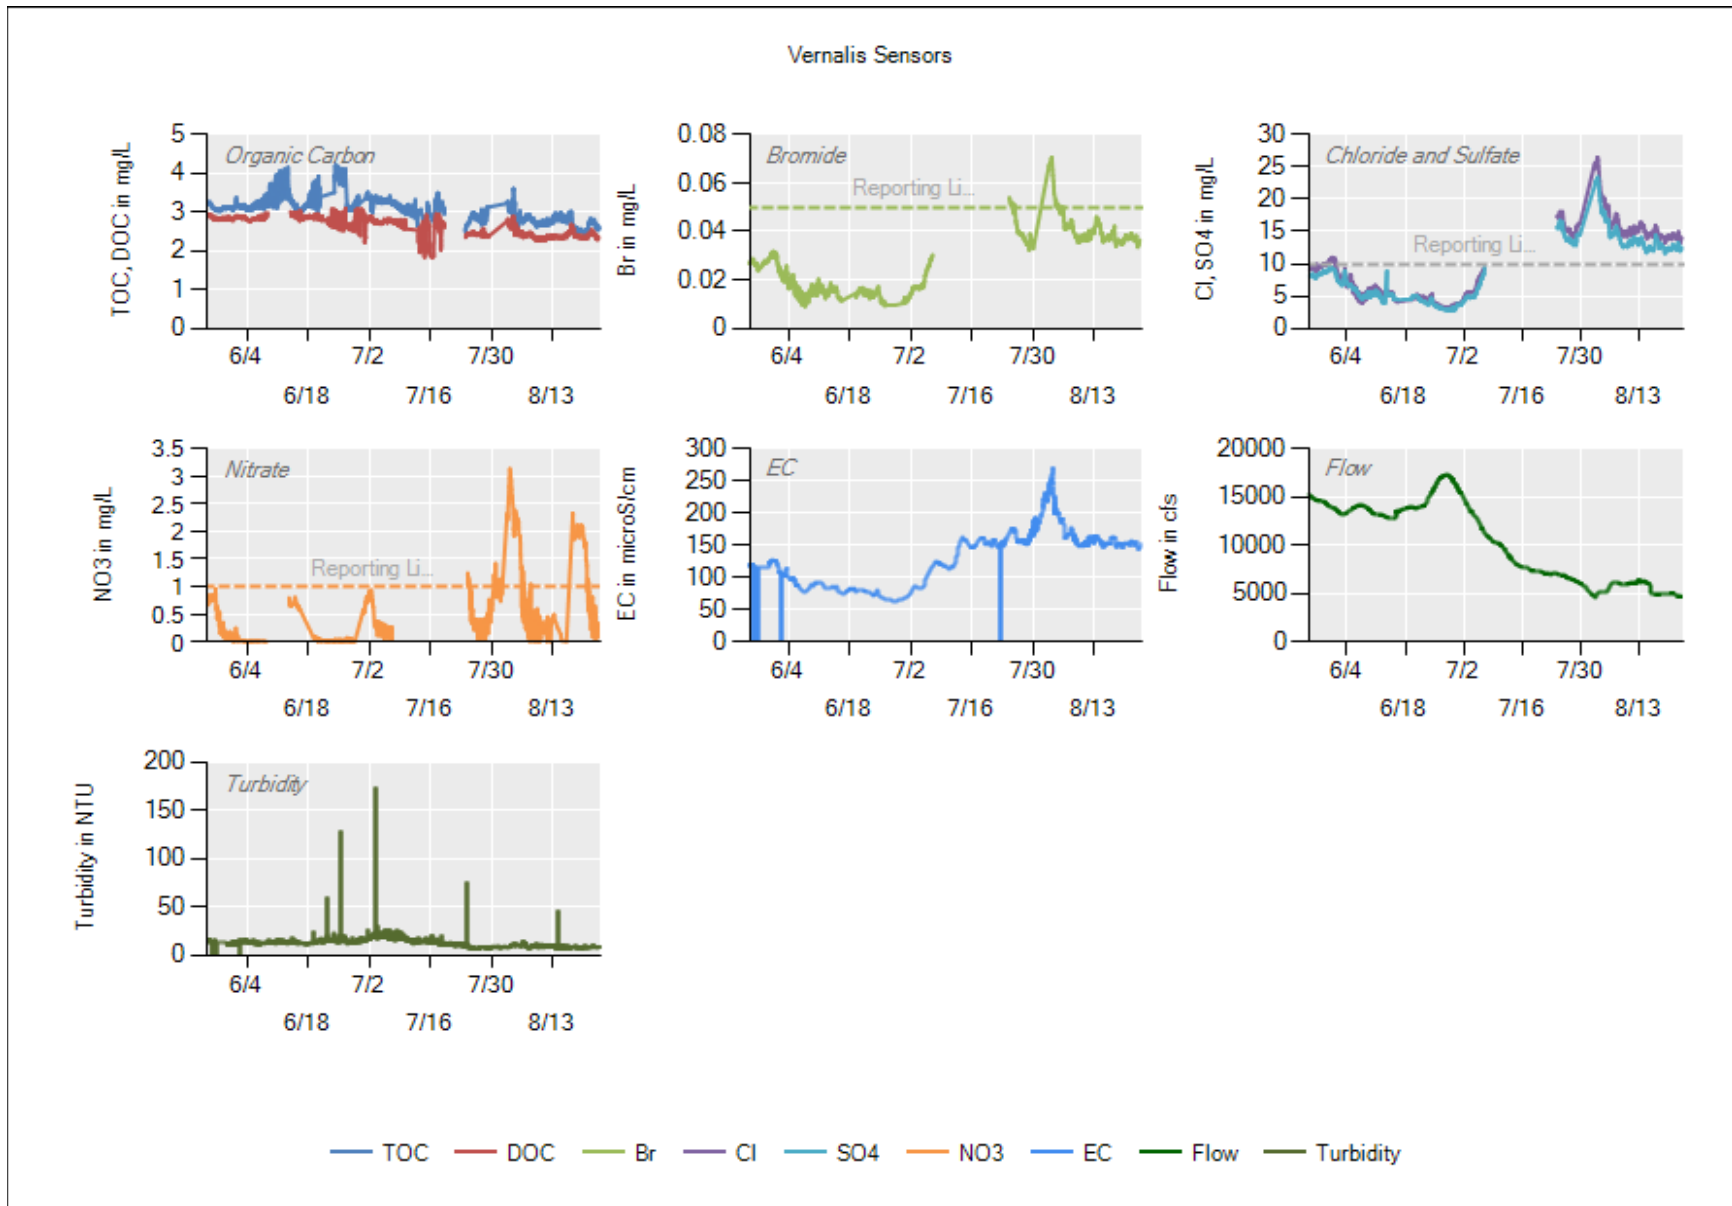
Events: July 6 – 24 = Dionex pump motor error, "lost control". Motor replaced at no cost, under contract, by Thermo-Fisher technician.

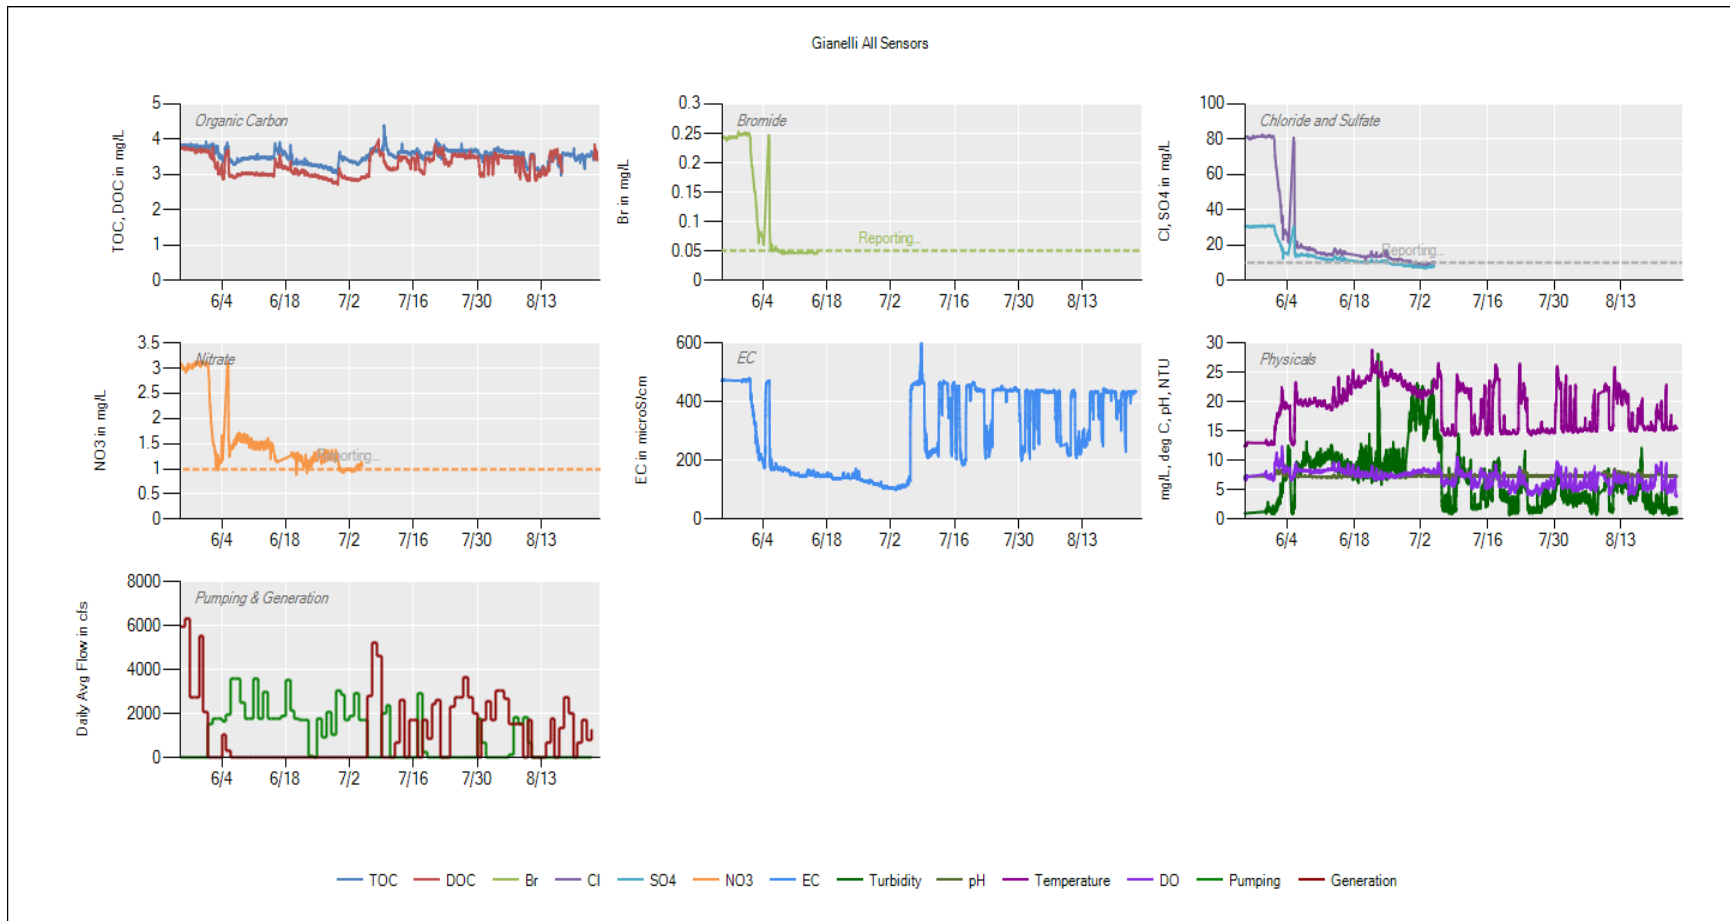
- 6/4 and 6/5 – A short blip of generation at the Plant caused an abrupt increase in several constituents back up the levels seen earlier in the month, prior to the start of pumping operations. This reflects the difference in concentration between the reservoir and Aqueduct.
- 7/4 to present – The Dionex went down due to a computer software problem. That problem has been fixed, but while the instrument was not recording data the eluent ran out (the eluent was allowed to continue flowing to preserve the column lifespan). We are waiting on the replacement eluent cartridge.
- 6/16 to 7/4 – Bromide data was so far below the RL that the peaks didn't register on the Dionex. Meaning the water was tested but there are no reportable values to show on the graph.
- 8/17 to 8/24 – DOC valve was clogged and stopped flow for that stream
