Precipitation & Flow

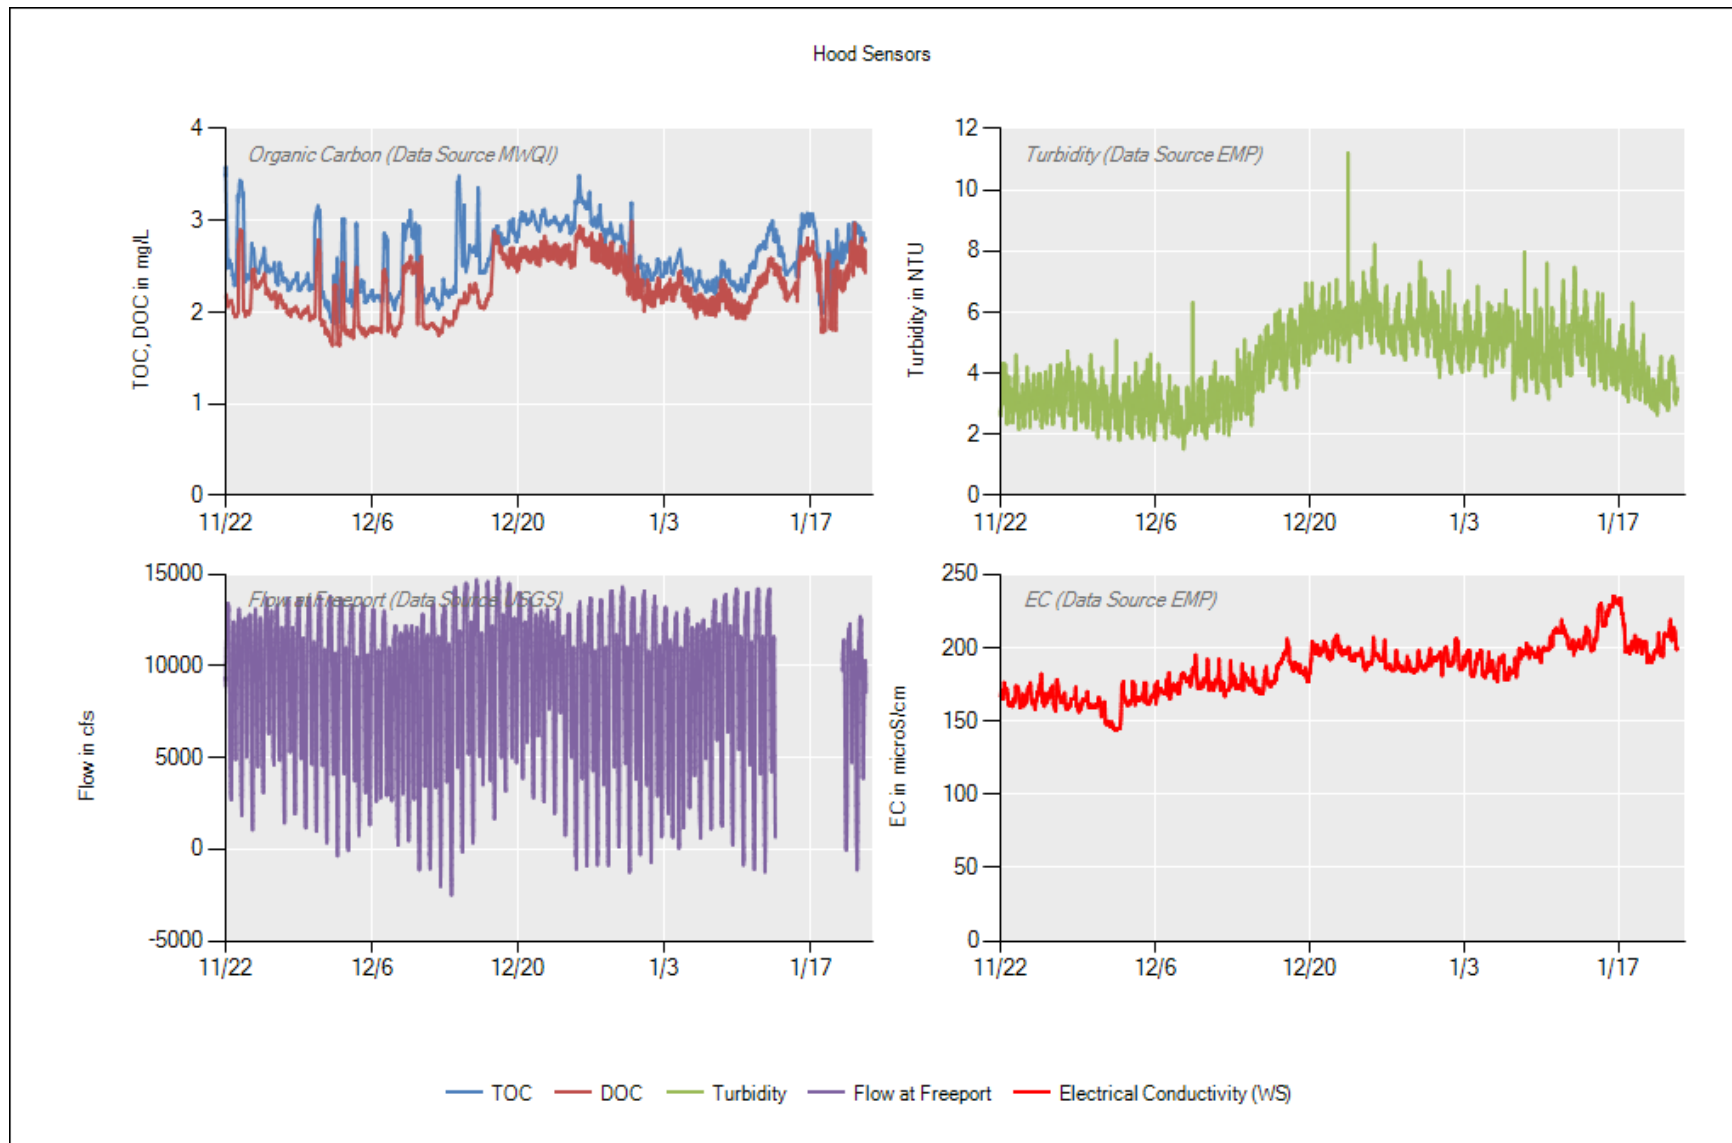
11/24: Replaced all system filters - 12/4: Cleaned sample port inlet - 12/17: Replaced all system filters, analyzed QC samples – 1/8: Replaced 50 um filter, checked TOC valve for leakage, no leak – 1/15: Communication disruption, re-started the carbon data logger

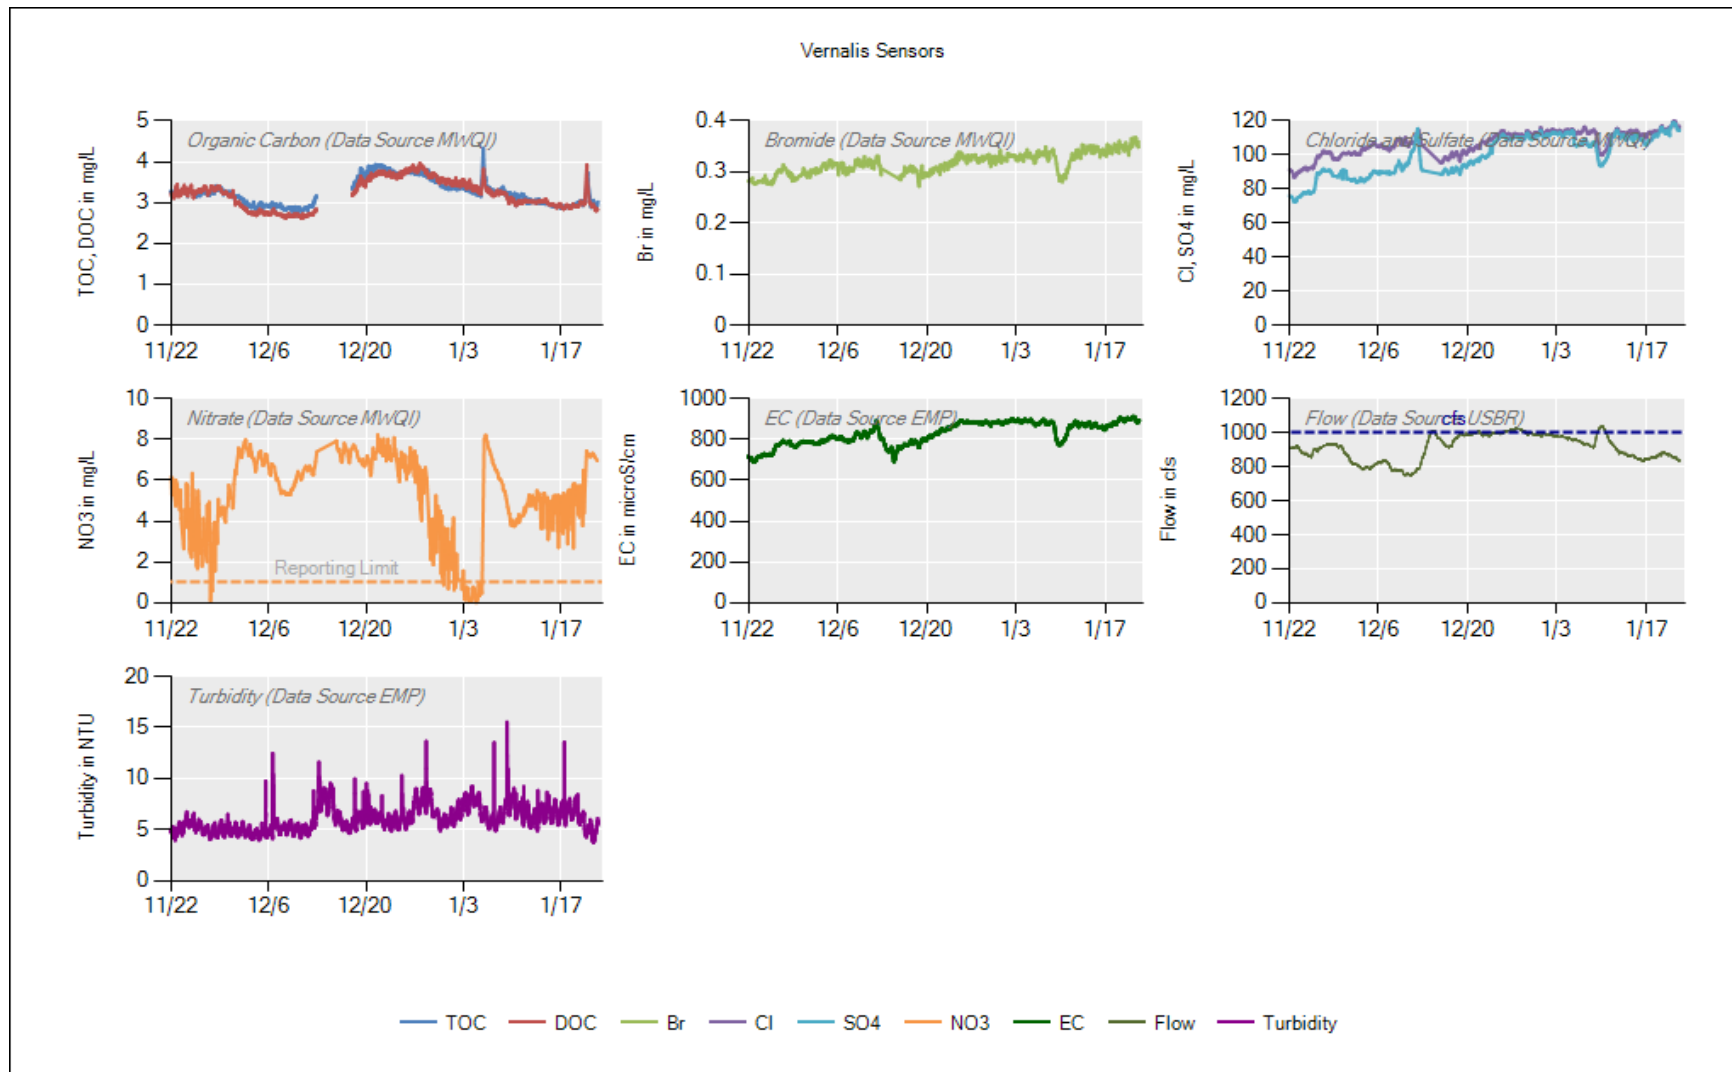
12/4: Replaced all system filters – 12/15: Power outage/communication disruption, re-started the computer, data transfers resumed, replaced all system filters, analyzed QC samples – 12/18: Communication disruption, re-started the communication software, it appeared to be locked up 1/5: TOC and DOC data have converged and DOC has also been reporting higher than TOC, replaced all system filters, DOC is now slightly lower than TOC – 1/20: Replaced all system filters, replaced a consumable in the carbon analyzer

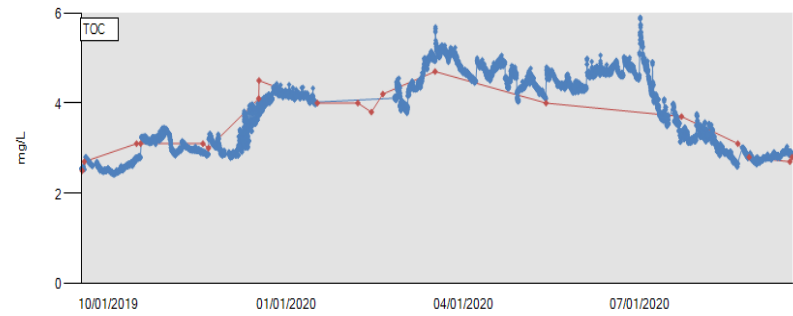
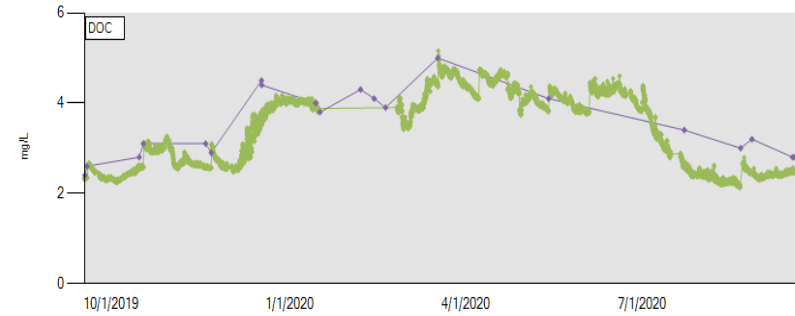
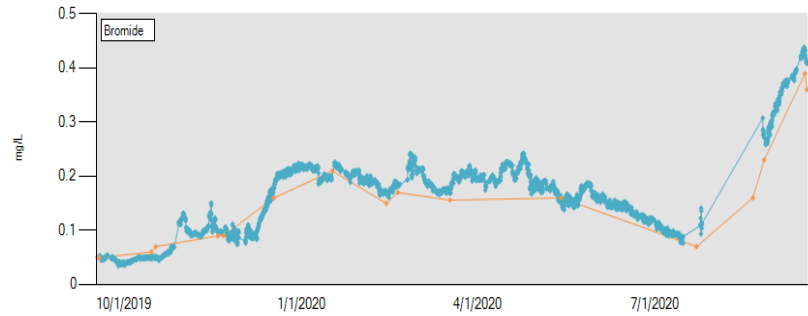
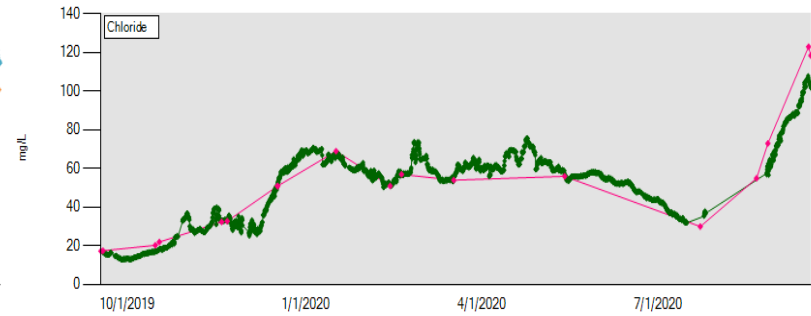
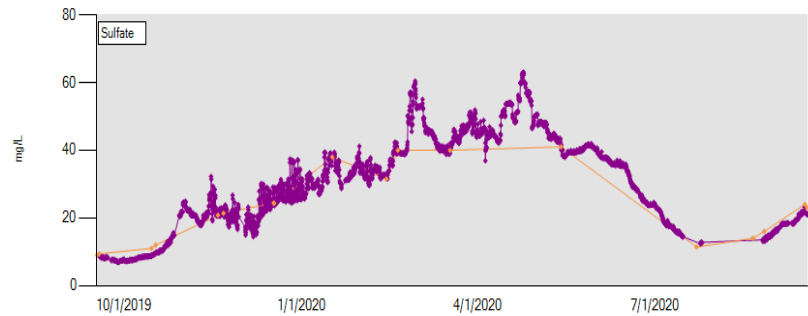
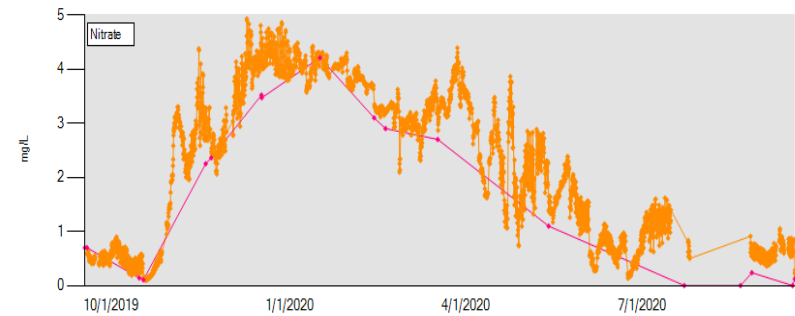
Banks Pumping Plant

HRO - Harvey O. Banks Pumping Plant-Sievers TOC
 HRO - Harvey O. Banks Pumping Plant-Sievers DOC
 HRO - Harvey O. Banks Pumping Plant-Bromide
 HRO - Harvey O. Banks Pumping Plant-Chloride
 HRO - Harvey O. Banks Pumping Plant-Sulfate
 HRO - Harvey O. Banks Pumping Plant-Nitrate
 HRO - Harvey O. Banks Pumping Plant-TOC Grab
 HRO - Harvey O. Banks Pumping Plant-DOC Grab
 HRO - Harvey O. Banks Pumping Plant-Bromide Grab
 HRO - Harvey O. Banks Pumping Plant-Chloride Grab
 HRO - Harvey O. Banks Pumping Plant-Sulfate Grab
 HRO - Harvey O. Banks Pumping Plant-Nitrate Grab

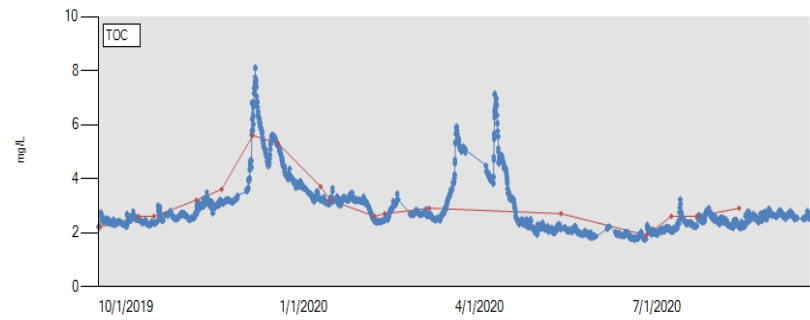
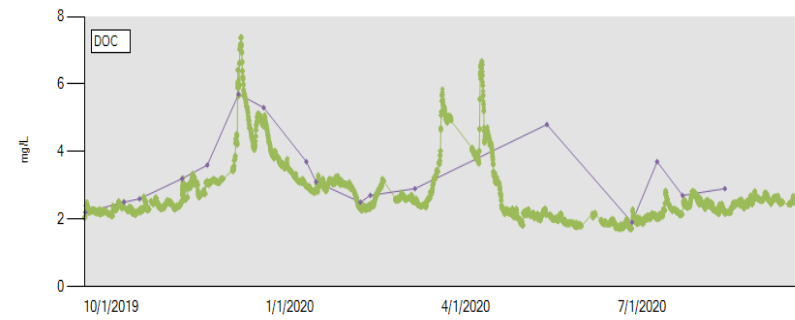
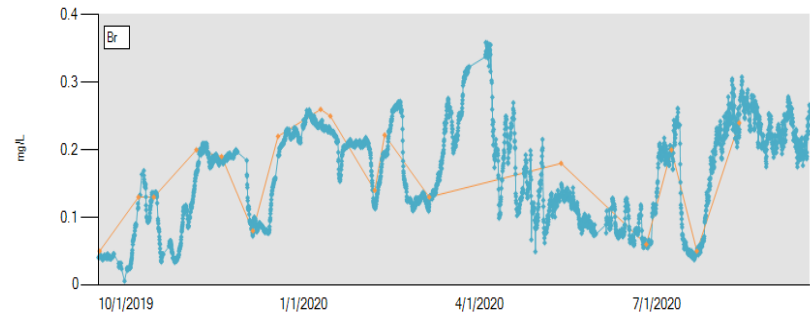
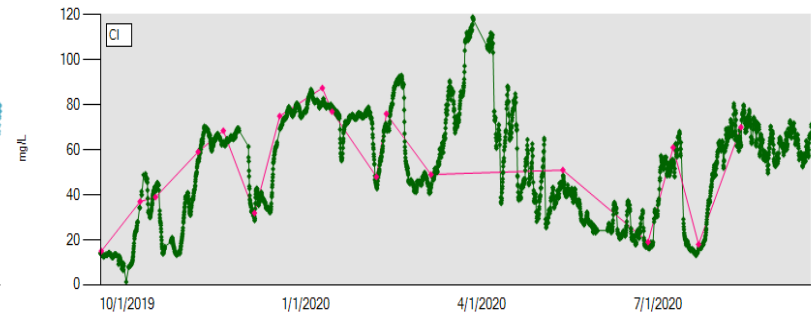
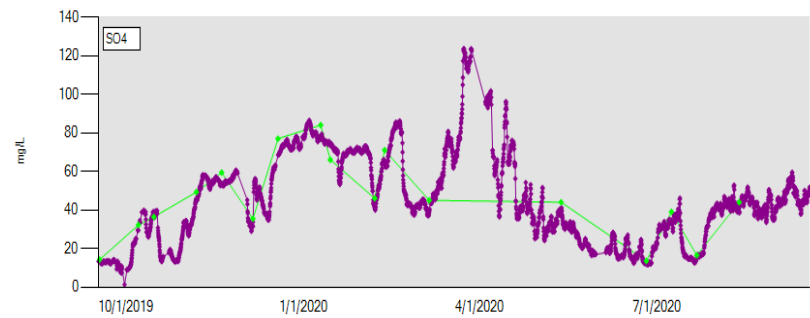
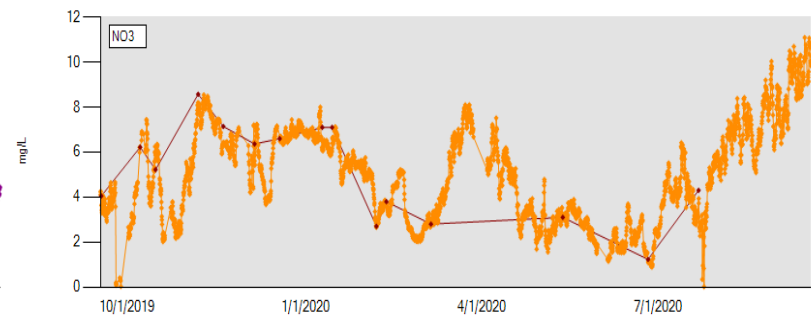
SJR Vernalis

SJR - San Joaquin River at Vernalis-Sievers TOC
 SJR - San Joaquin River at Vernalis-Sievers DOC
 SJR - San Joaquin River at Vernalis-Bromide
 SJR - San Joaquin River at Vernalis-Chloride
 SJR - San Joaquin River at Vernalis-Chloride Grab
 SJR - San Joaquin River at Vernalis-Sulfate
 SJR - San Joaquin River at Vernalis-Sulfate Grab
 SJR - San Joaquin River at Vernalis-Nitrate
 SJR - San Joaquin River at Vernalis-Nitrate Grab
