## Banks Pumping Plant: Discharge Pumping – TOC, DOC – EC

## Significant Events: May 14<sup>th</sup> 2015 to June 11<sup>th</sup> 2015

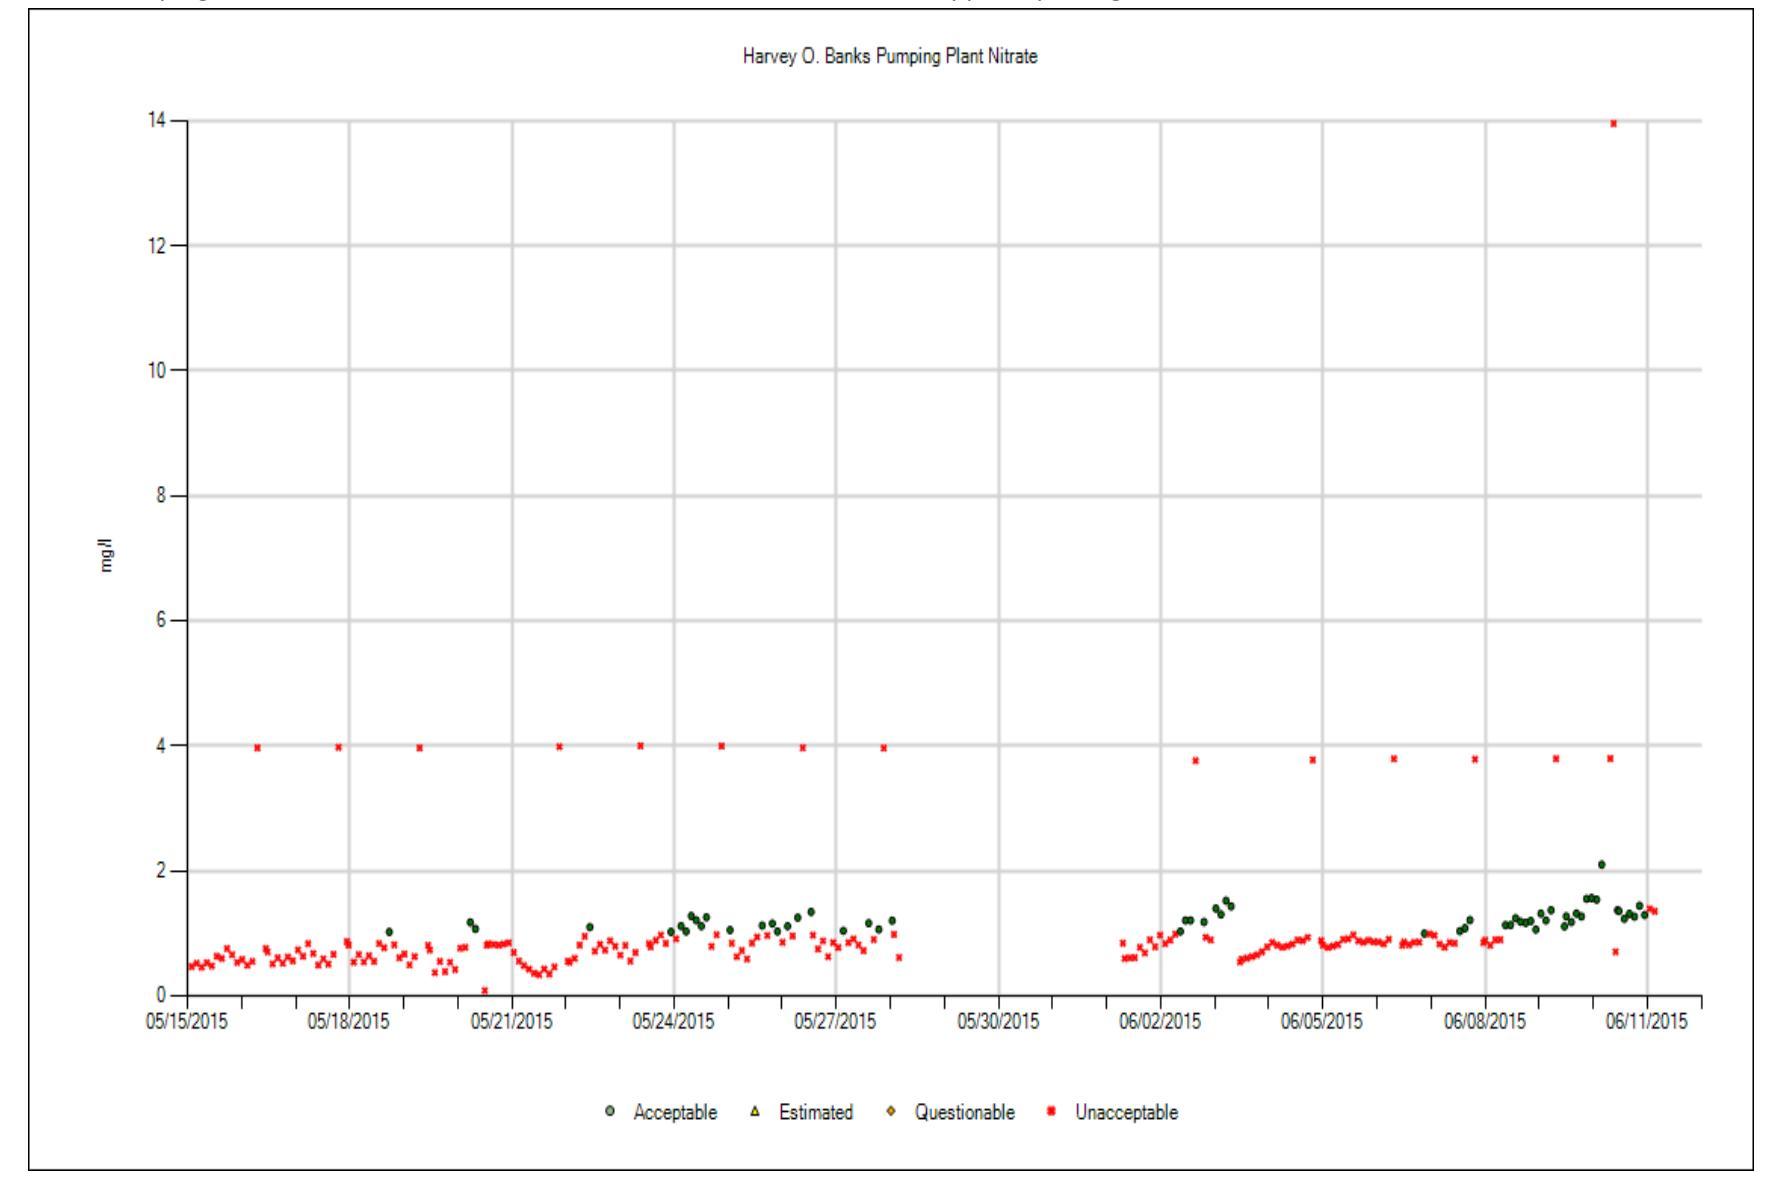
Banks Pumping Plant: Nitrate with Check Standards and values below the 1.0 ppm reporting limit

5/20 – Sample delivery system filter change

5/28 – Sample delivery system 100 um and 0.45 um filter change, anion analyzer annual preventative maintenance, calibration issue resolved on June 1

6/3 – Sample delivery system filter change

6/10 - Found that a non-50 um filter was installed in the 50 um housing, replaced with a 50 um filter, replaced the 100 um and 0.45 um, analyzed all QC samples, cleaned various lines

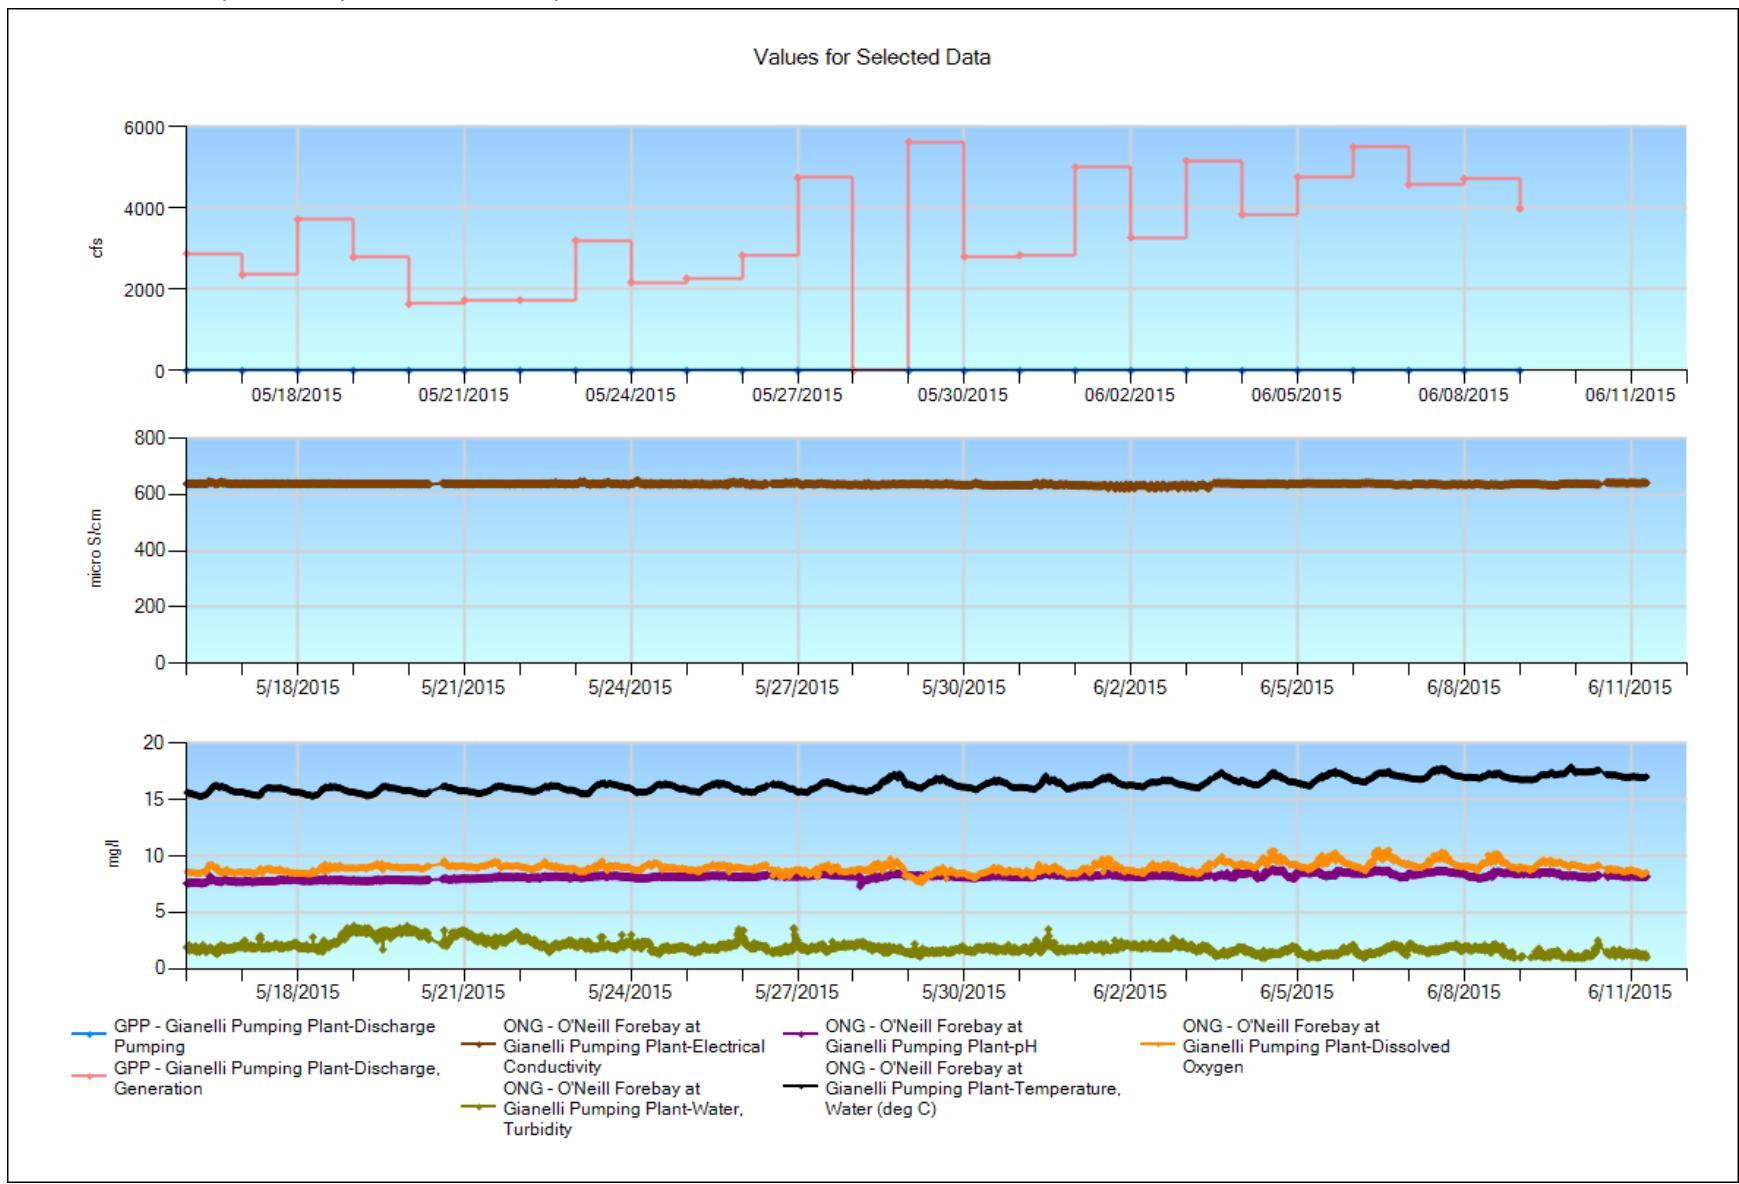
- > All parameters (5/16 5/18) --- Shutdown due to communication error.
- ▶ 5/20 --- Installed new computer to run the Metrohm software exclusively.
- > All parameters (5/21 5/26) --- The new computer shutdown due to incorrect power/hibernation settings.
- All parameters (5/26 6/2, intermittent) --- Low flow due to bypass valve setting and/or solenoid valve malfunction caused intermittent readings to measure non-representative water.

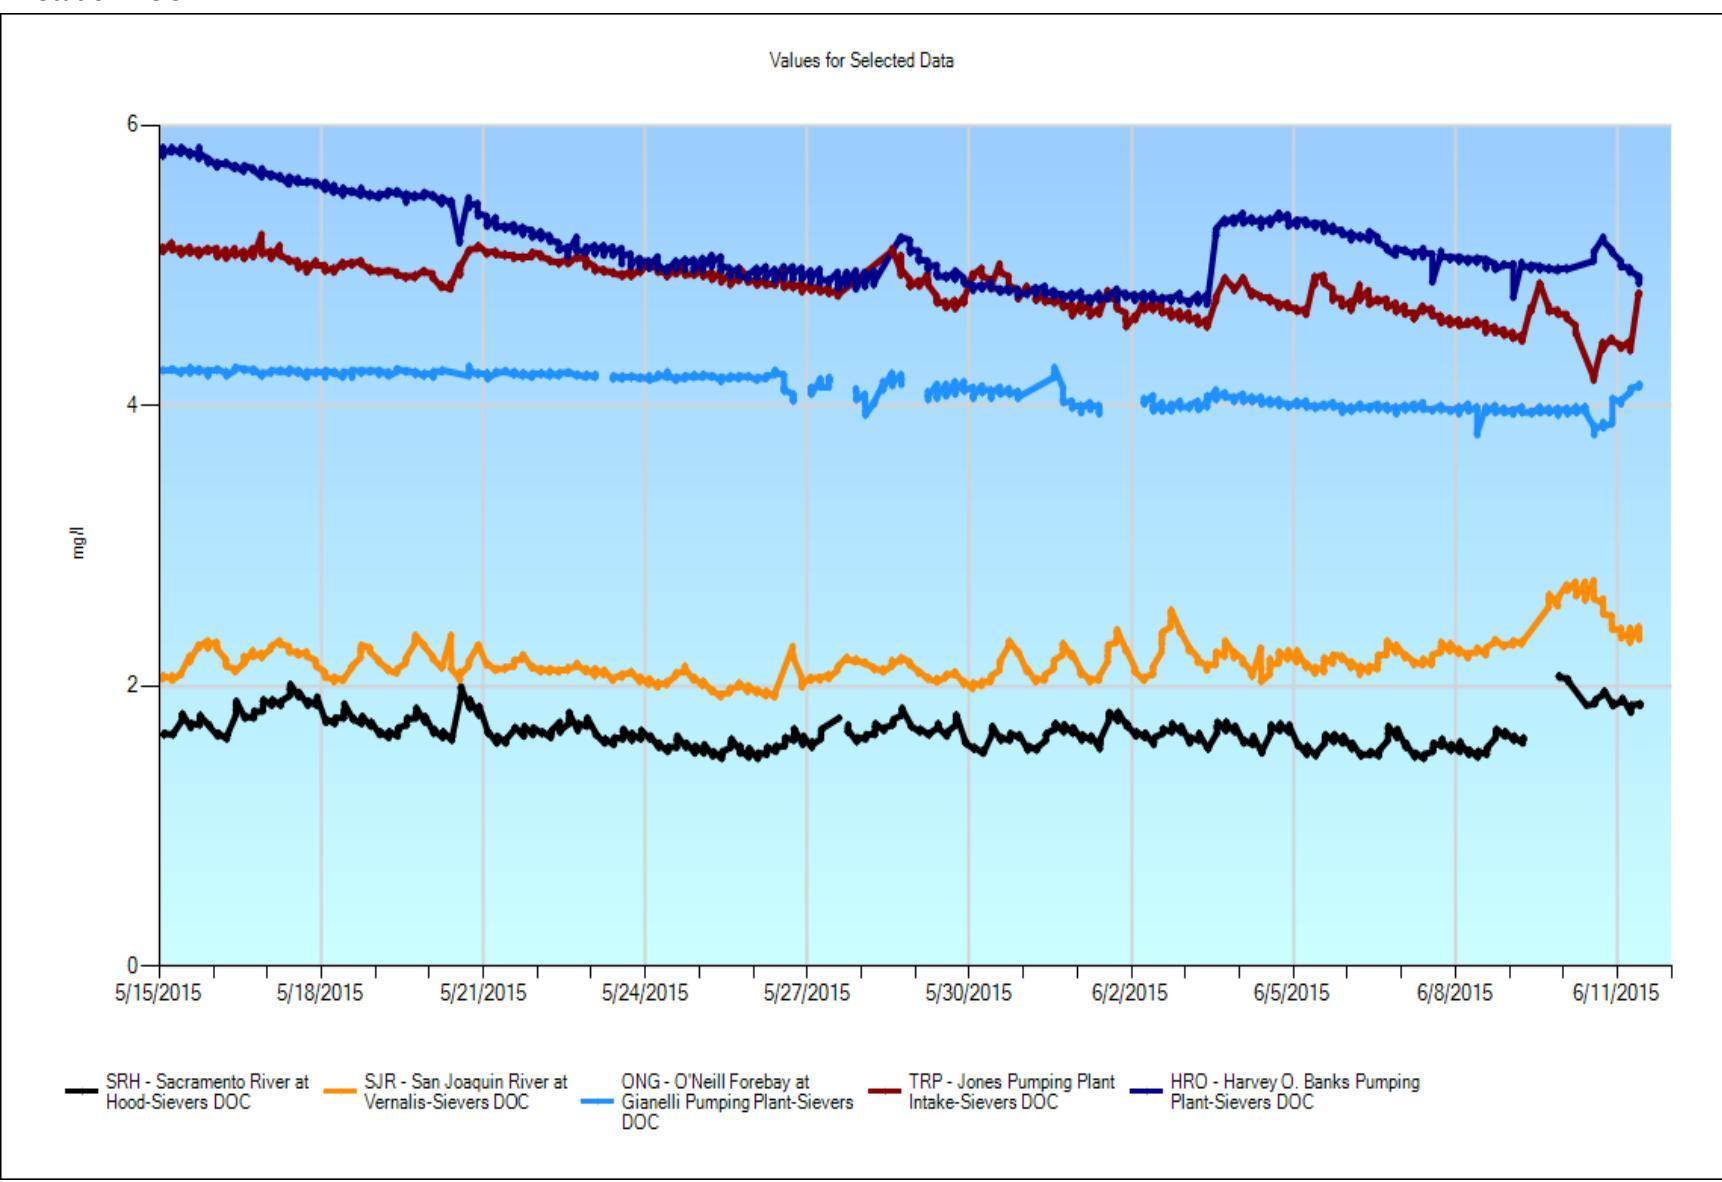
- **5/27 RTMQC**: Changed all pre-filters (75, 50, and 5 micron filters) except for the .45micron.
- 6/9 RTMQC: Changed the 75, 50 and .45 micron filters. The .45 micron filter was not flushed prior to install. This caused a spike in DOC values on the first 6 readings and I had to QC the data as unacceptable. Also, the computer restarted around 4:00 AM and Indigo never reopened.
